Tioga County Mitigation Advisory Committee

The following legislative master document is the product of a series of special meetings convened in the summer of 2025 by the Tioga County Mitigation Advisory Committee (MAC), operating under the exclusive authority of the FEMA and PEMA approved Tioga County All-Hazard Mitigation Plan. This Plan has been adopted by the Tioga County Board of Commissioners, all municipalities, stakeholder groups, and formally approved by FEMA and PEMA, ensuring its alignment with both local priorities and federal/state standards.

The centerpiece of the document, featuring imagery, site descriptions, and data collected during field assessments throughout the Cowanesque Valley. This section highlights observed damages, erosion sites, and areas requiring stabilization, as well as opportunities for proactive mitigation.

Published By: Tioga County (PA) GIS Department
September 22, 2025

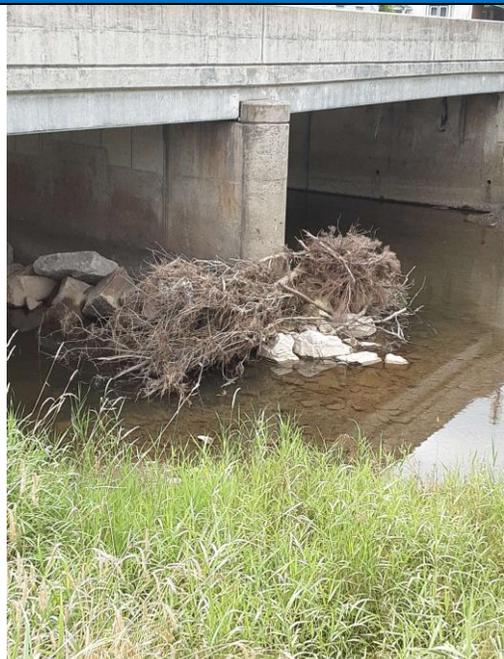
Infrastructure Protection	Map ID: 7
<p>WESTFIELD TWP (Y) Lat: 41.912376 (X) Long: -77.603179</p> <p>Gravel Bar Severity: Moderate Length: 50 ft Width: 12 ft Height: 1 ft Cubic Yards: 22.22 Immediate Concern: No Suggested Action:</p> <p>Comments: South bank.</p>

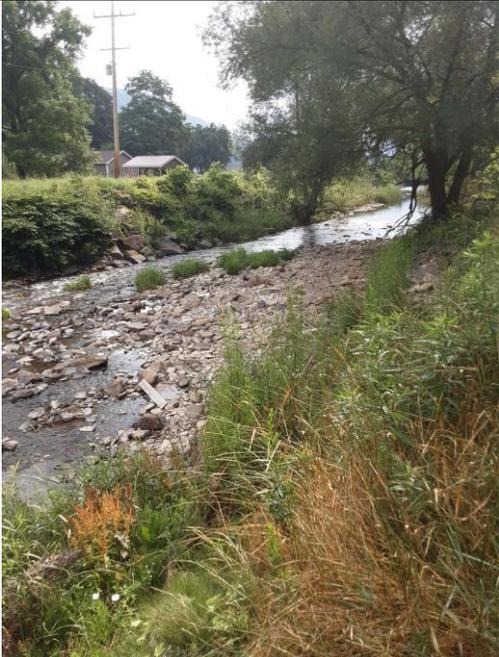
Debris Management	Map ID: 8
<p>WESTFIELD TWP (Y) Lat: 41.912421 (X) Long: -77.596337</p> <p>Debris Severity: High Length: 500 ft Width: 12 ft Height: 4 ft Cubic Yards: 888.89 Immediate Concern: Yes Suggested Action: Remove Debris</p> <p>Comments: Revisit with plan of access. Not too far from the bridge and an industrial plant.</p>

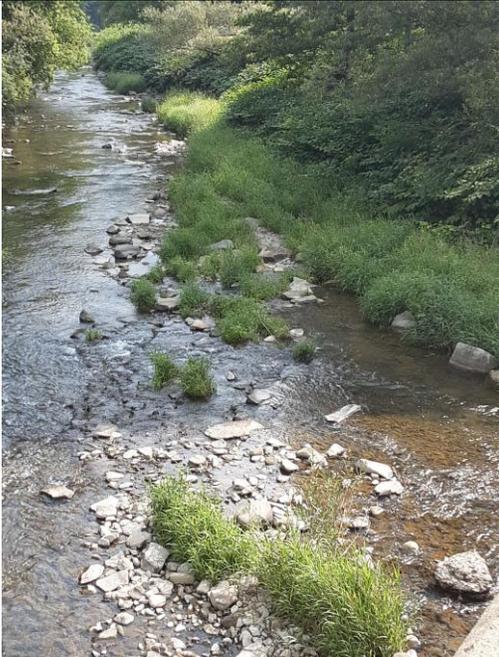
Debris Management	Map ID: 10
<p>WESTFIELD TWP (Y) Lat: 41.914865 (X) Long: -77.585062</p> <p>Debris Severity: High Length: 100 ft Width: 50 ft Height: 10 ft Cubic Yards: 1851.85 Immediate Concern: Yes Suggested Action: Remove Debris</p> <p>Comments: Large tree stump near homes and bridge. Homes would be affected in flooding. Tributary flows into river.</p>

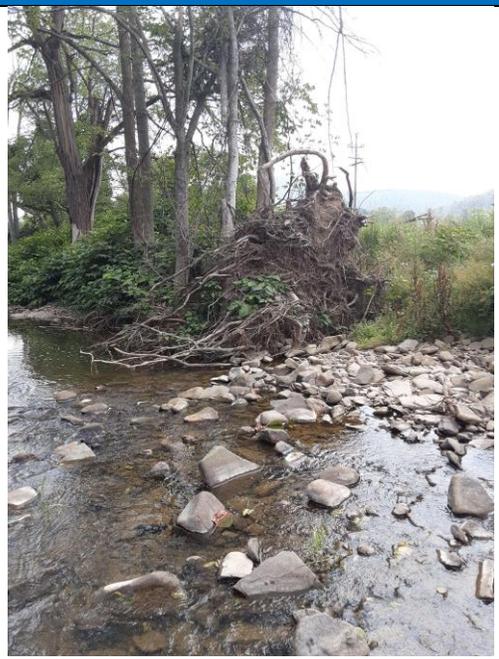
Debris Management	Map ID: 11
<p>WESTFIELD TWP (Y) Lat: 41.914879 (X) Long: -77.584074</p> <p>Vegetation Encroachment Severity: High Length: 100 ft Width: 14 ft Height: 8 ft Cubic Yards: 414.81 Immediate Concern: Yes Suggested Action:</p> <p>Comments: Bottleneck.</p>

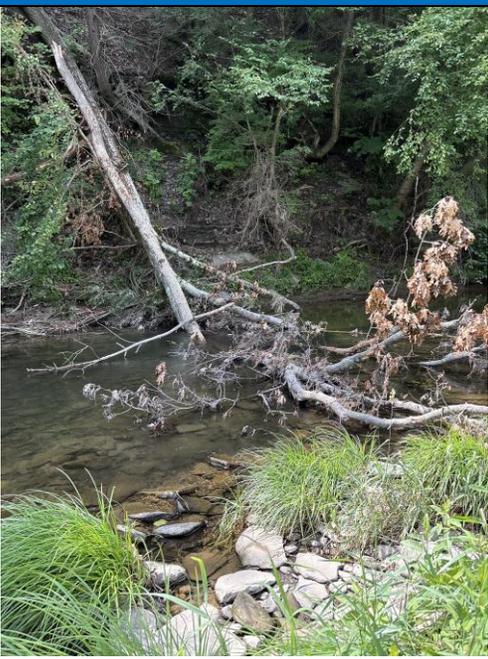
Debris Management	Map ID: 41
<p>WESTFIELD BORO (Y) Lat: 41.917320 (X) Long: -77.551918</p> <p>Debris Severity: Low Length: 15 ft Width: 10 ft Height: 4 ft Cubic Yards: 22.22 Immediate Concern: No Suggested Action:</p> <p>Comments:</p>

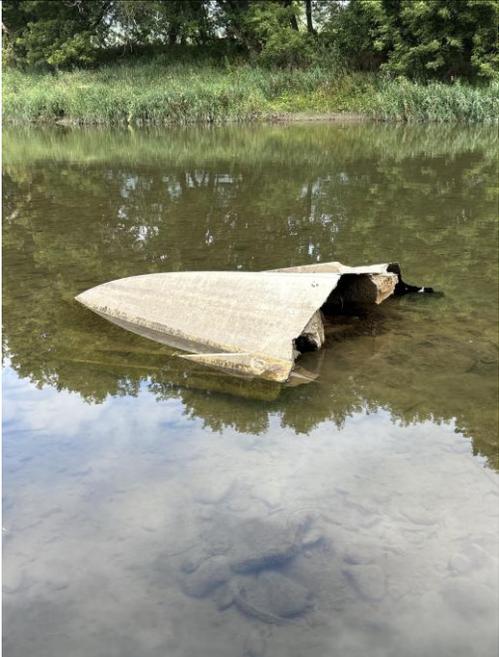
Bank Stabilization	Map ID: 60
<p>WESTFIELD TWP (Y) Lat: 41.924196 (X) Long: -77.528138</p> <p>Undercut Bank Severity: High Length: 175 ft Width: 5 ft Height: 3 ft Cubic Yards: 97.22 Immediate Concern: No Suggested Action:</p> <p>Comments:</p>

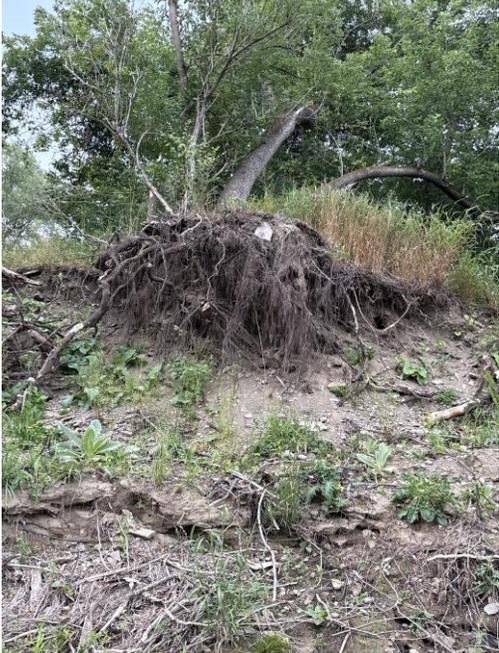
Bank Stabilization	Map ID: 64
<p>WESTFIELD TWP (Y) Lat: 41.925654 (X) Long: -77.526281</p> <p>Erosion Severity: Moderate Length: 200 ft Width: 5 ft Height: 8 ft Cubic Yards: 296.30 Immediate Concern: Yes Suggested Action: Stabilize Bank</p> <p>Comments:</p>

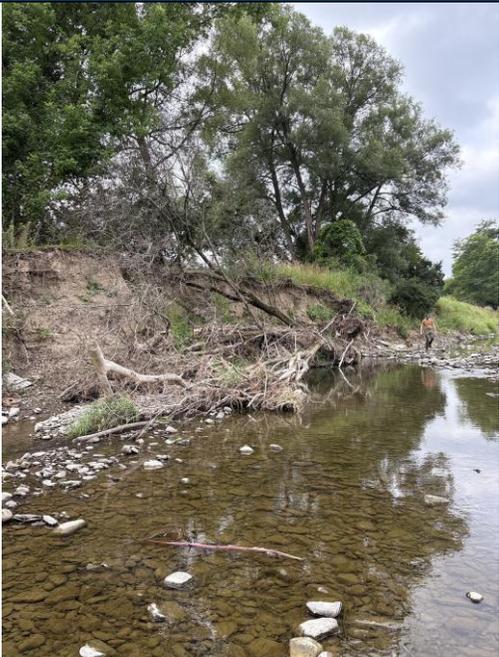
Debris Management	Map ID: 66
<p>WESTFIELD TWP (Y) Lat: 41.926114 (X) Long: -77.521829</p> <p>Debris Severity: Low Length: 25 ft Width: 8 ft Height: 3 ft Cubic Yards: 22.22 Immediate Concern: No Suggested Action:</p> <p>Comments:</p>

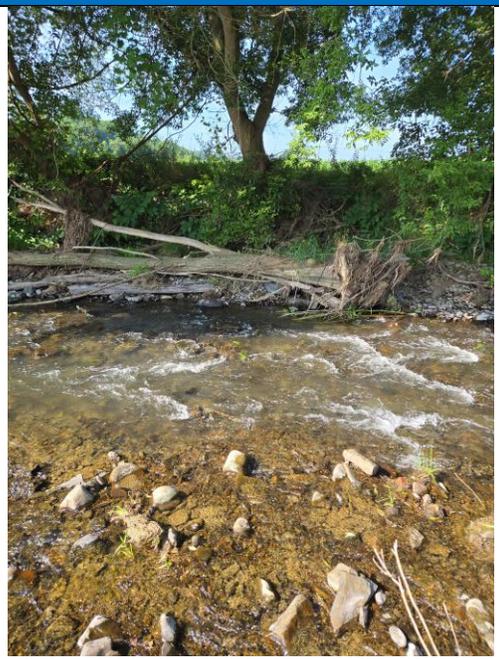
Debris Management	Map ID: 67
<p>WESTFIELD TWP (Y) Lat: 41.925517 (X) Long: -77.521773</p> <p>Debris Severity: Moderate Length: 30 ft Width: 15 ft Height: 8 ft Cubic Yards: 133.33 Immediate Concern: Yes Suggested Action: Remove Debris</p> <p>Comments:</p>

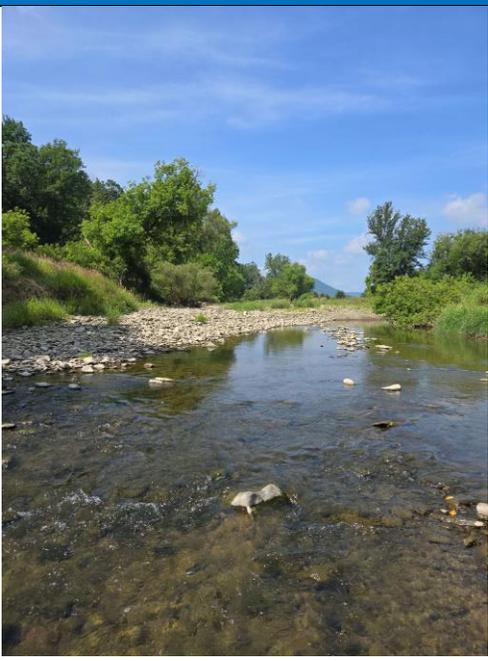
Debris Management	Map ID: 79
<p>WESTFIELD TWP (Y) Lat: 41.931519 (X) Long: -77.502077</p> <p>Debris Severity: Moderate Length: 20 ft Width: 20 ft Height: 1 ft Cubic Yards: 14.81 Immediate Concern: Yes Suggested Action: Remove Debris</p> <p>Comments: Long view.</p>

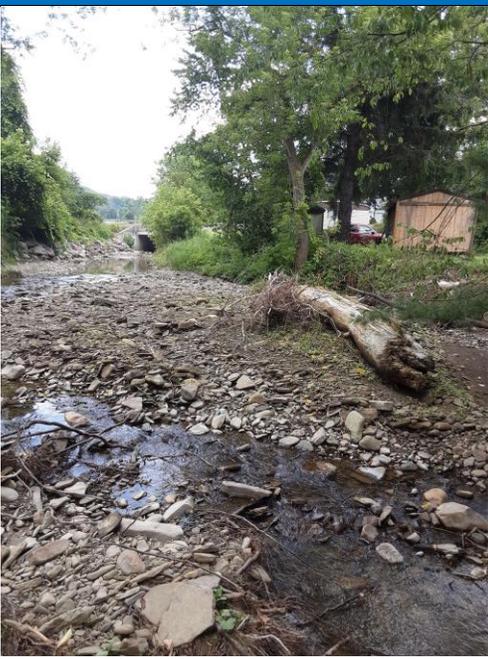
Debris Management	Map ID: 81
<p>WESTFIELD TWP (Y) Lat: 41.930613 (X) Long: -77.501529</p> <p>Debris Severity: Low Length: 6 ft Width: 1 ft Height: 1 ft Cubic Yards: 0.22 Immediate Concern: No Suggested Action:</p> <p>Comments: Debris car bumper.</p>

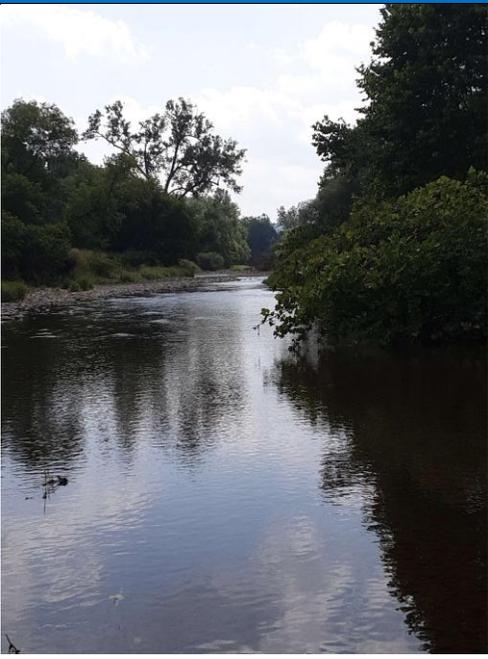
Debris Management	Map ID: 83
<p>WESTFIELD TWP (Y) Lat: 41.930152 (X) Long: -77.501067</p> <p>Gravel Bar Severity: High Length: 50 ft Width: 50 ft Height: 2 ft Cubic Yards: 185.19 Immediate Concern: Yes Suggested Action: Remove Debris</p> <p>Comments: Debris also present, huge tree down. Near bridge and homes.</p>

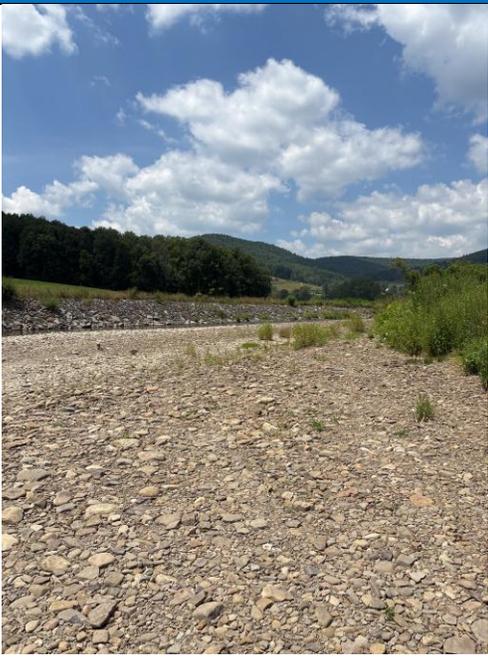
Debris Management	Map ID: 97
<p>DEERFIELD TWP (Y) Lat: 41.948863 (X) Long: -77.458719</p> <p>Debris Severity: High Length: 60 ft Width: 6 ft Height: 5 ft Cubic Yards: 66.67 Immediate Concern: No Suggested Action:</p> <p>Comments: Debris and gravel bar.</p>

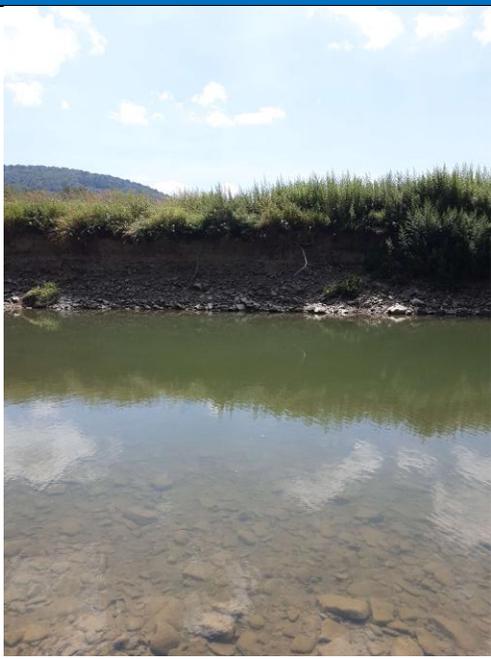
Stream Restoration	Map ID: 129
<p>DEERFIELD TWP (Y) Lat: 41.954959 (X) Long: -77.413566</p> <p>Gravel Bar Severity: Low Length: 400 ft Width: 40 ft Height: 2 ft Cubic Yards: 1185.19 Immediate Concern: No Suggested Action:</p> <p>Comments:</p>

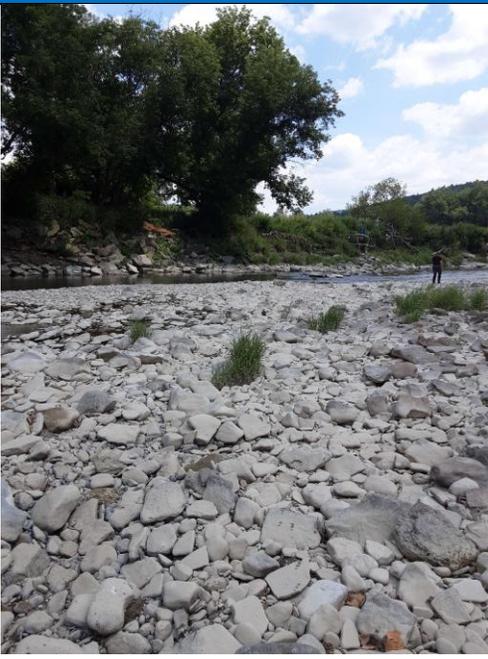
Debris Management	Map ID: 131
<p>DEERFIELD TWP (Y) Lat: 41.955016 (X) Long: -77.410921</p> <p>Debris Severity: Moderate Length: 20 ft Width: 20 ft Height: 10 ft Cubic Yards: 148.15 Immediate Concern: Yes Suggested Action: Remove Debris</p> <p>Comments: Tree and debris</p>

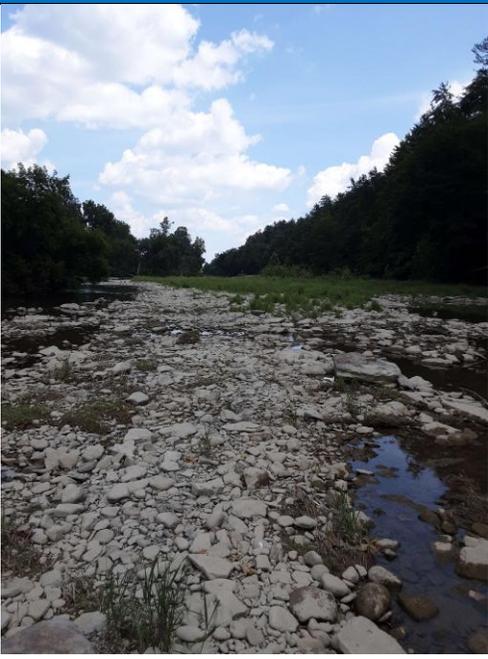
Debris Management	Map ID: 139
<p>DEERFIELD TWP (Y) Lat: 41.955560 (X) Long: -77.405694</p> <p>Debris Severity: Moderate Length: 50 ft Width: 10 ft Height: 3 ft Cubic Yards: 55.56 Immediate Concern: Yes Suggested Action: Remove Debris</p> <p>Comments: Trees</p>

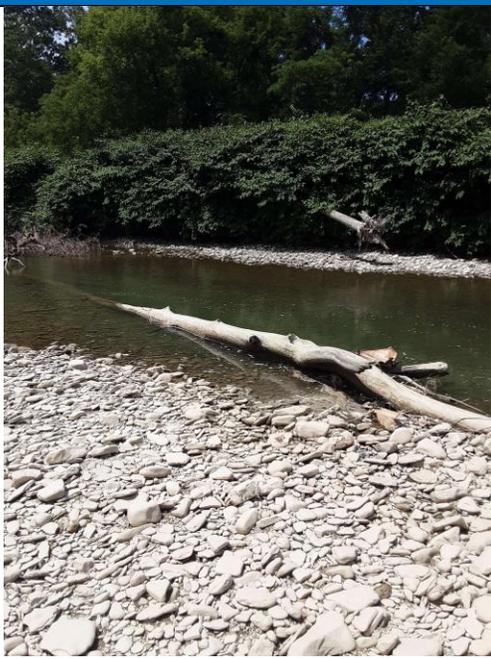
Stream Restoration	Map ID: 141
<p>DEERFIELD TWP (Y) Lat: 41.955912 (X) Long: -77.404787</p> <p>Gravel Bar Severity: Moderate Length: 200 ft Width: 50 ft Height: 1.5 ft Cubic Yards: 555.56 Immediate Concern: Yes Suggested Action: Restore Channel</p> <p>Comments: Upstream as well</p>

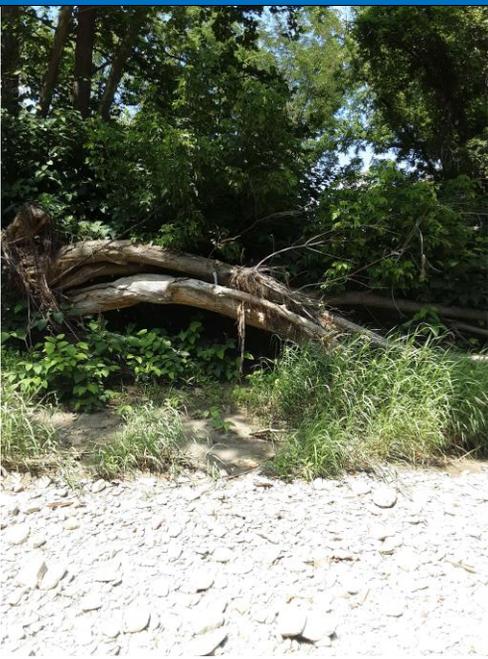
Debris Management	Map ID: 145
<p>DEERFIELD TWP (Y) Lat: 41.957018 (X) Long: -77.402048</p> <p>Gravel Bar Severity: Moderate Length: 100 ft Width: 100 ft Height: 50 ft Cubic Yards: 18518.52 Immediate Concern: No Suggested Action:</p> <p>Comments: Trees and gravel bar.</p>

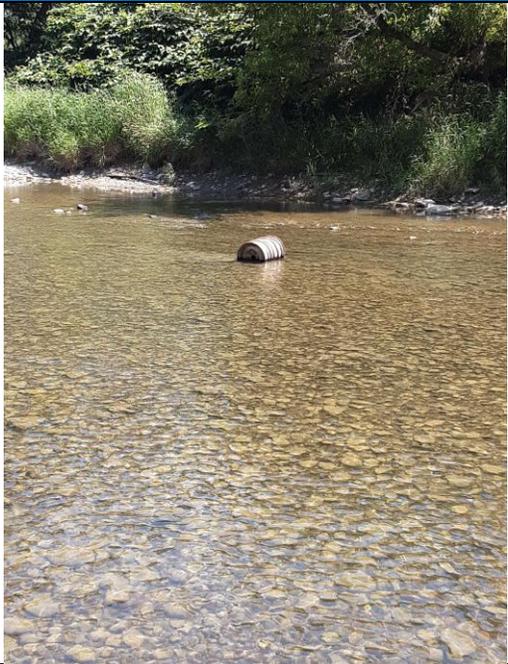
Debris Management	Map ID: 147
<p>DEERFIELD TWP (Y) Lat: 41.957646 (X) Long: -77.400965</p> <p>Debris Severity: High Length: 10 ft Width: 10 ft Height: 1 ft Cubic Yards: 3.70 Immediate Concern: Yes Suggested Action: Remove Debris</p> <p>Comments:</p>

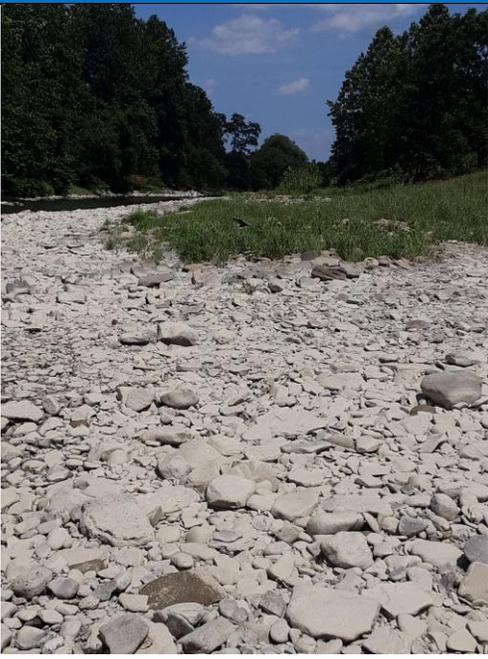
Debris Management	Map ID: 151
<p>DEERFIELD TWP (Y) Lat: 41.958820 (X) Long: -77.398397</p> <p>other Severity: Low Length: 50 ft Width: 10 ft Height: 4 ft Cubic Yards: 74.07 Immediate Concern: No Suggested Action:</p> <p>Comments:</p>

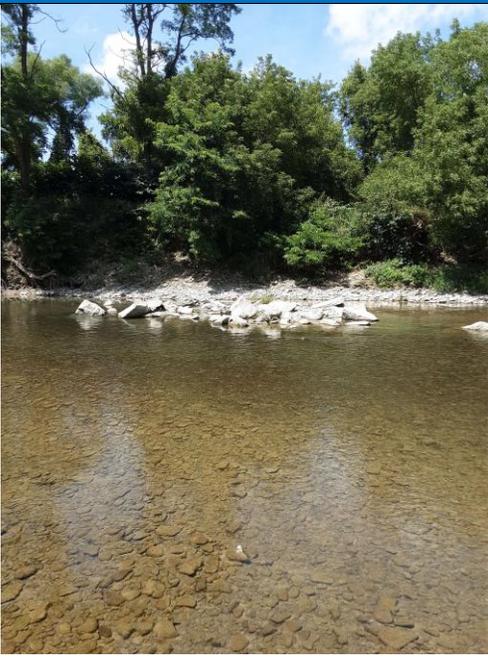
Debris Management	Map ID: 155
<p>DEERFIELD TWP (Y) Lat: 41.959403 (X) Long: -77.396344</p> <p>Debris Severity: Moderate Length: 200 ft Width: 75 ft Height: 10 ft Cubic Yards: 5555.56 Immediate Concern: Yes Suggested Action: Remove Debris</p> <p>Comments: Rip rap rocks, gravel rock bar and huge fallen trees.</p>

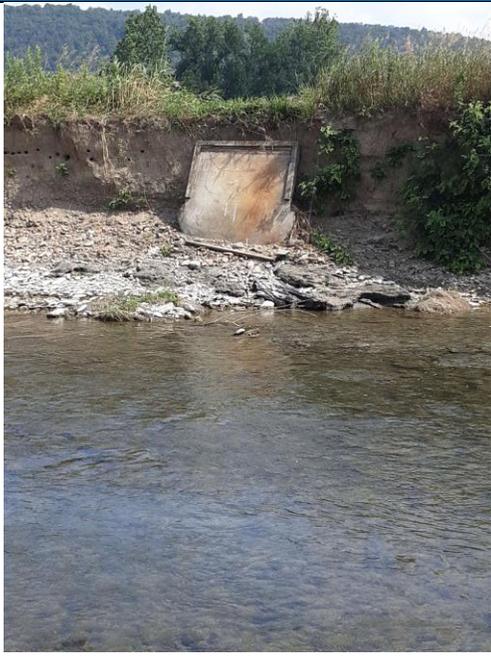
Bank Stabilization	Map ID: 171
<p>OSCEOLA TWP (Y) Lat: 41.970003 (X) Long: -77.368310</p> <p>Undercut Bank Severity: Moderate Length: 200 ft Width: 3 ft Height: 10 ft Cubic Yards: 222.22 Immediate Concern: No Suggested Action:</p> <p>Comments:</p>

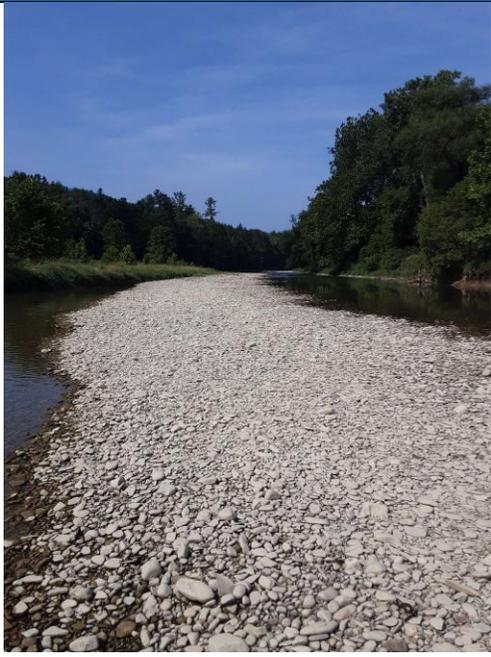
Debris Management	Map ID: 187
<p>OSCEOLA TWP (Y) Lat: 41.972332 (X) Long: -77.351990</p> <p>Debris Severity: Moderate Length: 30 ft Width: 5 ft Height: 4 ft Cubic Yards: 22.22 Immediate Concern: Yes Suggested Action: Remove Debris</p> <p>Comments: Could float down river and cause problems.</p>

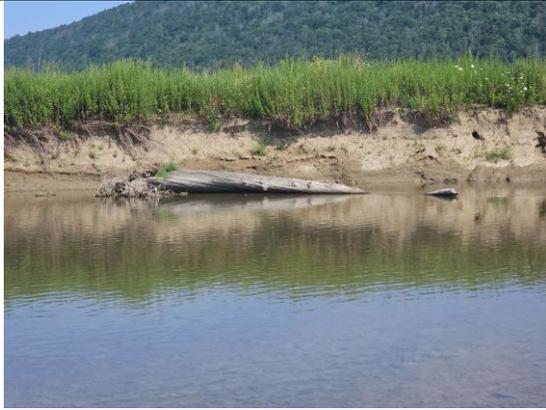
Bank Stabilization	Map ID: 188
<p>OSCEOLA TWP (Y) Lat: 41.972744 (X) Long: -77.350840</p> <p>Undercut Bank Severity: High Length: 500 ft Width: 10 ft Height: 8 ft Cubic Yards: 1481.48 Immediate Concern: Yes Suggested Action: Stabilize Bank</p> <p>Comments: Severe undercut.</p>
