Tioga County Mitigation Advisory Committee

The following legislative master document is the product of a series of special meetings convened in the summer of 2025 by the Tioga County Mitigation Advisory Committee (MAC), operating under the exclusive authority of the FEMA and PEMA approved Tioga County All-Hazard Mitigation Plan. This Plan has been adopted by the Tioga County Board of Commissioners, all municipalities, stakeholder groups, and formally approved by FEMA and PEMA, ensuring its alignment with both local priorities and federal/state standards.

The centerpiece of the document, featuring imagery, site descriptions, and data collected during field assessments throughout the Cowanesque Valley. This section highlights observed damages, erosion sites, and areas requiring stabilization, as well as opportunities for proactive mitigation.

Published By: Tioga County (PA) GIS Department
September 22, 2025

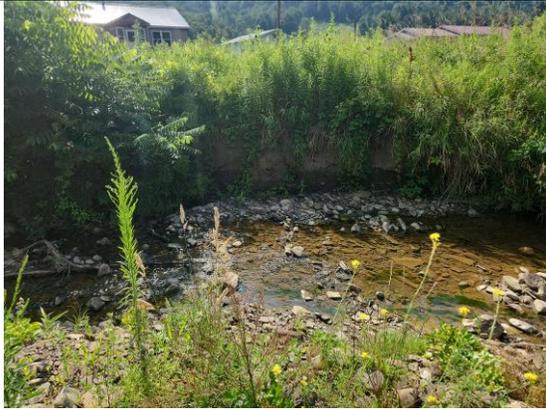
Bank Stabilization	Map ID: 1
<p>WESTFIELD TWP (Y) Lat: 41.910271 (X) Long: -77.604310</p> <p>Erosion Severity: Moderate Length: 20 ft Width: 10 ft Height: 5 ft Cubic Yards: 37.04 Immediate Concern: No Suggested Action:</p> <p>Comments: Eroding to within 20 feet of state road.</p>

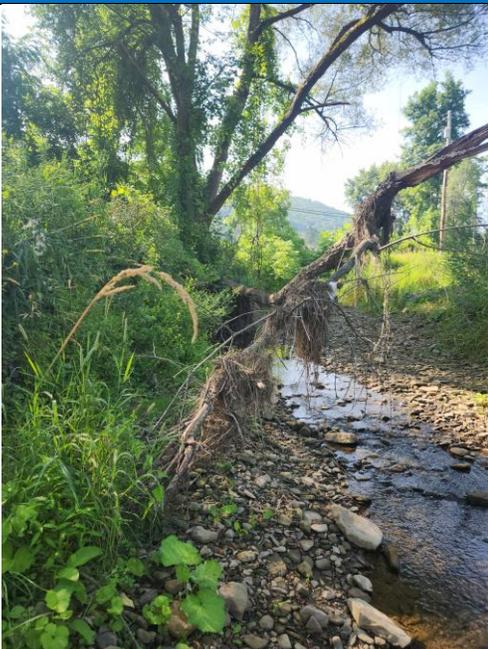
Debris Management	Map ID: 2
<p>WESTFIELD TWP (Y) Lat: 41.910611 (X) Long: -77.604305</p> <p>Infrastructure Risk Severity: High Length: 80 ft Width: 20 ft Height: 8 ft Cubic Yards: 474.07 Immediate Concern: Yes Suggested Action: Other</p> <p>Comments: Total 80 lineal feet of 1 foot diameter trees plus smaller limbs and a large root ball about 120 feet upstream from a small state road bridge.</p>

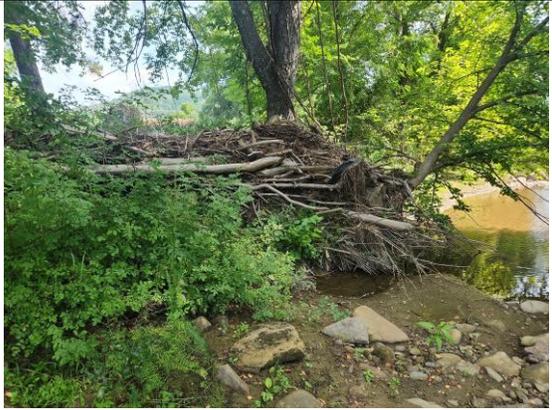
Debris Management	Map ID: 3
<p>WESTFIELD TWP (Y) Lat: 41.910975 (X) Long: -77.603697</p> <p>Vegetation Encroachment Severity: Low Length: 50 ft Width: 15 ft Height: 25 ft Cubic Yards: 694.44 Immediate Concern: No Suggested Action:</p> <p>Comments: Medium size tree overhanging stream with other wood debris piled behind it.</p>

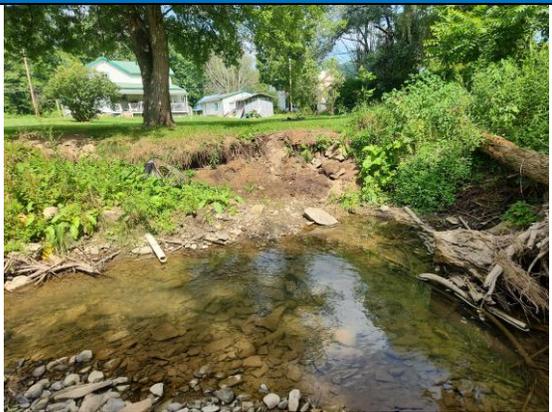
Bank Stabilization	Map ID: 4
<p>WESTFIELD TWP (Y) Lat: 41.911199 (X) Long: -77.603135</p> <p>Undercut Bank Severity: Moderate Length: 15 ft Width: 12 ft Height: 6 ft Cubic Yards: 40.00 Immediate Concern: No Suggested Action:</p> <p>Comments: Undercut to lawn with wooded debris that will encourage more erosion.</p>

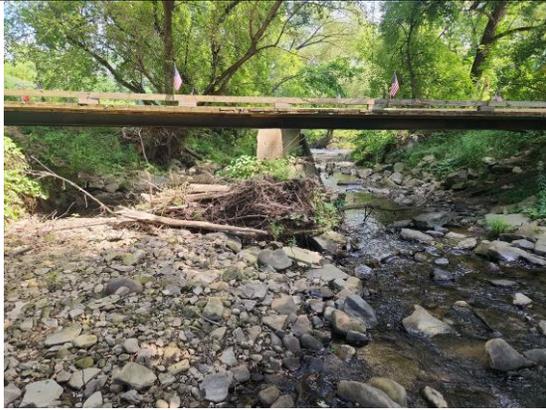
Debris Management	Map ID: 5
<p>WESTFIELD TWP (Y) Lat: 41.912012 (X) Long: -77.602863</p> <p>Debris Severity: Moderate Length: 10 ft Width: 6 ft Height: 5 ft Cubic Yards: 11.11 Immediate Concern: No Suggested Action:</p> <p>Comments: Debris against pier of private bridge.</p>

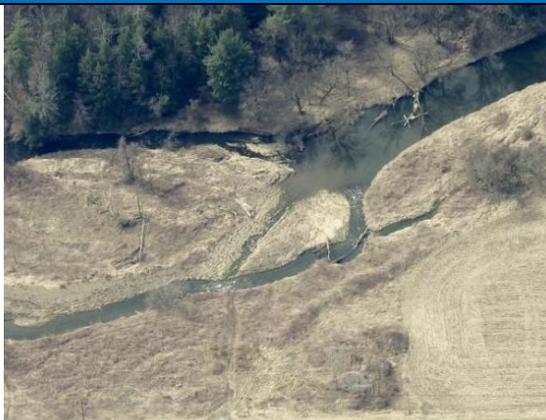
Debris Management	Map ID: 8
<p>WESTFIELD TWP (Y) Lat: 41.912421 (X) Long: -77.596337</p> <p>Debris Severity: High Length: 500 ft Width: 12 ft Height: 4 ft Cubic Yards: 888.89 Immediate Concern: Yes Suggested Action: Remove Debris</p> <p>Comments: Revisit with plan of access. Not too far from the bridge and an industrial plant.</p>

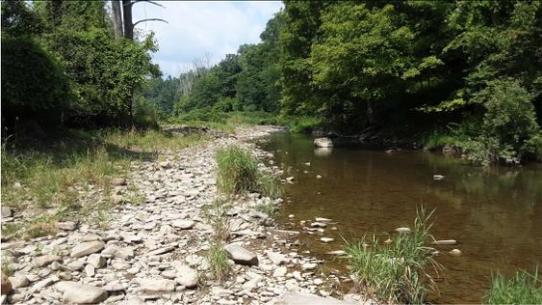
Debris Management	Map ID: 11
<p>WESTFIELD TWP (Y) Lat: 41.914879 (X) Long: -77.584074</p> <p>Vegetation Encroachment Severity: High Length: 100 ft Width: 14 ft Height: 8 ft Cubic Yards: 414.81 Immediate Concern: Yes Suggested Action:</p> <p>Comments: Bottleneck.</p>

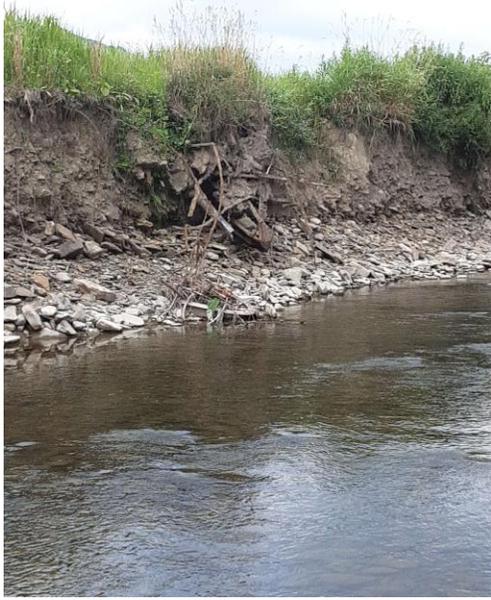
Bank Stabilization	Map ID: 12
<p>WESTFIELD TWP (Y) Lat: 41.914593 (X) Long: -77.580837</p> <p>Undercut Bank Severity: Moderate Length: 400 ft Width: 5 ft Height: 10 ft Cubic Yards: 740.74 Immediate Concern: Yes Suggested Action: Stabilize Bank</p> <p>Comments: Bank is about plus 10 ft high. Piping exposed. Bank could collapse on pipe.</p>

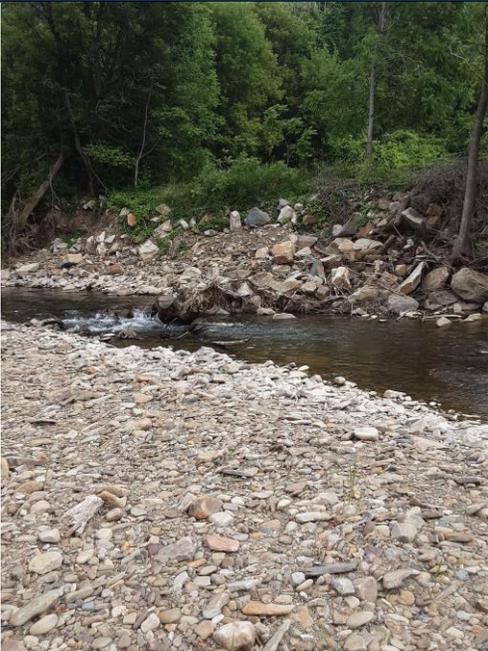
Debris Management	Map ID: 13
<p>WESTFIELD TWP (Y) Lat: 41.914670 (X) Long: -77.579901</p> <p>Debris Severity: Moderate Length: 7 ft Width: 7 ft Height: 4 ft Cubic Yards: 7.26 Immediate Concern: Yes Suggested Action:</p> <p>Comments: Large tree stump near bridge. Significant debris along bank.</p>

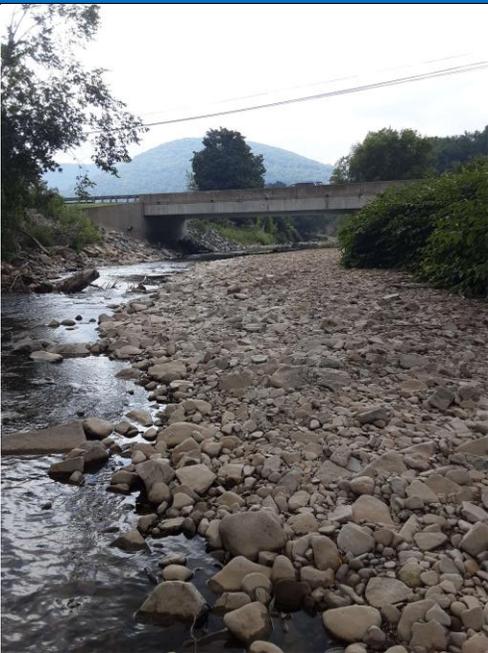
Infrastructure Protection	Map ID: 14
<p>WESTFIELD TWP (Y) Lat: 41.914509 (X) Long: -77.579757</p> <p>Gravel Bar Severity: High Length: 155 ft Width: 30 ft Height: 2.5 ft Cubic Yards: 430.56 Immediate Concern: Yes Suggested Action: Remove Debris</p> <p>Comments: Under bridge, severe. Near homes and barns.</p>

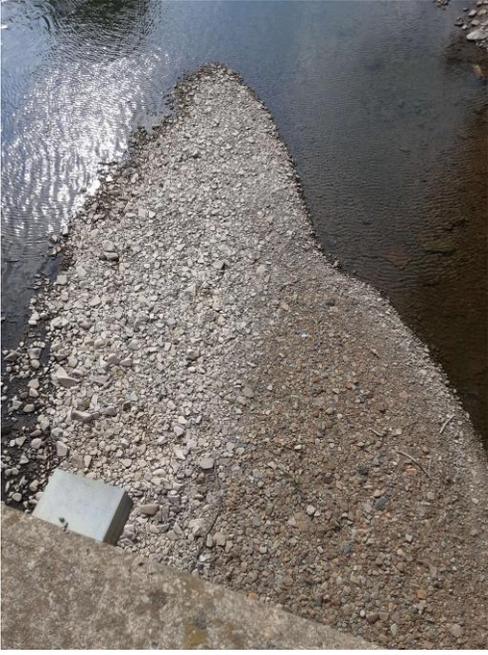
Infrastructure Protection	Map ID: 15
<p>WESTFIELD TWP (Y) Lat: 41.914415 (X) Long: -77.579478</p> <p>Gravel Bar Severity: High Length: 50 ft Width: 20 ft Height: 1 ft Cubic Yards: 37.04 Immediate Concern: No Suggested Action:</p> <p>Comments: Center below bridge. Threatening bridge infrastructure.</p>

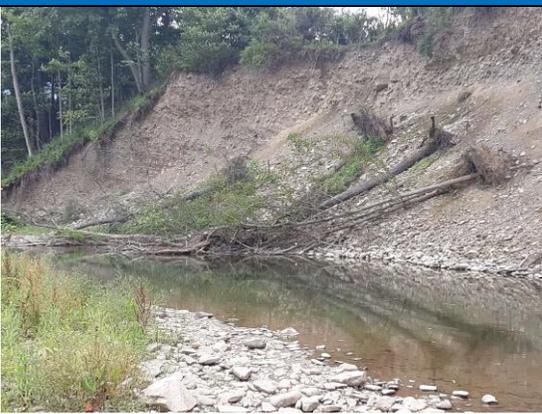
Bank Stabilization	Map ID: 16
<p>WESTFIELD TWP (Y) Lat: 41.913146 (X) Long: -77.577377</p> <p>Undercut Bank Severity: High Length: 100 ft Width: 50 ft Height: 150 ft Cubic Yards: 27777.78 Immediate Concern: Yes Suggested Action: Stabilize Bank</p> <p>Comments: Bad cut. Near bridge.</p>

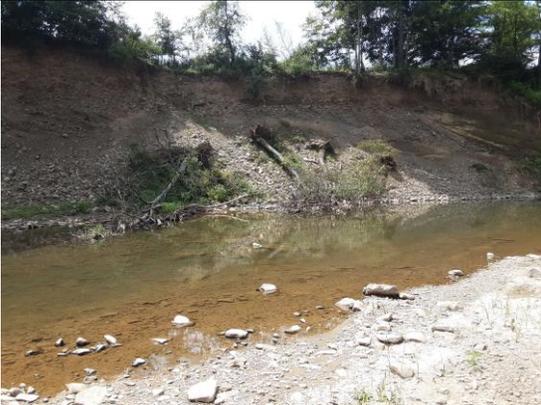
Bank Stabilization	Map ID: 17
<p>WESTFIELD TWP (Y) Lat: 41.913218 (X) Long: -77.576821</p> <p>Undercut Bank Severity: High Length: 1000 ft Width: 50 ft Height: 75 ft Cubic Yards: 138888.89 Immediate Concern: No Suggested Action:</p> <p>Comments: Bad cut and debris.</p>

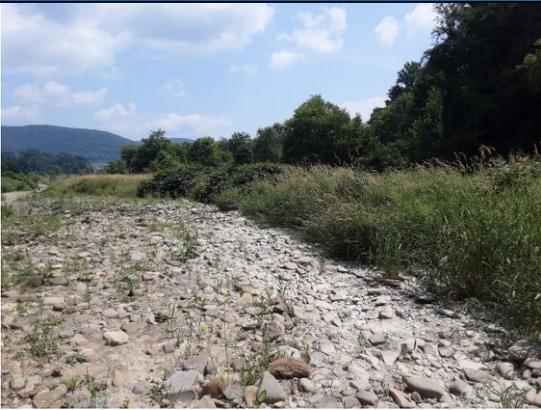
Stream Restoration	Map ID: 18
<p>WESTFIELD TWP (Y) Lat: 41.913863 (X) Long: -77.575735</p> <p>Gravel Bar Severity: High Length: 800 ft Width: 50 ft Height: 2 ft Cubic Yards: 2962.96 Immediate Concern: Yes Suggested Action: Remove Debris</p> <p>Comments:</p>

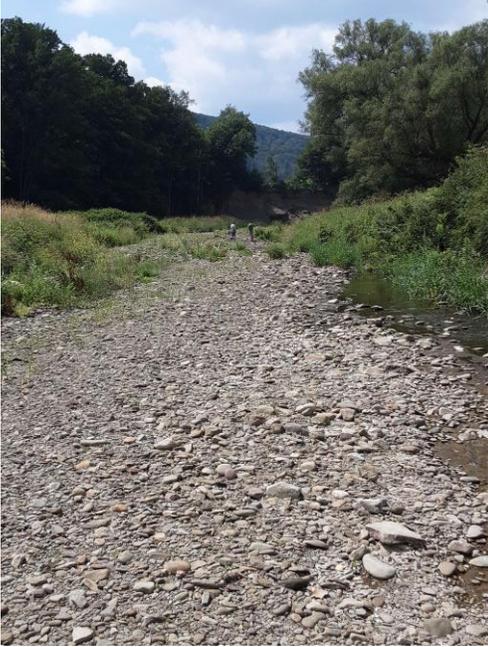
Stream Restoration	Map ID: 19
<p>WESTFIELD TWP (Y) Lat: 41.914213 (X) Long: -77.575381</p> <p>Gravel Bar Severity: High Length: 1000 ft Width: 50 ft Height: 2 ft Cubic Yards: 3703.70 Immediate Concern: No Suggested Action:</p> <p>Comments:</p>

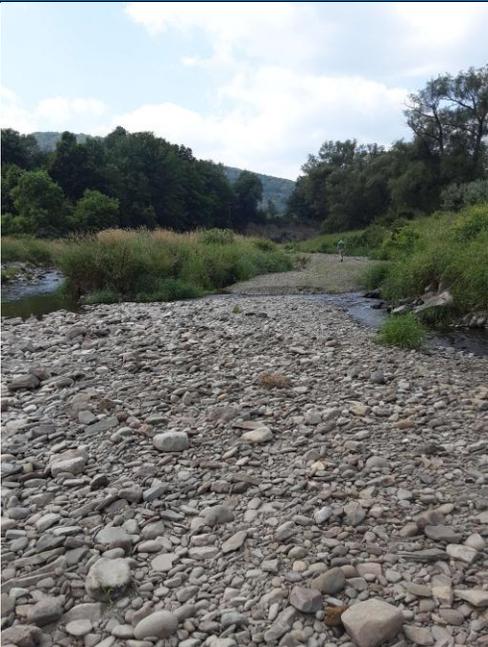
Stream Restoration	Map ID: 20
<p>WESTFIELD TWP (Y) Lat: 41.914452 (X) Long: -77.574972</p> <p>Gravel Bar Severity: High Length: 1000 ft Width: 50 ft Height: 3 ft Cubic Yards: 5555.56 Immediate Concern: Yes Suggested Action:</p> <p>Comments: Bad section.</p>

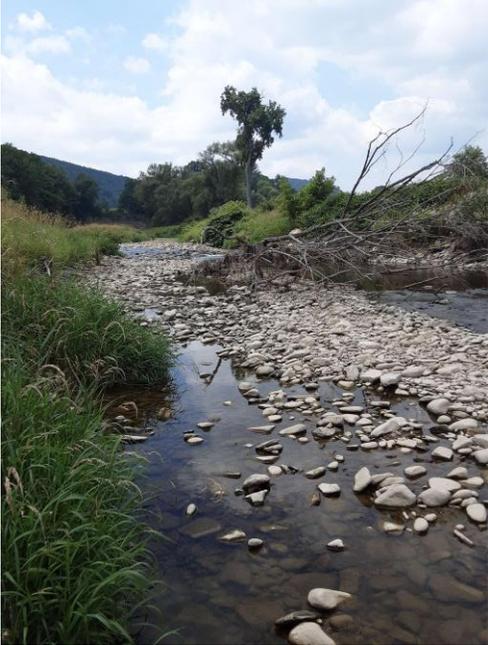
Debris Management	Map ID: 21
<p>WESTFIELD TWP (Y) Lat: 41.914771 (X) Long: -77.574458</p> <p>Debris Severity: High Length: 1000 ft Width: 50 ft Height: 3 ft Cubic Yards: 5555.56 Immediate Concern: Yes Suggested Action: Remove Debris</p> <p>Comments: Tree picture and bank erosion. Near a bridge, homes, and school nearby.</p>

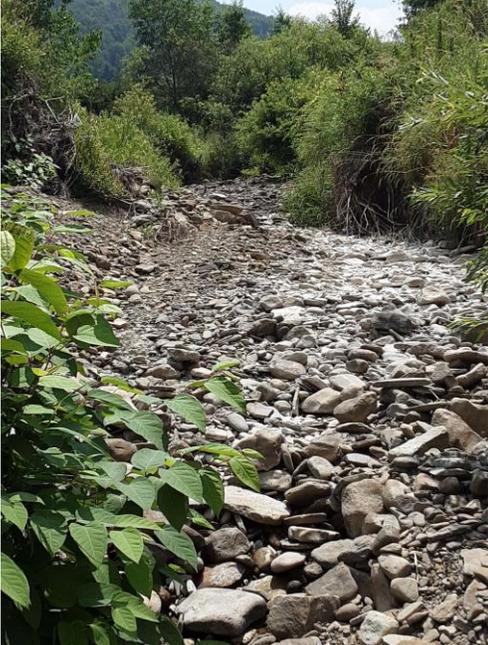
Stream Restoration	Map ID: 22
<p>WESTFIELD TWP (Y) Lat: 41.914987 (X) Long: -77.574148</p> <p>Gravel Bar Severity: High Length: 20 ft Width: 20 ft Height: 7 ft Cubic Yards: 103.70 Immediate Concern: Yes Suggested Action:</p> <p>Comments: Tributary.</p>

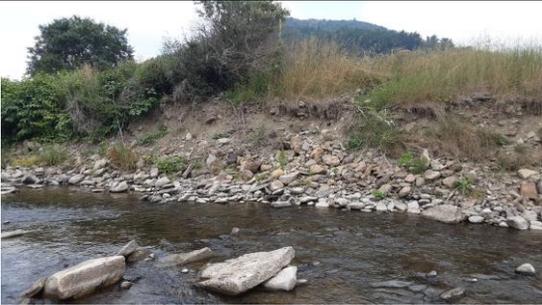
Bank Stabilization	Map ID: 23
<p>WESTFIELD TWP (Y) Lat: 41.915314 (X) Long: -77.573657</p> <p>Undercut Bank Severity: High Length: 50 ft Width: 10 ft Height: 12 ft Cubic Yards: 222.22 Immediate Concern: No Suggested Action:</p> <p>Comments:</p>

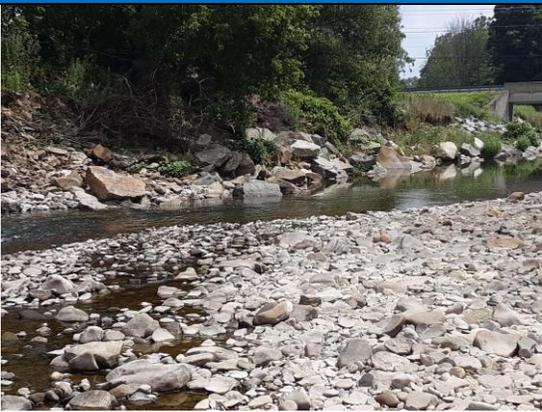
Stream Restoration	Map ID: 24
<p>WESTFIELD TWP (Y) Lat: 41.915709 (X) Long: -77.572317</p> <p>Gravel Bar Severity: Moderate Length: 100 ft Width: 25 ft Height: 2 ft Cubic Yards: 185.19 Immediate Concern: No Suggested Action:</p> <p>Comments: Gravel bar crance brook.</p>

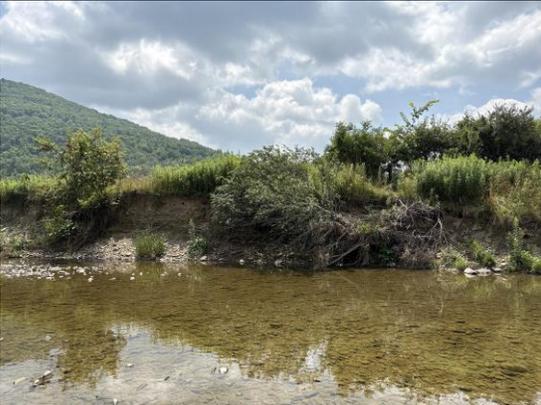
Bank Stabilization	Map ID: 25
<p>WESTFIELD TWP (Y) Lat: 41.915553 (X) Long: -77.570912</p> <p>Erosion Severity: Moderate Length: 125 ft Width: 6 ft Height: 8 ft Cubic Yards: 222.22 Immediate Concern: No Suggested Action:</p> <p>Comments:</p>

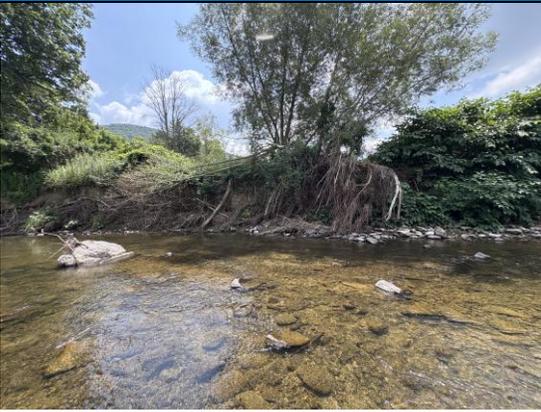
Bank Stabilization	Map ID: 26
<p>WESTFIELD TWP (Y) Lat: 41.915708 (X) Long: -77.570656</p> <p>Erosion Severity: Low Length: 75 ft Width: 8 ft Height: 9 ft Cubic Yards: 200.00 Immediate Concern: No Suggested Action:</p> <p>Comments:</p>

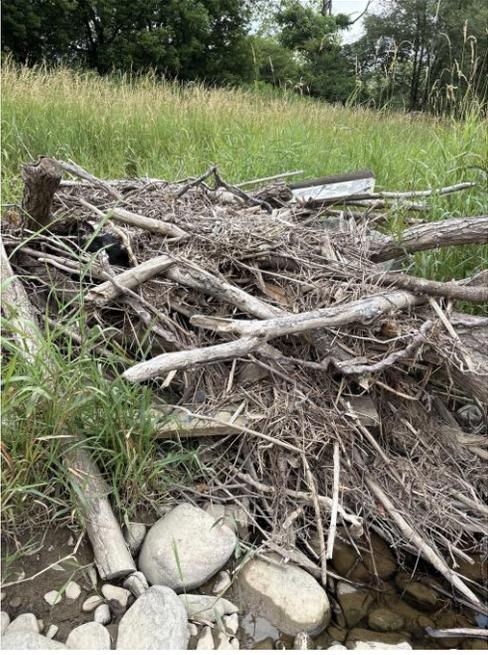
Debris Management	Map ID: 27
<p>WESTFIELD TWP (Y) Lat: 41.915682 (X) Long: -77.569522</p> <p>Debris Severity: Low Length: 10 ft Width: 6 ft Height: 4 ft Cubic Yards: 8.89 Immediate Concern: No Suggested Action:</p> <p>Comments:</p>

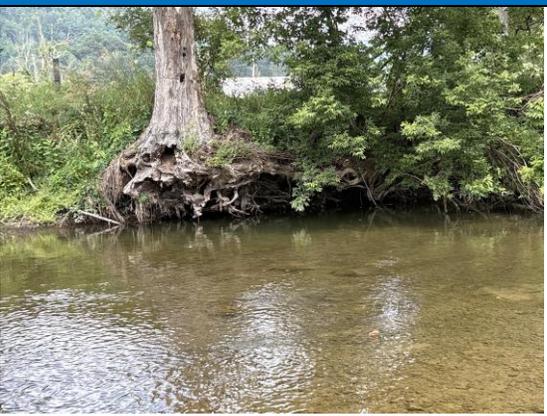
Bank Stabilization	Map ID: 28
<p>WESTFIELD TWP (Y) Lat: 41.915711 (X) Long: -77.569108</p> <p>Undercut Bank Severity: Low Length: 100 ft Width: 7 ft Height: 7 ft Cubic Yards: 181.48 Immediate Concern: No Suggested Action:</p> <p>Comments: No threat to homes.</p>

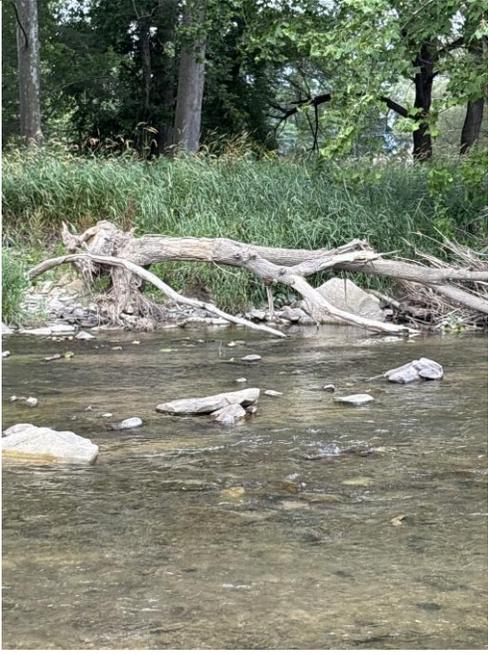
Debris Management	Map ID: 29
<p>WESTFIELD TWP (Y) Lat: 41.915711 (X) Long: -77.567657</p> <p>Debris Severity: Low Length: 12 ft Width: 2 ft Height: 1 ft Cubic Yards: 0.89 Immediate Concern: No Suggested Action:</p> <p>Comments:</p>

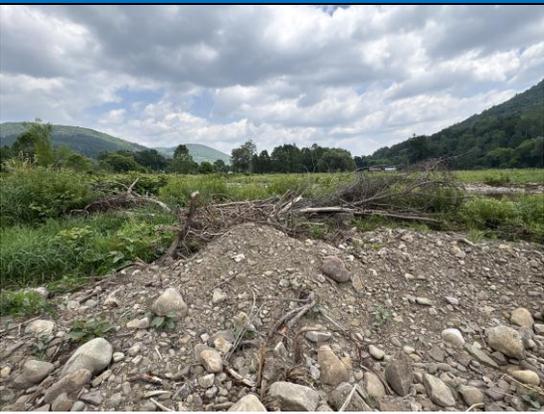
Debris Management	Map ID: 30
<p>WESTFIELD TWP (Y) Lat: 41.915745 (X) Long: -77.567311</p> <p>Debris Severity: Moderate Length: 10 ft Width: 10 ft Height: 2 ft Cubic Yards: 7.41 Immediate Concern: No Suggested Action:</p> <p>Comments:</p>

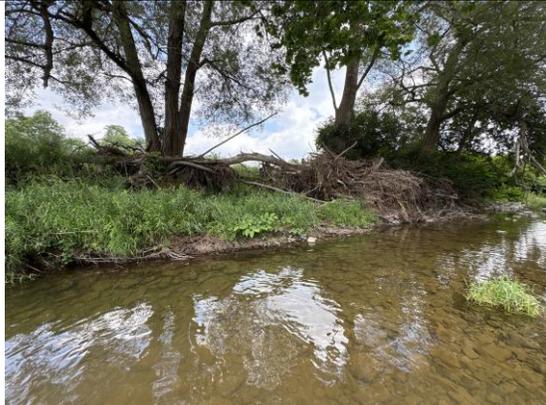
Debris Management	Map ID: 31
<p>WESTFIELD TWP (Y) Lat: 41.916020 (X) Long: -77.566140</p> <p>Debris Severity: Low Length: 15 ft Width: 15 ft Height: 8 ft Cubic Yards: 66.67 Immediate Concern: No Suggested Action:</p> <p>Comments:</p>

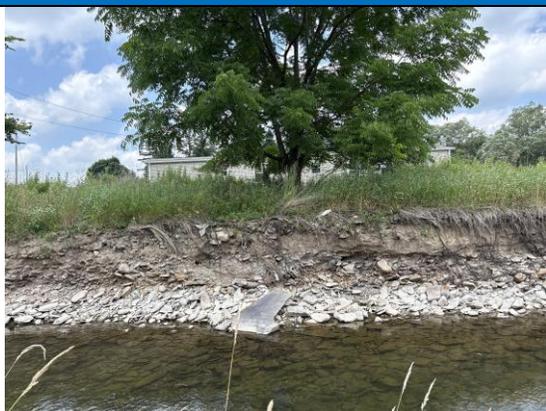
Bank Stabilization	Map ID: 32
<p>WESTFIELD TWP (Y) Lat: 41.917028 (X) Long: -77.563724</p> <p>Erosion Severity: Moderate Length: 250 ft Width: 5 ft Height: 8 ft Cubic Yards: 370.37 Immediate Concern: No Suggested Action:</p> <p>Comments: Houses next to creek with erosion.</p>

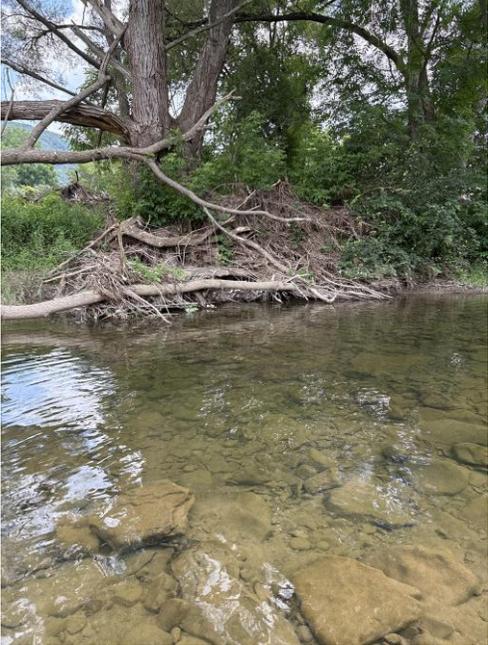
Debris Management	Map ID: 33
<p>WESTFIELD TWP (Y) Lat: 41.917279 (X) Long: -77.561723</p> <p>Debris Severity: Moderate Length: 8 ft Width: 6 ft Height: 5 ft Cubic Yards: 8.89 Immediate Concern: No Suggested Action:</p> <p>Comments:</p>

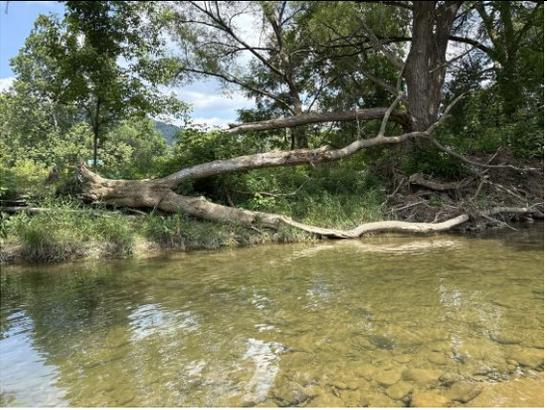
Debris Management	Map ID: 34
<p>WESTFIELD TWP (Y) Lat: 41.917359 (X) Long: -77.561366</p> <p>Debris Severity: Moderate Length: 25 ft Width: 4 ft Height: 3 ft Cubic Yards: 11.11 Immediate Concern: No Suggested Action:</p> <p>Comments:</p>

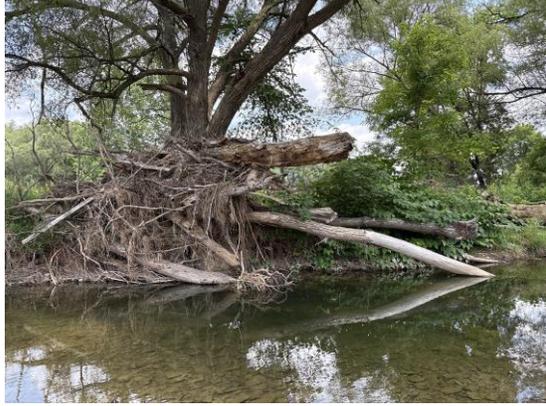
Debris Management	Map ID: 35
<p>WESTFIELD TWP (Y) Lat: 41.917264 (X) Long: -77.560817</p> <p>Debris Severity: Moderate Length: 25 ft Width: 10 ft Height: 10 ft Cubic Yards: 92.59 Immediate Concern: No Suggested Action:</p> <p>Comments:</p>

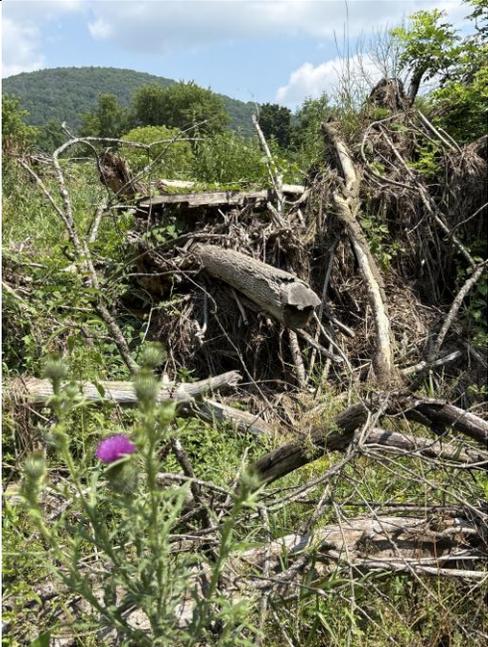
Debris Management	Map ID: 36
<p>WESTFIELD TWP (Y) Lat: 41.916868 (X) Long: -77.558937</p> <p>Debris Severity: Low Length: 15 ft Width: 15 ft Height: 15 ft Cubic Yards: 125.00 Immediate Concern: No Suggested Action:</p> <p>Comments:</p>

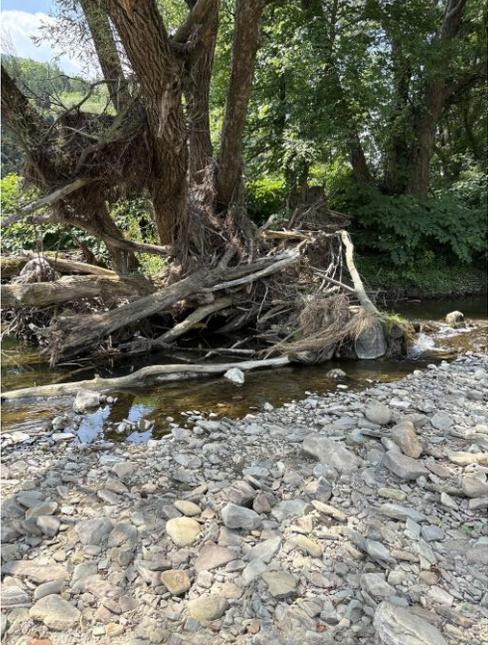
Debris Management	Map ID: 37
<p>WESTFIELD TWP (Y) Lat: 41.916868 (X) Long: -77.558937</p> <p>Debris Severity: Moderate Length: 15 ft Width: 15 ft Height: 8 ft Cubic Yards: 66.67 Immediate Concern: No Suggested Action:</p> <p>Comments:</p>

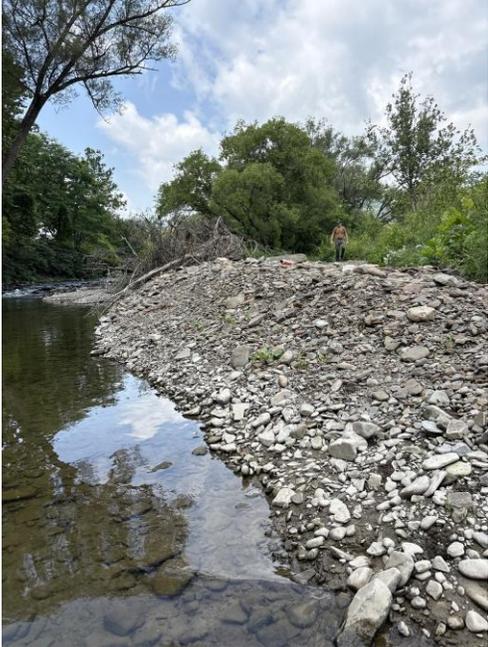
Debris Management	Map ID: 38
<p>WESTFIELD TWP (Y) Lat: 41.916819 (X) Long: -77.558728</p> <p>Gravel Bar Severity: Moderate Length: 125 ft Width: 40 ft Height: 4 ft Cubic Yards: 740.74 Immediate Concern: No Suggested Action:</p> <p>Comments: Confluence of North Fork.</p>

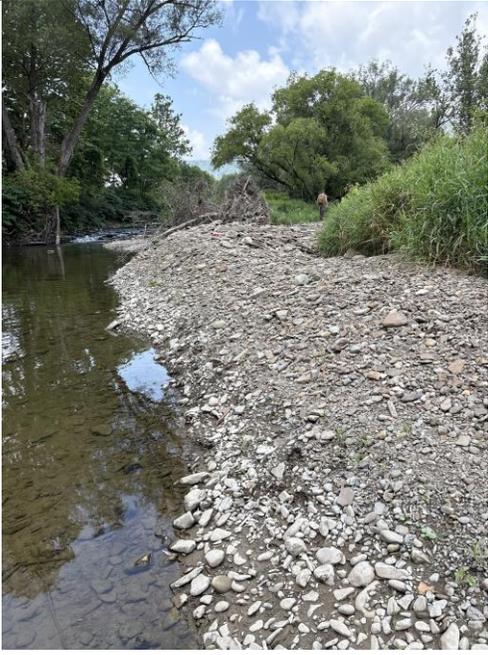
Debris Management	Map ID: 39
<p>WESTFIELD TWP (Y) Lat: 41.916819 (X) Long: -77.558728</p> <p>Debris Severity: Moderate Length: 75 ft Width: 10 ft Height: 12 ft Cubic Yards: 333.33 Immediate Concern: No Suggested Action:</p> <p>Comments:</p>

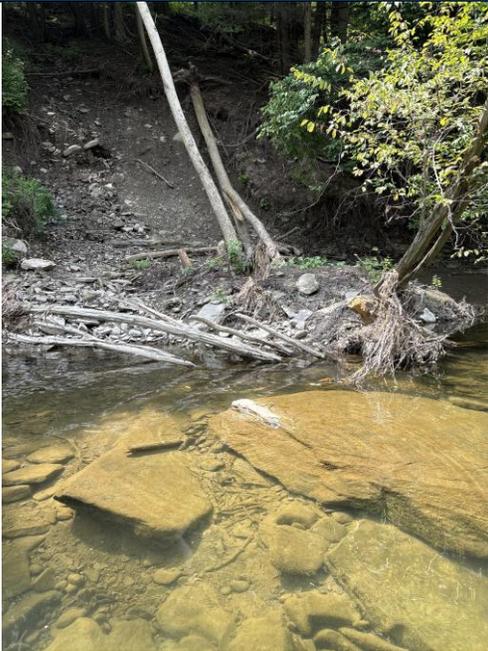
Debris Management	Map ID: 41
<p>WESTFIELD BORO (Y) Lat: 41.917320 (X) Long: -77.551918</p> <p>Debris Severity: Low Length: 15 ft Width: 10 ft Height: 4 ft Cubic Yards: 22.22 Immediate Concern: No Suggested Action:</p> <p>Comments:</p>

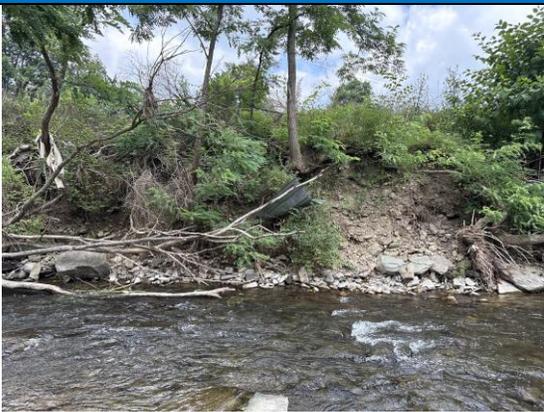
Bank Stabilization	Map ID: 42
<p>WESTFIELD BORO (Y) Lat: 41.917572 (X) Long: -77.550564</p> <p>Erosion Severity: Moderate Length: 275 ft Width: 10 ft Height: 8 ft Cubic Yards: 814.81 Immediate Concern: No Suggested Action:</p> <p>Comments: Close to guide railroad.</p>

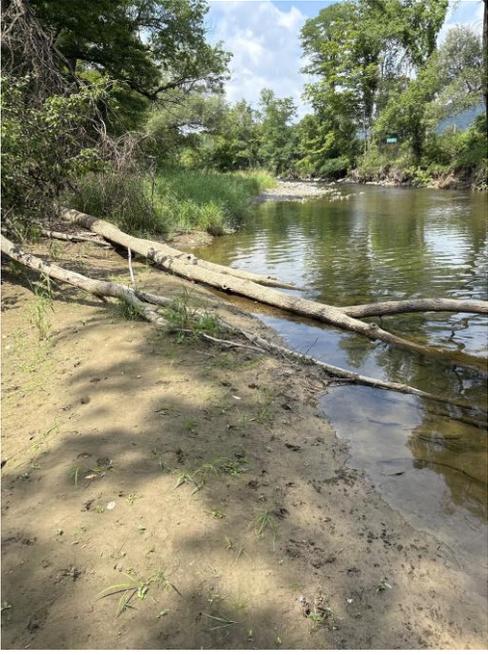
Debris Management	Map ID: 43
<p>WESTFIELD BORO (Y) Lat: 41.917594 (X) Long: -77.550265</p> <p>Debris Severity: Low Length: 55 ft Width: 2 ft Height: 1 ft Cubic Yards: 4.07 Immediate Concern: No Suggested Action:</p> <p>Comments:</p>

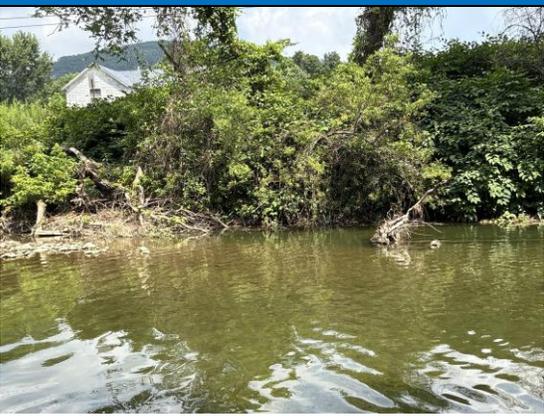
Debris Management	Map ID: 44
<p>WESTFIELD BORO (Y) Lat: 41.917684 (X) Long: -77.549656</p> <p>Debris Severity: Low Length: 25 ft Width: 6 ft Height: 6 ft Cubic Yards: 33.33 Immediate Concern: No Suggested Action:</p> <p>Comments:</p>

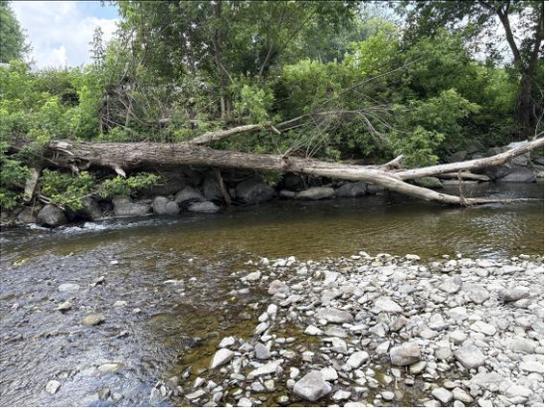
Debris Management	Map ID: 45
<p>WESTFIELD BORO (Y) Lat: 41.917866 (X) Long: -77.548520</p> <p>Debris Severity: Low Length: 60 ft Width: 2 ft Height: 1 ft Cubic Yards: 4.44 Immediate Concern: No Suggested Action:</p> <p>Comments:</p>

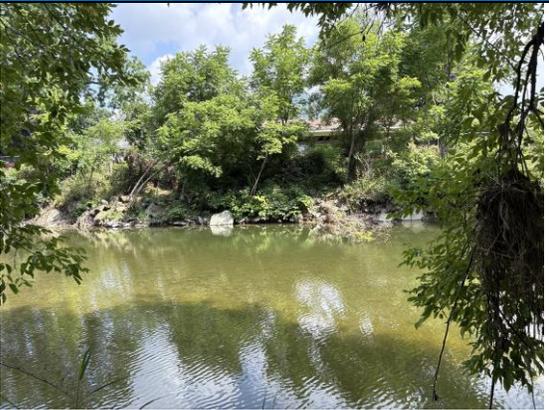
Bank Stabilization	Map ID: 46
<p>WESTFIELD BORO (Y) Lat: 41.917698 (X) Long: -77.545887</p> <p>Erosion Severity: Moderate Length: 500 ft Width: 15 ft Height: 8 ft Cubic Yards: 2222.22 Immediate Concern: No Suggested Action:</p> <p>Comments: Behind park. Some rip rap at west end.</p>

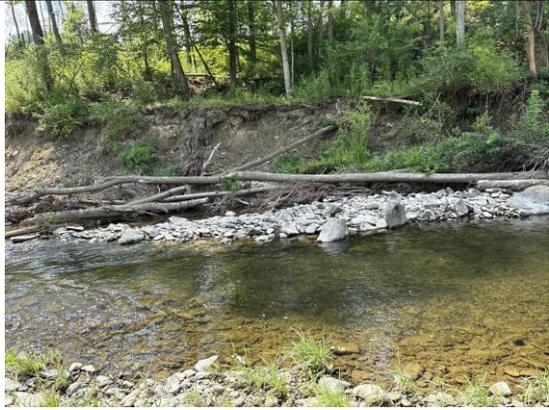
Debris Management	Map ID: 47
<p>WESTFIELD BORO (Y) Lat: 41.917385 (X) Long: -77.544983</p> <p>Debris Severity: Low Length: 60 ft Width: 2 ft Height: 1 ft Cubic Yards: 4.44 Immediate Concern: No Suggested Action:</p> <p>Comments:</p>

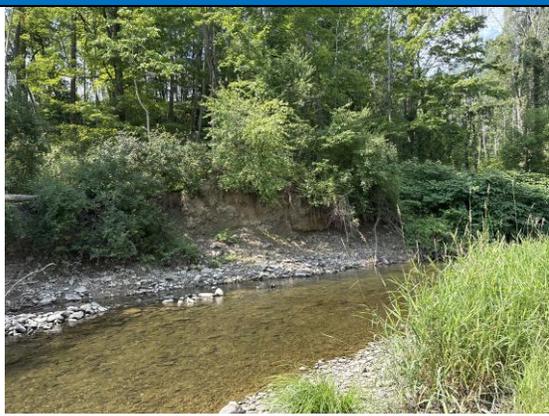
Bank Stabilization	Map ID: 48
<p>WESTFIELD BORO (Y) Lat: 41.917180 (X) Long: -77.544060</p> <p>Erosion Severity: Moderate Length: 300 ft Width: 20 ft Height: 10 ft Cubic Yards: 2222.22 Immediate Concern: No Suggested Action:</p> <p>Comments:</p>

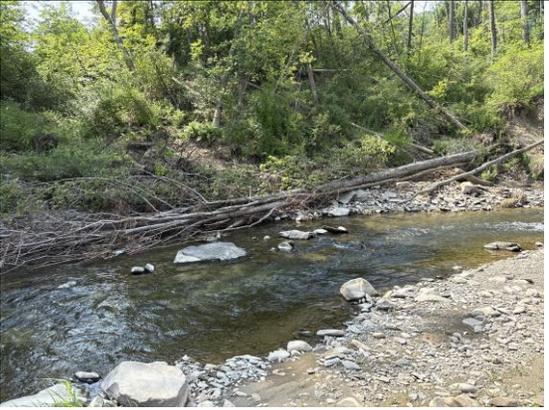
Debris Management	Map ID: 49
<p>WESTFIELD BORO (Y) Lat: 41.917310 (X) Long: -77.543836</p> <p>Debris Severity: Low Length: 60 ft Width: 2 ft Height: 1 ft Cubic Yards: 4.44 Immediate Concern: No Suggested Action:</p> <p>Comments:</p>

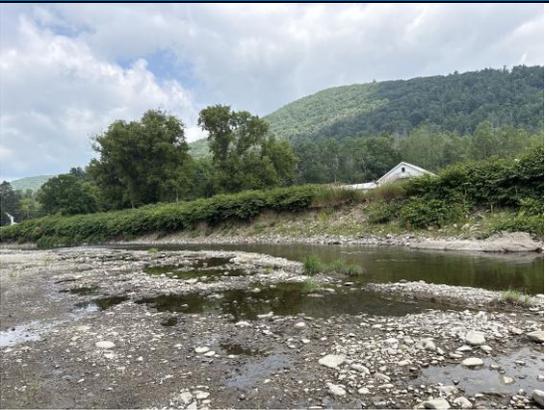
Bank Stabilization	Map ID: 50
<p>WESTFIELD BORO (Y) Lat: 41.921948 (X) Long: -77.538015</p> <p>Erosion Severity: Low Length: 700 ft Width: 20 ft Height: 10 ft Cubic Yards: 5185.19 Immediate Concern: No Suggested Action:</p> <p>Comments:</p>

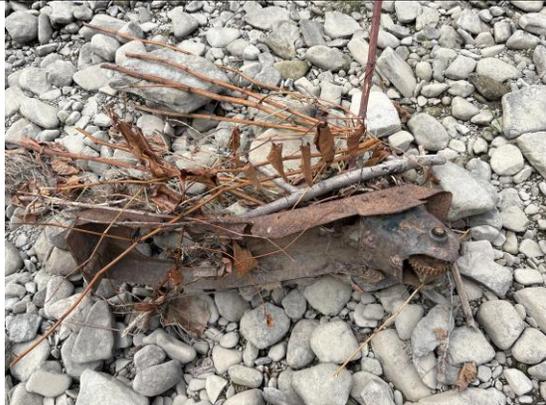
Debris Management	Map ID: 51
<p>WESTFIELD BORO (Y) Lat: 41.921934 (X) Long: -77.537768</p> <p>Debris Severity: Low Length: 2 ft Width: 0.5 ft Height: 0.5 ft Cubic Yards: 0.02 Immediate Concern: No Suggested Action:</p> <p>Comments: Scrap Metal.</p>

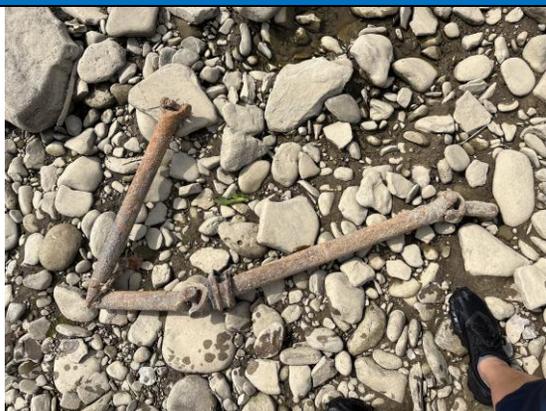
Debris Management	Map ID: 52
<p>WESTFIELD BORO (Y) Lat: 41.921888 (X) Long: -77.537515</p> <p>Debris Severity: Length: 4 ft Width: 0.2999999999999999 ft Height: 0.2999999999999999 ft Cubic Yards: 0.01 Immediate Concern: No Suggested Action:</p> <p>Comments: Scrap Metal.</p>

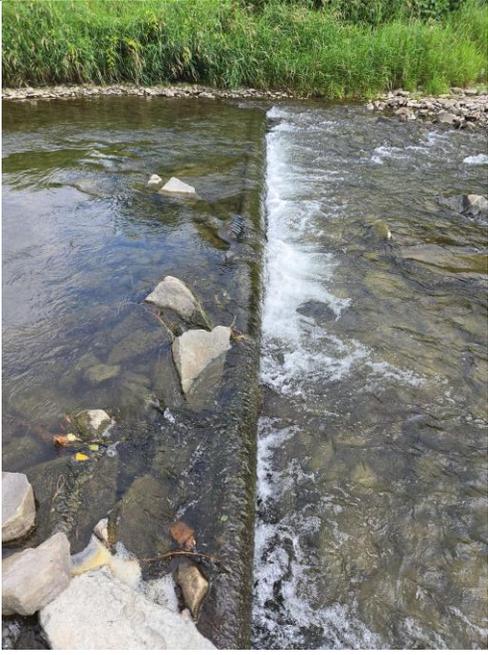
Infrastructure Protection	Map ID: 53
<p>WESTFIELD BORO (Y) Lat: 41.921714 (X) Long: -77.535834</p> <p>Infrastructure Risk Severity: High Length: 40 ft Width: 2 ft Height: 2 ft Cubic Yards: 5.93 Immediate Concern: Yes Suggested Action: Other</p> <p>Comments: Exposed 12 inch steel pipe.</p>

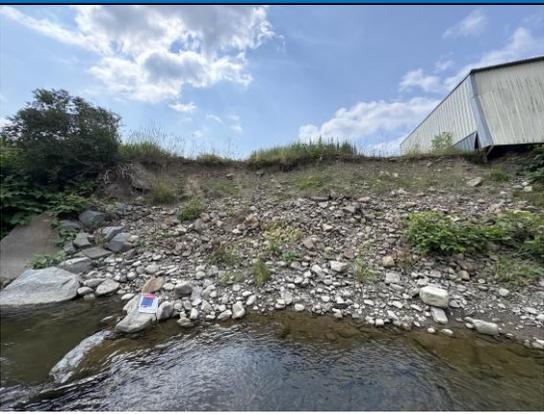
Bank Stabilization	Map ID: 54
<p>WESTFIELD BORO (Y) Lat: 41.921769 (X) Long: -77.535602</p> <p>Erosion Severity: Moderate Length: 100 ft Width: 20 ft Height: 15 ft Cubic Yards: 1111.11 Immediate Concern: No Suggested Action:</p> <p>Comments:</p>

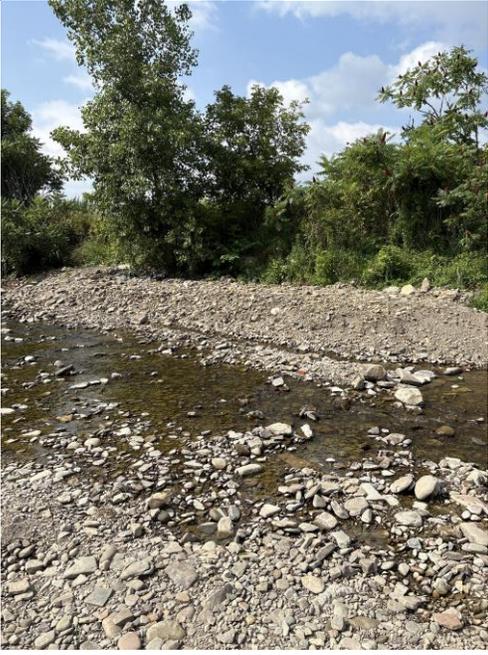
Stream Restoration	Map ID: 55
<p>WESTFIELD BORO (Y) Lat: 41.921938 (X) Long: -77.534976</p> <p>Gravel Bar Severity: Low Length: 75 ft Width: 60 ft Height: 1 ft Cubic Yards: 166.67 Immediate Concern: No Suggested Action:</p> <p>Comments: Flooding threat to Tier II Facility.</p>

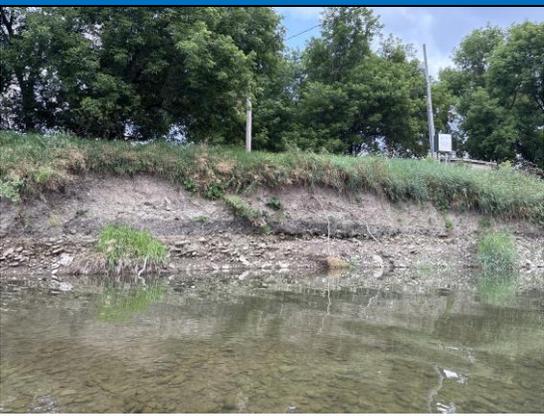
Bank Stabilization	Map ID: 56
<p>WESTFIELD BORO (Y) Lat: 41.922897 (X) Long: -77.532026</p> <p>Erosion Severity: Moderate Length: 150 ft Width: 10 ft Height: 15 ft Cubic Yards: 833.33 Immediate Concern: No Suggested Action:</p> <p>Comments:</p>

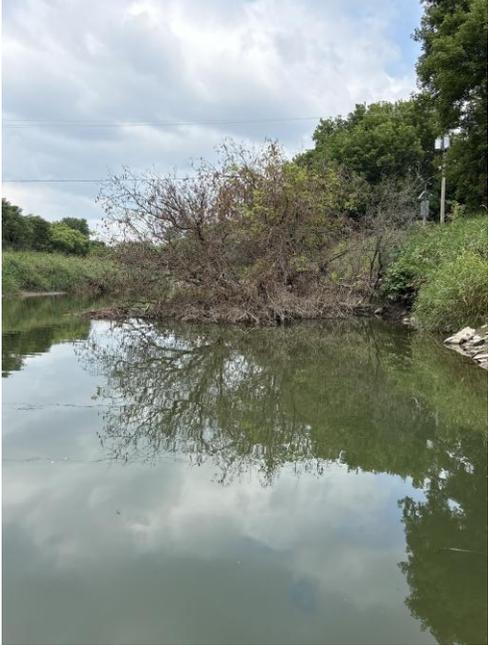
Debris Management	Map ID: 57
<p>WESTFIELD BORO (Y) Lat: 41.922925 (X) Long: -77.531778</p> <p>Debris Severity: High Length: 20 ft Width: 20 ft Height: 25 ft Cubic Yards: 370.37 Immediate Concern: No Suggested Action:</p> <p>Comments:</p>

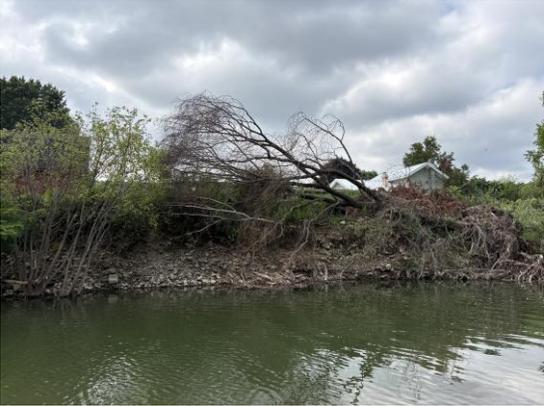
Bank Stabilization	Map ID: 58
<p>WESTFIELD TWP (Y) Lat: 41.923195 (X) Long: -77.529838</p> <p>Erosion Severity: Moderate Length: 300 ft Width: 20 ft Height: 9 ft Cubic Yards: 2000.00 Immediate Concern: No Suggested Action:</p> <p>Comments: Behind occupied buildings.</p>

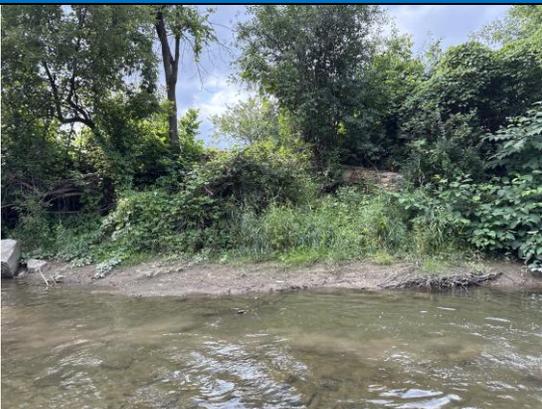
Bank Stabilization	Map ID: 60
<p>WESTFIELD TWP (Y) Lat: 41.924196 (X) Long: -77.528138</p> <p>Undercut Bank Severity: High Length: 175 ft Width: 5 ft Height: 3 ft Cubic Yards: 97.22 Immediate Concern: No Suggested Action:</p> <p>Comments:</p>

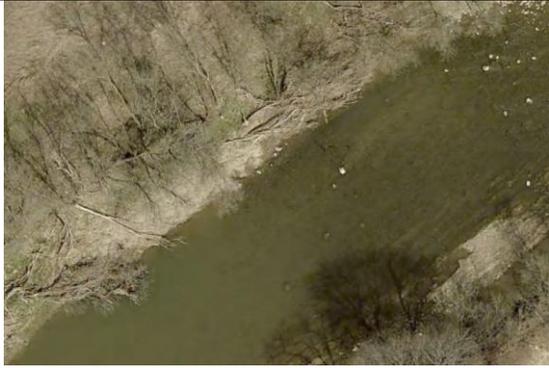
Debris Management	Map ID: 61
<p>WESTFIELD TWP (Y) Lat: 41.924380 (X) Long: -77.527831</p> <p>Debris Severity: Moderate Length: 40 ft Width: 10 ft Height: 10 ft Cubic Yards: 148.15 Immediate Concern: No Suggested Action:</p> <p>Comments:</p>

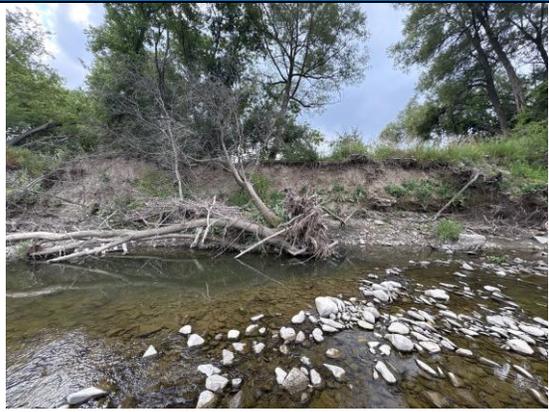
Bank Stabilization	Map ID: 62
<p>WESTFIELD TWP (Y) Lat: 41.924777 (X) Long: -77.527149</p> <p>Undercut Bank Severity: High Length: 60 ft Width: 2 ft Height: 8 ft Cubic Yards: 35.56 Immediate Concern: Yes Suggested Action:</p> <p>Comments:</p>

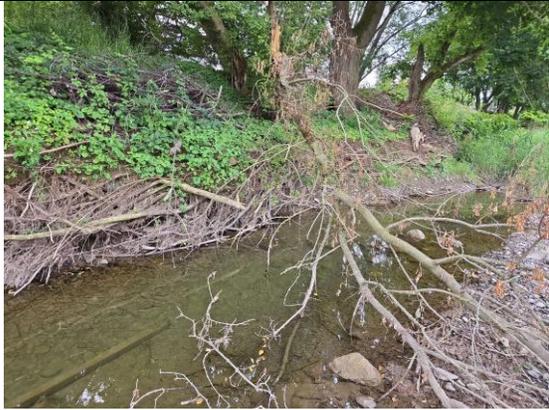
Bank Stabilization	Map ID: 64
<p>WESTFIELD TWP (Y) Lat: 41.925654 (X) Long: -77.526281</p> <p>Erosion Severity: Moderate Length: 200 ft Width: 5 ft Height: 8 ft Cubic Yards: 296.30 Immediate Concern: Yes Suggested Action: Stabilize Bank</p> <p>Comments:</p>

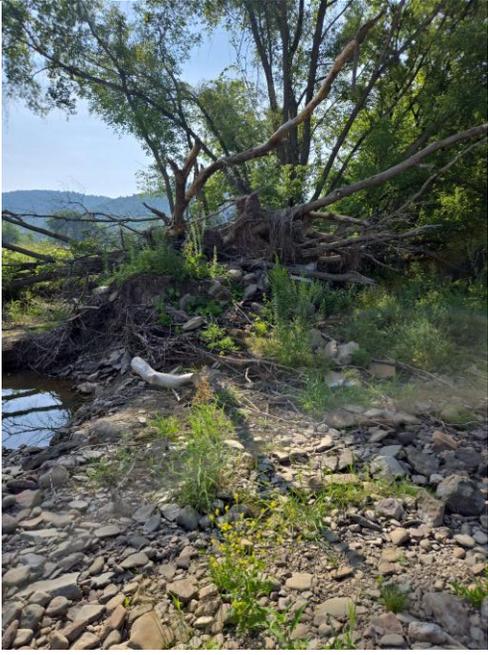
Debris Management	Map ID: 67
<p>WESTFIELD TWP (Y) Lat: 41.925517 (X) Long: -77.521773</p> <p>Debris Severity: Moderate Length: 30 ft Width: 15 ft Height: 8 ft Cubic Yards: 133.33 Immediate Concern: Yes Suggested Action: Remove Debris</p> <p>Comments:</p>

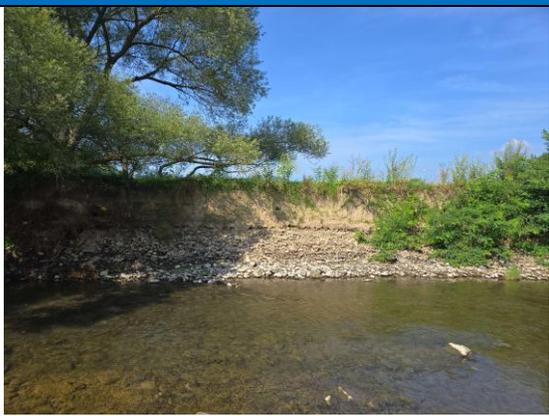
Bank Stabilization	Map ID: 68
<p>WESTFIELD TWP (Y) Lat: 41.924825 (X) Long: -77.521172</p> <p>Erosion Severity: High Length: 75 ft Width: 8 ft Height: 8 ft Cubic Yards: 177.78 Immediate Concern: Yes Suggested Action: Stabilize Bank</p> <p>Comments:</p>

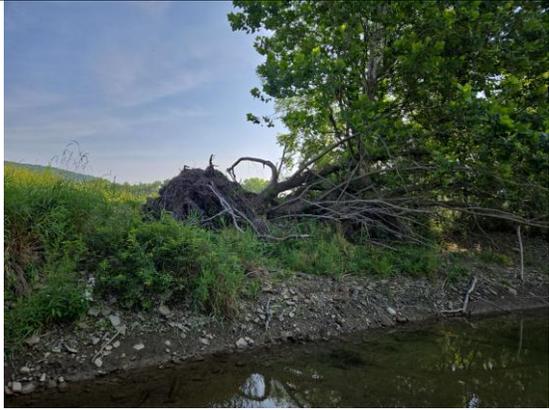
Debris Management	Map ID: 69
<p>WESTFIELD TWP (Y) Lat: 41.924667 (X) Long: -77.520914</p> <p>Debris Severity: Low Length: 40 ft Width: 15 ft Height: 7 ft Cubic Yards: 155.56 Immediate Concern: No Suggested Action:</p> <p>Comments:</p>

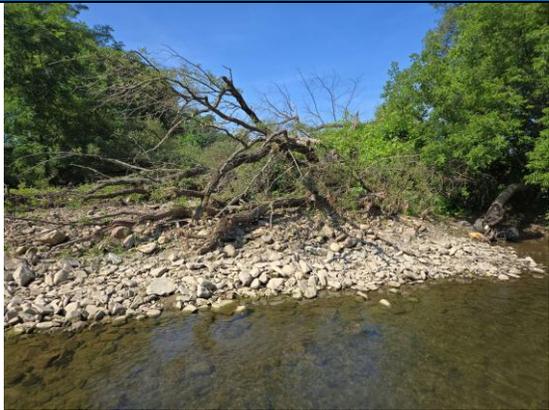
Bank Stabilization	Map ID: 71
<p>WESTFIELD TWP (Y) Lat: 41.923469 (X) Long: -77.518828</p> <p>Erosion Severity: High Length: 300 ft Width: 15 ft Height: 20 ft Cubic Yards: 3333.33 Immediate Concern: No Suggested Action:</p> <p>Comments: Beginning for distance.</p>

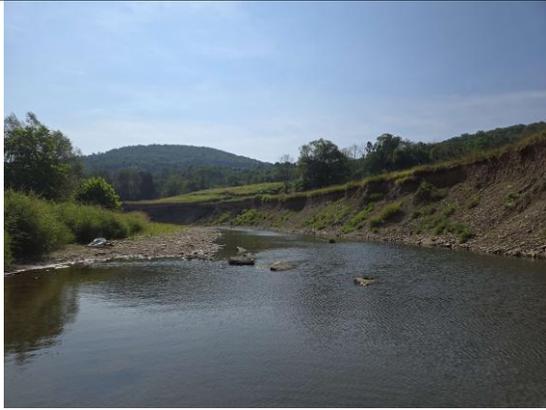
Bank Stabilization	Map ID: 72
<p>WESTFIELD TWP (Y) Lat: 41.923129 (X) Long: -77.517831</p> <p>Erosion Severity: High Length: 300 ft Width: 25 ft Height: 20 ft Cubic Yards: 5555.56 Immediate Concern: Yes Suggested Action: Stabilize Bank</p> <p>Comments: Mid point capture for distance.</p>

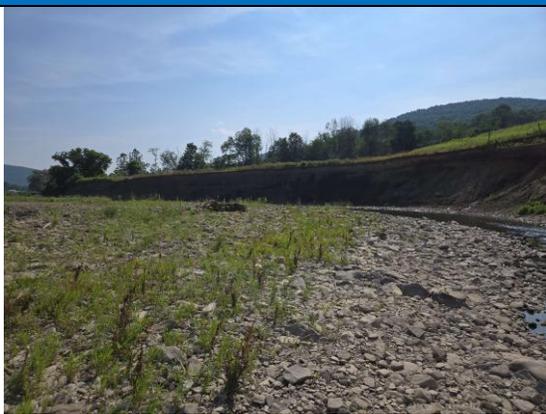
Bank Stabilization	Map ID: 73
<p>WESTFIELD TWP (Y) Lat: 41.923765 (X) Long: -77.517014</p> <p>Erosion Severity: High Length: 400 ft Width: 25 ft Height: 20 ft Cubic Yards: 7407.41 Immediate Concern: Yes Suggested Action: Stabilize Bank</p> <p>Comments: End point for erosion.</p>

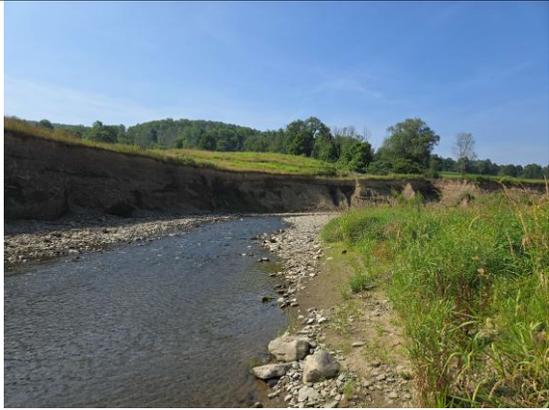
Debris Management	Map ID: 74
<p>WESTFIELD TWP (Y) Lat: 41.924131 (X) Long: -77.516825</p> <p>Debris Severity: Low Length: 25 ft Width: 10 ft Height: 5 ft Cubic Yards: 46.30 Immediate Concern: No Suggested Action:</p> <p>Comments:</p>

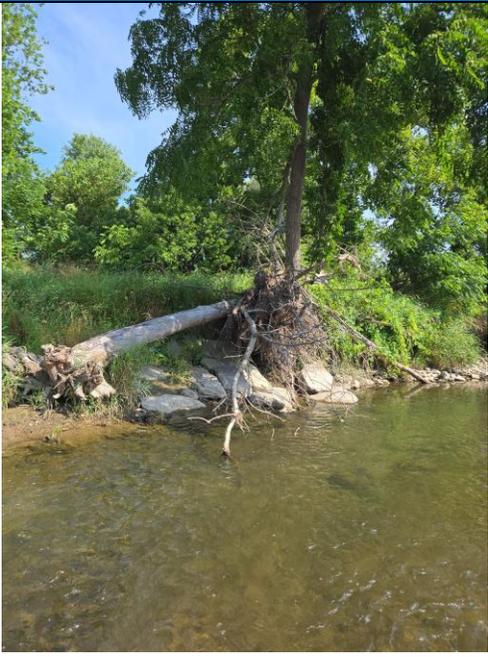
Bank Stabilization	Map ID: 75
<p>WESTFIELD TWP (Y) Lat: 41.924746 (X) Long: -77.513632</p> <p>Erosion Severity: Low Length: 100 ft Width: 8 ft Height: 5 ft Cubic Yards: 148.15 Immediate Concern: No Suggested Action:</p> <p>Comments:</p>

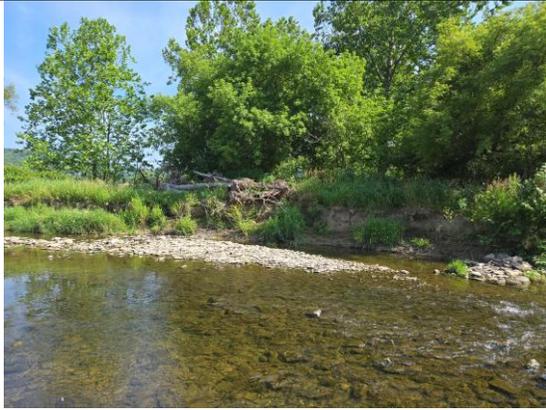
Debris Management	Map ID: 76
<p>WESTFIELD TWP (Y) Lat: 41.925465 (X) Long: -77.510250</p> <p>Debris Severity: High Length: 75 ft Width: 10 ft Height: 8 ft Cubic Yards: 222.22 Immediate Concern: Yes Suggested Action: Remove Debris</p> <p>Comments:</p>

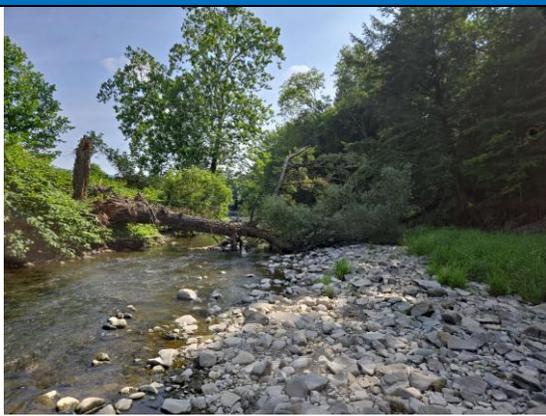
Debris Management	Map ID: 77
<p>WESTFIELD TWP (Y) Lat: 41.928799 (X) Long: -77.503406</p> <p>Debris Severity: Moderate Length: 40 ft Width: 15 ft Height: 7 ft Cubic Yards: 155.56 Immediate Concern: No Suggested Action:</p> <p>Comments:</p>

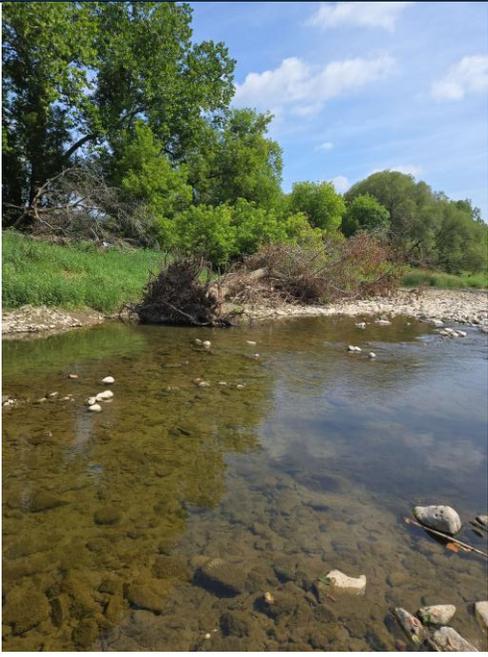
Debris Management	Map ID: 78
<p>WESTFIELD TWP (Y) Lat: 41.928884 (X) Long: -77.503247</p> <p>Gravel Bar Severity: Moderate Length: 200 ft Width: 75 ft Height: 4 ft Cubic Yards: 2222.22 Immediate Concern: No Suggested Action:</p> <p>Comments:</p>
