Tioga County Mitigation Advisory Committee

The following legislative master document is the product of a series of special meetings convened in the summer of 2025 by the Tioga County Mitigation Advisory Committee (MAC), operating under the exclusive authority of the FEMA and PEMA approved Tioga County All-Hazard Mitigation Plan. This Plan has been adopted by the Tioga County Board of Commissioners, all municipalities, stakeholder groups, and formally approved by FEMA and PEMA, ensuring its alignment with both local priorities and federal/state standards.

The centerpiece of the document, featuring imagery, site descriptions, and data collected during field assessments throughout the Cowanesque Valley. This section highlights observed damages, erosion sites, and areas requiring stabilization, as well as opportunities for proactive mitigation.

Published By: Tioga County (PA) GIS Department
September 22, 2025

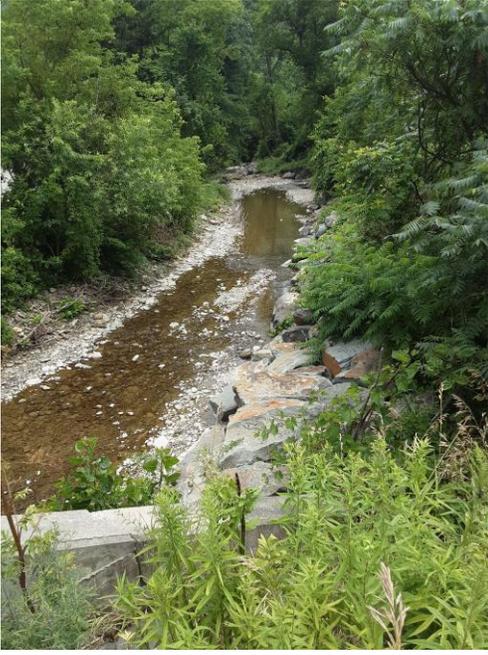
Debris Management	Map ID: 80
<p>WESTFIELD TWP (Y) Lat: 41.931116 (X) Long: -77.501853</p> <p>Debris Severity: Moderate Length: 50 ft Width: 15 ft Height: 2 ft Cubic Yards: 55.56 Immediate Concern: Yes Suggested Action: Remove Debris</p> <p>Comments: Tree and rock. Homes nearby.</p>

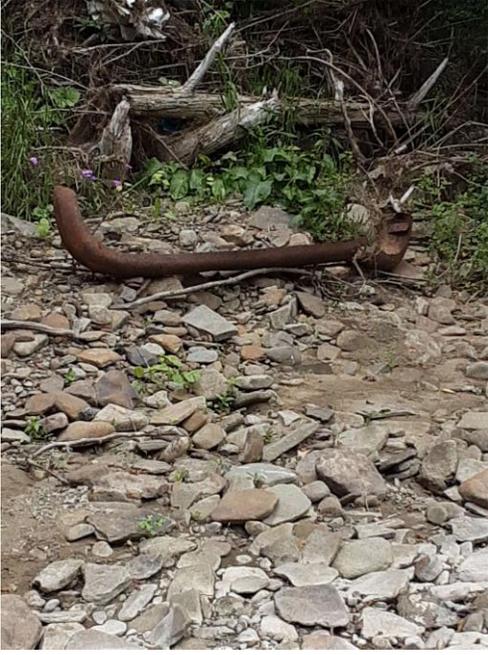
Stream Restoration	Map ID: 82
<p>WESTFIELD TWP (Y) Lat: 41.930003 (X) Long: -77.501098</p> <p>Gravel Bar Severity: Moderate Length: 100 ft Width: 20 ft Height: 1 ft Cubic Yards: 74.07 Immediate Concern: Yes Suggested Action:</p> <p>Comments: Deep water not much access. Near homes and bridge.</p>

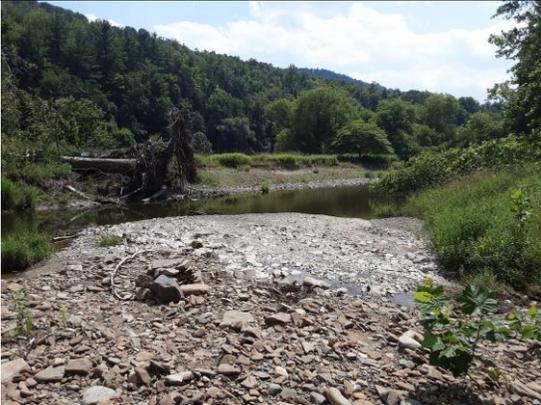
Debris Management	Map ID: 84
<p>WESTFIELD TWP (Y) Lat: 41.930289 (X) Long: -77.500934</p> <p>Gravel Bar Severity: High Length: 300 ft Width: 50 ft Height: 2.5 ft Cubic Yards: 1388.89 Immediate Concern: Yes Suggested Action:</p> <p>Comments: Long gravel bar looking both ways. Confluence of Purple Brook.</p>

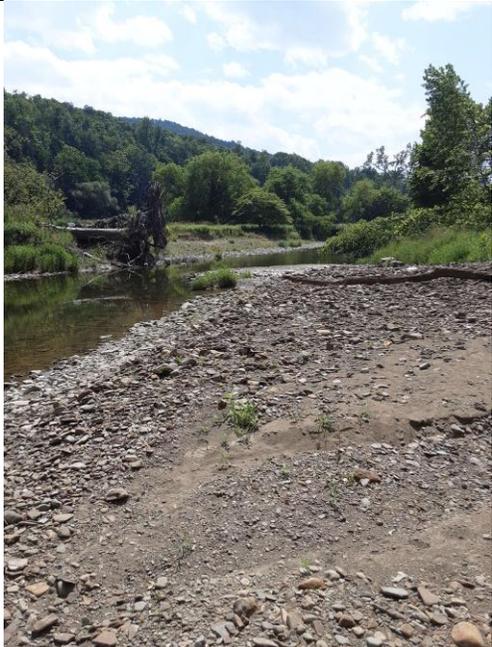
Debris Management	Map ID: 85
<p>WESTFIELD TWP (Y) Lat: 41.930587 (X) Long: -77.500284</p> <p>Debris Severity: Moderate Length: 50 ft Width: 50 ft Height: 2.5 ft Cubic Yards: 231.48 Immediate Concern: Yes Suggested Action: Restore Channel</p> <p>Comments: Gravel bar drastically affecting course of river.</p>

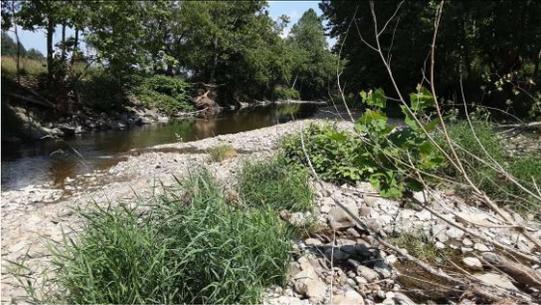
Stream Restoration	Map ID: 86
<p>WESTFIELD TWP (Y) Lat: 41.930696 (X) Long: -77.499156</p> <p>Gravel Bar Severity: Moderate Length: 60 ft Width: 20 ft Height: 4 ft Cubic Yards: 177.78 Immediate Concern: No Suggested Action: Remove Debris</p> <p>Comments: South bank. Homes not far from river bank.</p>

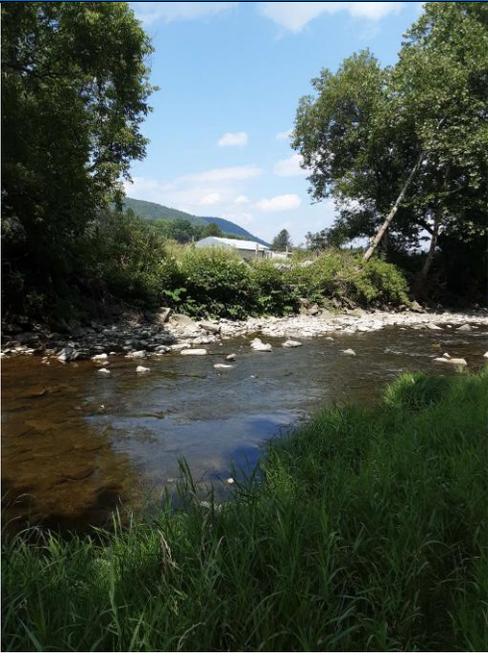
Debris Management	Map ID: 87
<p>WESTFIELD TWP (Y) Lat: 41.932534 (X) Long: -77.488941</p> <p>Debris Severity: Low Length: 30 ft Width: 15 ft Height: 7 ft Cubic Yards: 116.67 Immediate Concern: No Suggested Action:</p> <p>Comments:</p>

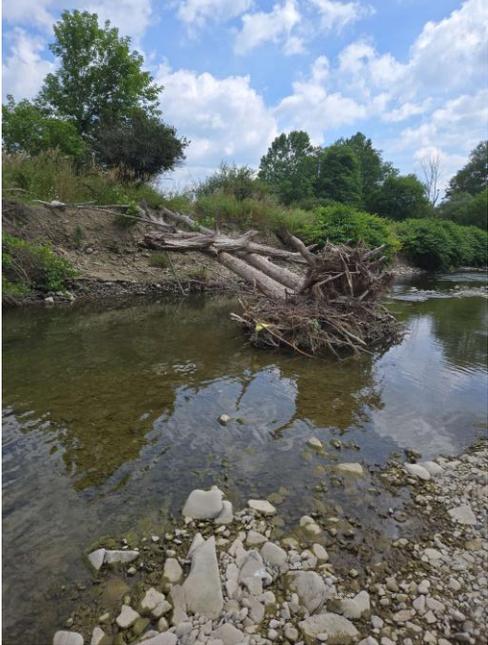
Debris Management	Map ID: 88
<p>WESTFIELD TWP (Y) Lat: 41.934256 (X) Long: -77.485277</p> <p>Debris Severity: Moderate Length: 50 ft Width: 15 ft Height: 12 ft Cubic Yards: 333.33 Immediate Concern: No Suggested Action:</p> <p>Comments:</p>

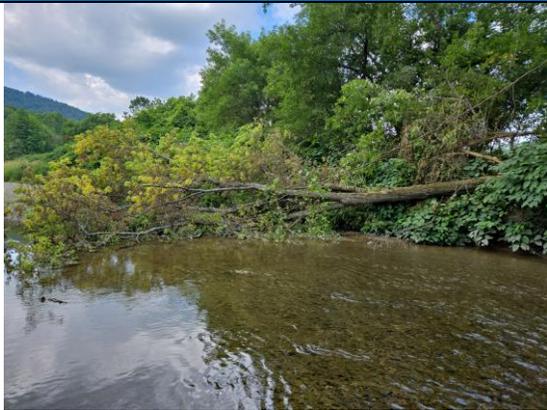
Debris Management	Map ID: 89
<p>WESTFIELD TWP (Y) Lat: 41.935069 (X) Long: -77.484228</p> <p>Debris Severity: Moderate Length: 75 ft Width: 15 ft Height: 5 ft Cubic Yards: 208.33 Immediate Concern: No Suggested Action:</p> <p>Comments:</p>

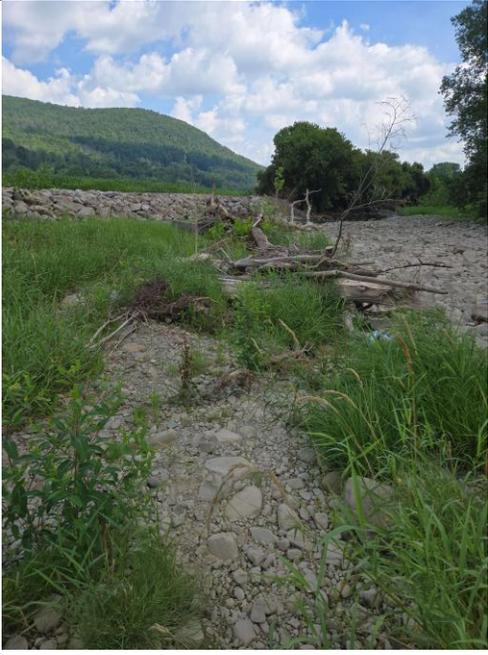
Infrastructure Protection	Map ID: 90
<p>WESTFIELD TWP (Y) Lat: 41.942908 (X) Long: -77.474041</p> <p>Infrastructure Risk Severity: High Length: 200 ft Width: 1 ft Height: 1 ft Cubic Yards: 7.41 Immediate Concern: Yes Suggested Action: Stabilize Bank</p> <p>Comments: 8 inch steel pipe exposed crossing river.</p>

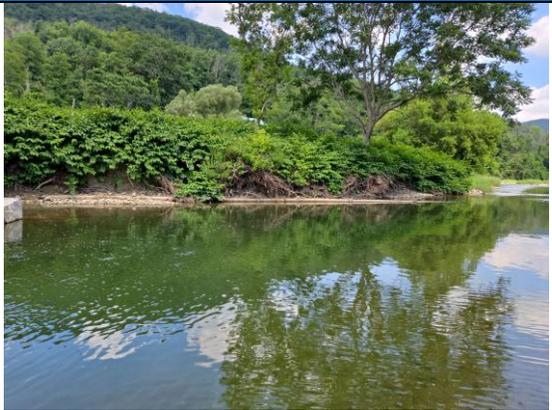
Debris Management	Map ID: 91
<p>DEERFIELD TWP (Y) Lat: 41.946958 (X) Long: -77.470426</p> <p>Debris Severity: Low Length: 30 ft Width: 20 ft Height: 10 ft Cubic Yards: 222.22 Immediate Concern: No Suggested Action:</p> <p>Comments:</p>

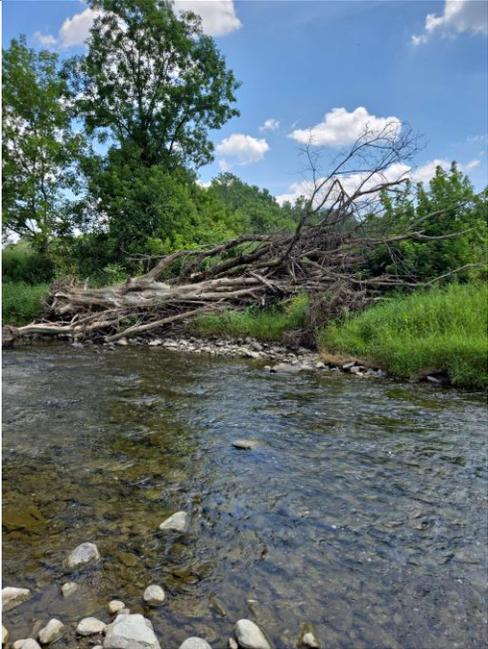
Debris Management	Map ID: 92
<p>DEERFIELD TWP (Y) Lat: 41.947177 (X) Long: -77.470248</p> <p>Debris Severity: Moderate Length: 60 ft Width: 15 ft Height: 10 ft Cubic Yards: 333.33 Immediate Concern: No Suggested Action:</p> <p>Comments:</p>

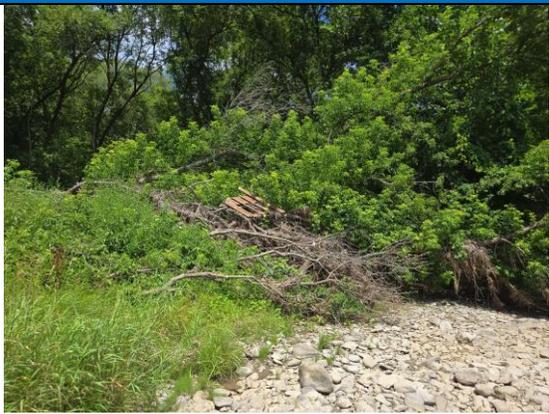
Debris Management	Map ID: 93
<p>DEERFIELD TWP (Y) Lat: 41.951032 (X) Long: -77.464645</p> <p>Debris Severity: Low Length: 25 ft Width: 10 ft Height: 4 ft Cubic Yards: 37.04 Immediate Concern: No Suggested Action:</p> <p>Comments:</p>

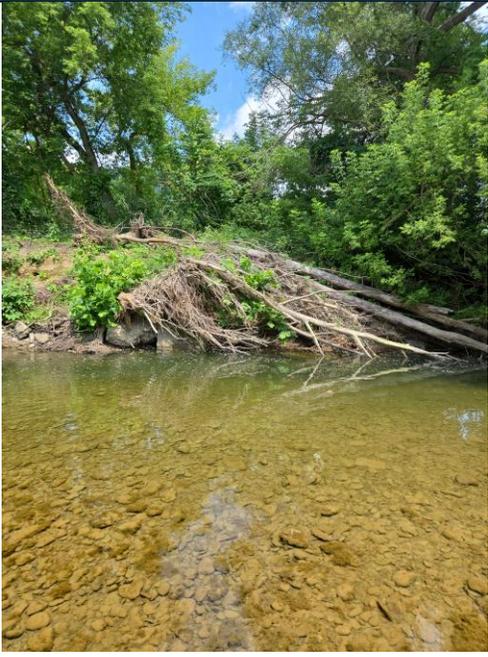
Debris Management	Map ID: 94
<p>DEERFIELD TWP (Y) Lat: 41.949978 (X) Long: -77.460990</p> <p>Debris Severity: Low Length: 15 ft Width: 15 ft Height: 5 ft Cubic Yards: 41.67 Immediate Concern: No Suggested Action:</p> <p>Comments:</p>

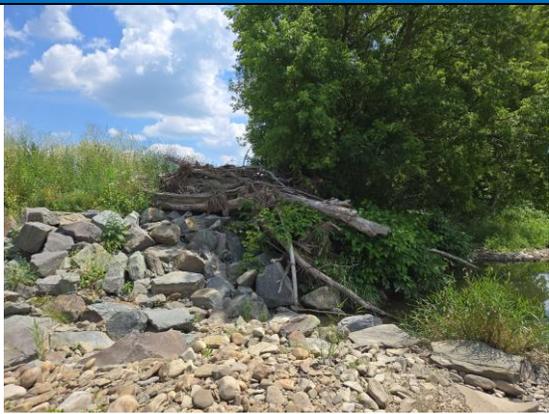
Debris Management	Map ID: 95
<p>DEERFIELD TWP (Y) Lat: 41.948998 (X) Long: -77.459814</p> <p>Debris Severity: Moderate Length: 30 ft Width: 8 ft Height: 5 ft Cubic Yards: 44.44 Immediate Concern: Yes Suggested Action: Remove Debris</p> <p>Comments:</p>

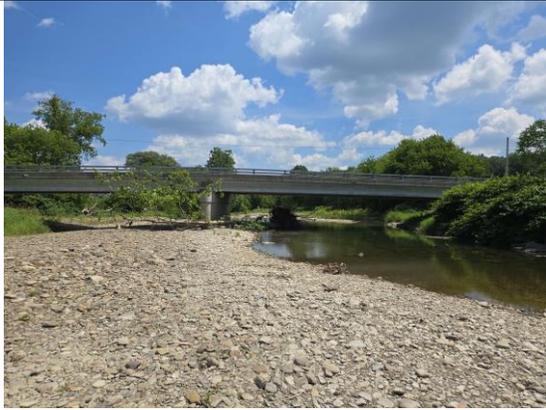
Stream Restoration	Map ID: 96
<p>DEERFIELD TWP (Y) Lat: 41.949062 (X) Long: -77.459640</p> <p>Gravel Bar Severity: Low Length: 400 ft Width: 40 ft Height: 2 ft Cubic Yards: 1185.19 Immediate Concern: No Suggested Action:</p> <p>Comments: Possible yearly maintenance already being done.</p>

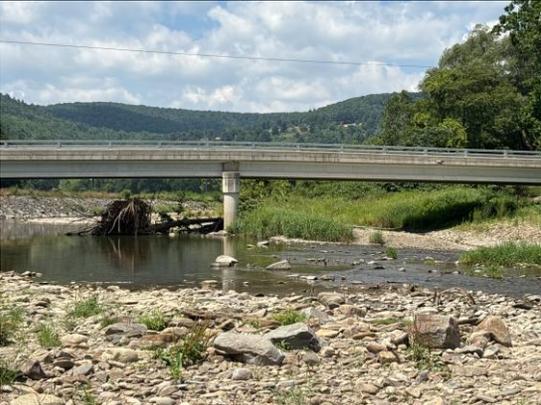
Bank Stabilization	Map ID: 98
<p>DEERFIELD TWP (Y) Lat: 41.948745 (X) Long: -77.457725</p> <p>Erosion Severity: Moderate Length: 400 ft Width: 6 ft Height: 9 ft Cubic Yards: 800.00 Immediate Concern: No Suggested Action:</p> <p>Comments: Sawtooth through the trees not the whole length.</p>

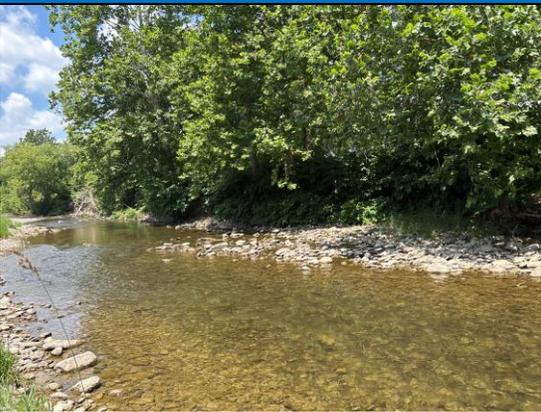
Bank Stabilization	Map ID: 99
<p>DEERFIELD TWP (Y) Lat: 41.948714 (X) Long: -77.457400</p> <p>Undercut Bank Severity: Low Length: 30 ft Width: 5 ft Height: 12 ft Cubic Yards: 66.67 Immediate Concern: No Suggested Action:</p> <p>Comments: Erosion and undercutting.</p>

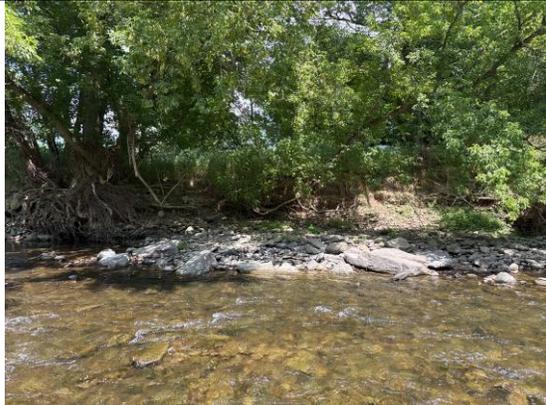
Debris Management	Map ID: 100
<p>DEERFIELD TWP (Y) Lat: 41.947206 (X) Long: -77.454707</p> <p>Debris Severity: Low Length: 75 ft Width: 2 ft Height: 2 ft Cubic Yards: 11.11 Immediate Concern: No Suggested Action:</p> <p>Comments:</p>

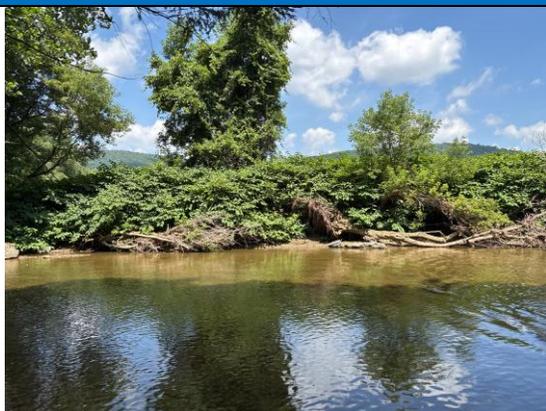
Stream Restoration	Map ID: 101
<p>DEERFIELD TWP (Y) Lat: 41.947881 (X) Long: -77.451399</p> <p>Gravel Bar Severity: Moderate Length: 400 ft Width: 30 ft Height: 2 ft Cubic Yards: 888.89 Immediate Concern: No Suggested Action:</p> <p>Comments: Potential gravel bar removal for flood relief. Need engineer.</p>

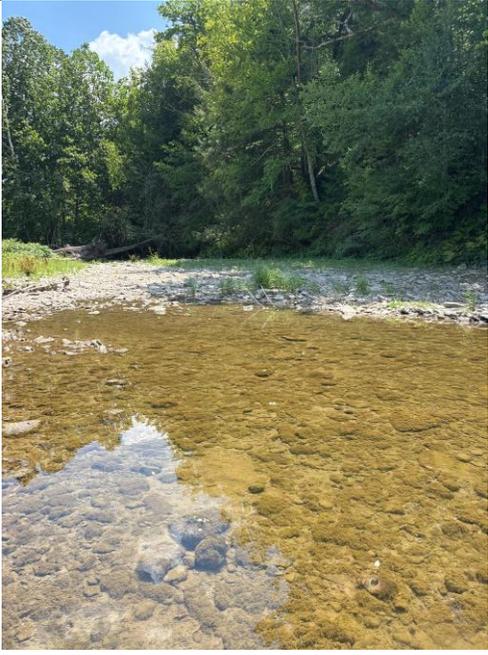
Bank Stabilization	Map ID: 102
<p>DEERFIELD TWP (Y) Lat: 41.948319 (X) Long: -77.450124</p> <p>Erosion Severity: High Length: 300 ft Width: 6 ft Height: 8 ft Cubic Yards: 533.33 Immediate Concern: No Suggested Action:</p> <p>Comments: May already be an NCRS project.</p>

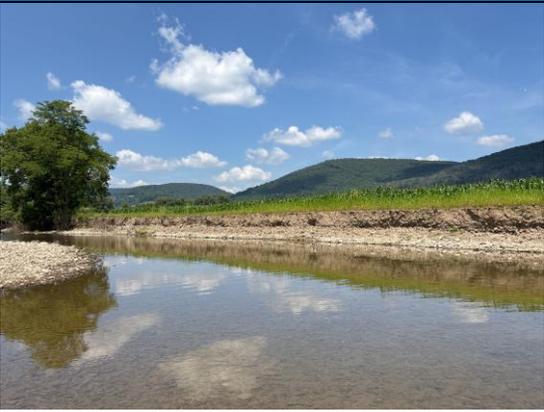
Stream Restoration	Map ID: 103
<p>DEERFIELD TWP (Y) Lat: 41.948348 (X) Long: -77.447925</p> <p>Gravel Bar Severity: Low Length: 500 ft Width: 30 ft Height: 4 ft Cubic Yards: 2222.22 Immediate Concern: No Suggested Action:</p> <p>Comments: Lower gravel bar for flood relief channel. Maintenance.</p>

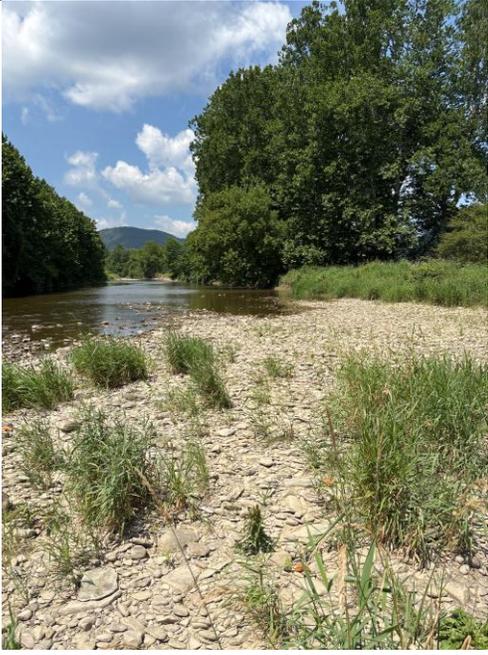
Debris Management	Map ID: 104
<p>DEERFIELD TWP (Y) Lat: 41.948392 (X) Long: -77.447896</p> <p>Debris Severity: Low Length: 45 ft Width: 4 ft Height: 3 ft Cubic Yards: 20.00 Immediate Concern: No Suggested Action:</p> <p>Comments:</p>

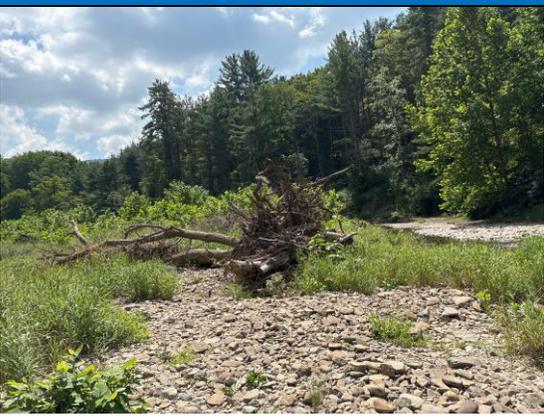
Bank Stabilization	Map ID: 105
<p>DEERFIELD TWP (Y) Lat: 41.951477 (X) Long: -77.443736</p> <p>Erosion Severity: Moderate Length: 45 ft Width: 5 ft Height: 8 ft Cubic Yards: 66.67 Immediate Concern: No Suggested Action:</p> <p>Comments:</p>

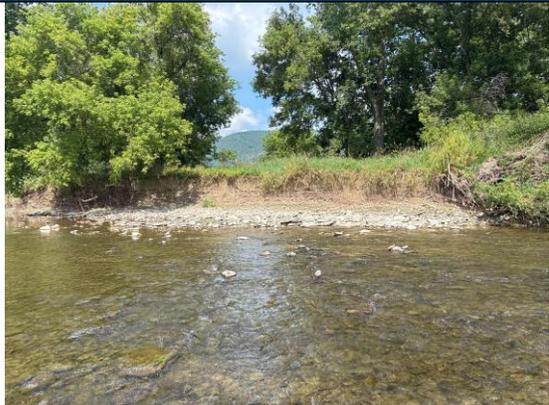
Debris Management	Map ID: 106
<p>DEERFIELD TWP (Y) Lat: 41.951401 (X) Long: -77.442500</p> <p>Debris Severity: Low Length: 25 ft Width: 5 ft Height: 5 ft Cubic Yards: 23.15 Immediate Concern: No Suggested Action:</p> <p>Comments:</p>

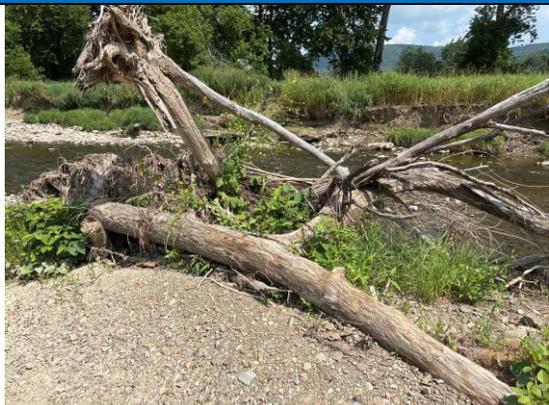
Bank Stabilization	Map ID: 107
<p>DEERFIELD TWP (Y) Lat: 41.951404 (X) Long: -77.442499</p> <p>Erosion Severity: Low Length: 120 ft Width: 6 ft Height: 15 ft Cubic Yards: 400.00 Immediate Concern: No Suggested Action:</p> <p>Comments: Field behind.</p>

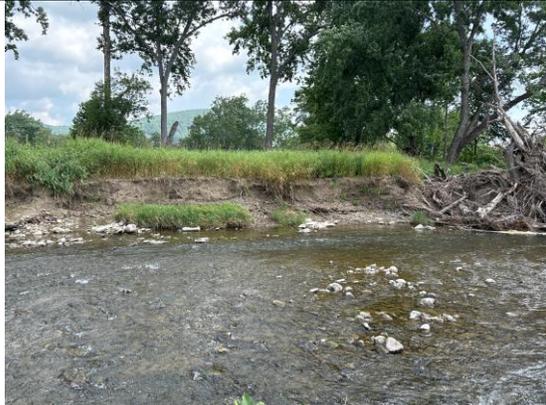
Debris Management	Map ID: 108
<p>DEERFIELD TWP (Y) Lat: 41.951425 (X) Long: -77.441979</p> <p>Debris Severity: High Length: 110 ft Width: 7 ft Height: 8 ft Cubic Yards: 228.15 Immediate Concern: Yes Suggested Action: Remove Debris</p> <p>Comments: Tree with root ball and woody debris.</p>

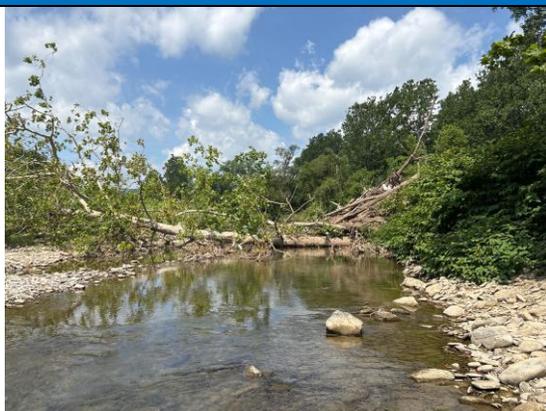
Bank Stabilization	Map ID: 109
<p>DEERFIELD TWP (Y) Lat: 41.951688 (X) Long: -77.441107</p> <p>Erosion Severity: High Length: 300 ft Width: 6 ft Height: 20 ft Cubic Yards: 1333.33 Immediate Concern: Yes Suggested Action: Stabilize Bank</p> <p>Comments: Erosion and sloping major. Homes extremely close.</p>

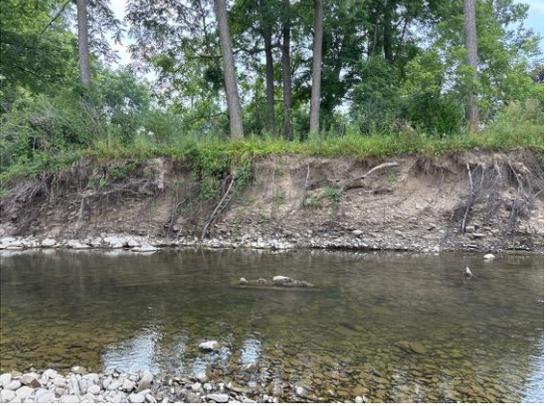
Debris Management	Map ID: 110
<p>DEERFIELD TWP (Y) Lat: 41.952442 (X) Long: -77.440878</p> <p>Gravel Bar Severity: High Length: 450 ft Width: 45 ft Height: 4 ft Cubic Yards: 3000.00 Immediate Concern: No Suggested Action:</p> <p>Comments: Possibly already permitted work and maybe not complete. Confluence of Troups Creek.</p>

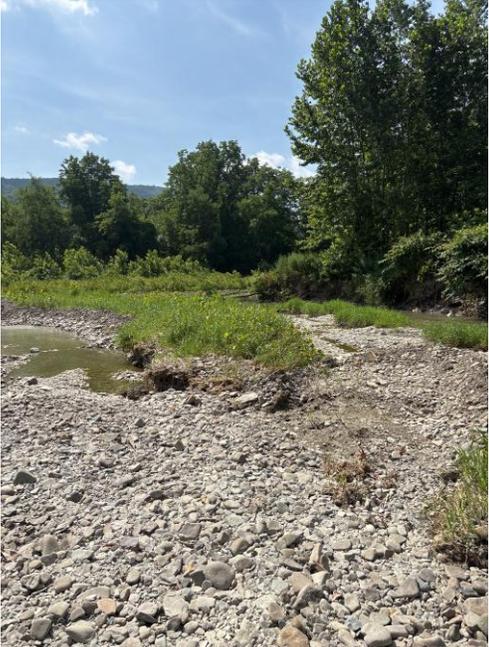
Stream Restoration	Map ID: 111
<p>DEERFIELD TWP (Y) Lat: 41.954146 (X) Long: -77.442625</p> <p>other Severity: Low Length: 25 ft Width: 6 ft Height: 12 ft Cubic Yards: 66.67 Immediate Concern: No Suggested Action:</p> <p>Comments:</p>

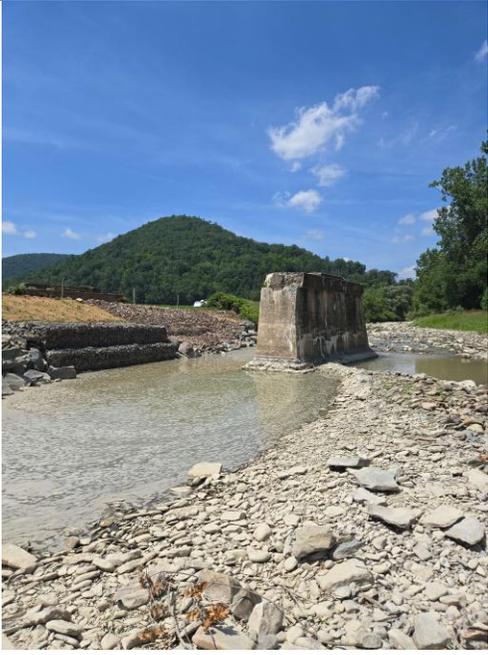
Bank Stabilization	Map ID: 112
<p>DEERFIELD TWP (Y) Lat: 41.961990 (X) Long: -77.444893</p> <p>Erosion Severity: Moderate Length: 500 ft Width: 10 ft Height: 10 ft Cubic Yards: 1851.85 Immediate Concern: No Suggested Action:</p> <p>Comments:</p>

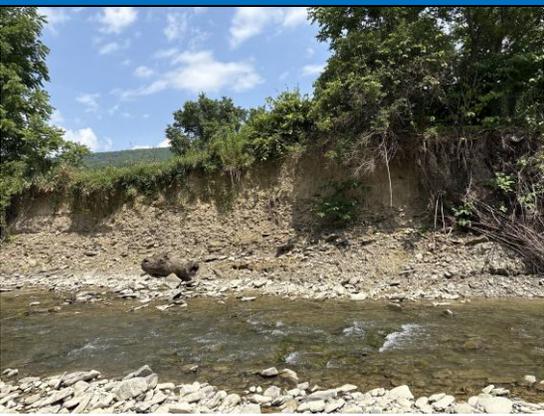
Bank Stabilization	Map ID: 113
<p>DEERFIELD TWP (Y) Lat: 41.967923 (X) Long: -77.449111</p> <p>Erosion Severity: Moderate Length: 50 ft Width: 8 ft Height: 10 ft Cubic Yards: 148.15 Immediate Concern: No Suggested Action:</p> <p>Comments: Sharp s curve in river impacts road.</p>

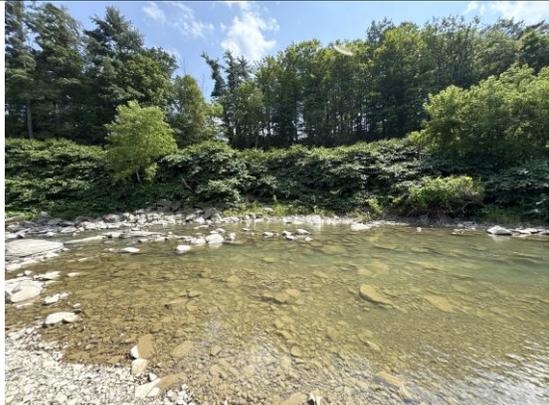
Bank Stabilization	Map ID: 114
<p>DEERFIELD TWP (Y) Lat: 41.971971 (X) Long: -77.454505</p> <p>Erosion Severity: Moderate Length: 100 ft Width: 30 ft Height: 2 ft Cubic Yards: 222.22 Immediate Concern: No Suggested Action:</p> <p>Comments: Water cuts over on wrong side of bank and floods down to homes.</p>

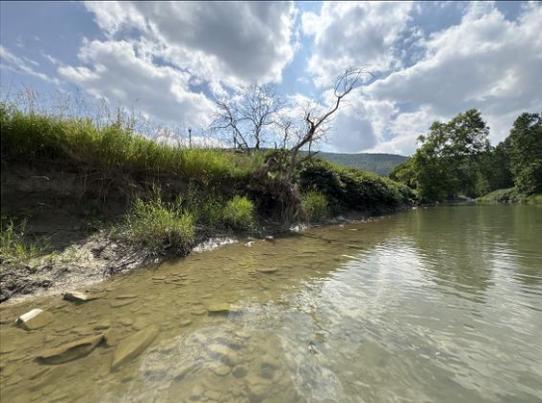
Bank Stabilization	Map ID: 115
<p>DEERFIELD TWP (Y) Lat: 41.971673 (X) Long: -77.455853</p> <p>Erosion Severity: Moderate Length: 250 ft Width: 6 ft Height: 8 ft Cubic Yards: 444.44 Immediate Concern: No Suggested Action:</p> <p>Comments: Behind homes. Too deep to walk full length for pictures.</p>

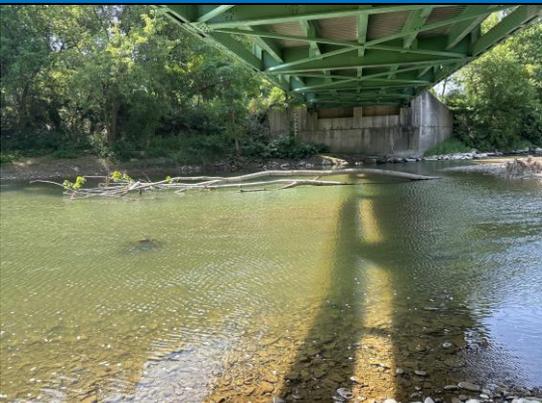
Debris Management	Map ID: 116
<p>DEERFIELD TWP (Y) Lat: 41.952661 (X) Long: -77.439591</p> <p>Debris Severity: Moderate Length: 60 ft Width: 2 ft Height: 2 ft Cubic Yards: 8.89 Immediate Concern: No Suggested Action:</p> <p>Comments: Middle of river.</p>

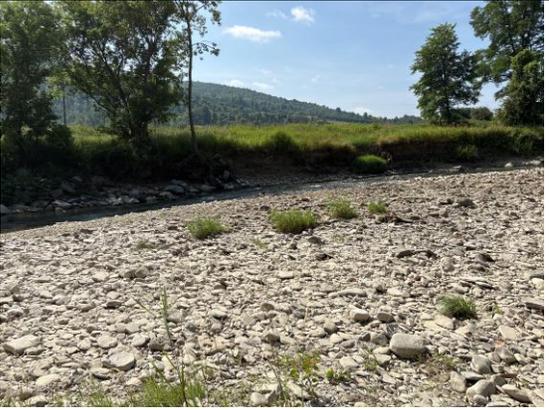
Stream Restoration	Map ID: 117
<p>DEERFIELD TWP (Y) Lat: 41.953171 (X) Long: -77.438420</p> <p>Gravel Bar Severity: Moderate Length: 400 ft Width: 75 ft Height: 2 ft Cubic Yards: 2222.22 Immediate Concern: No Suggested Action:</p> <p>Comments:</p>

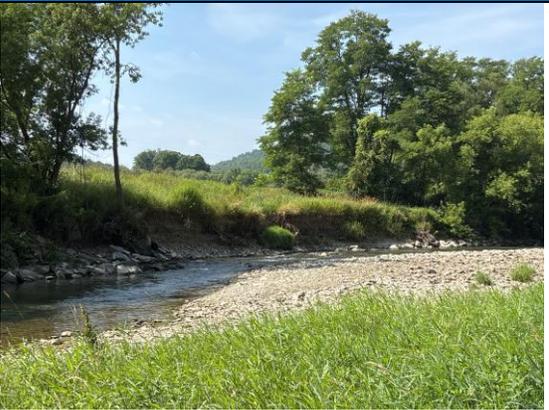
Bank Stabilization	Map ID: 118
<p>DEERFIELD TWP (Y) Lat: 41.953365 (X) Long: -77.438143</p> <p>Erosion Severity: Moderate Length: 250 ft Width: 6 ft Height: 20 ft Cubic Yards: 1111.11 Immediate Concern: No Suggested Action:</p> <p>Comments:</p>

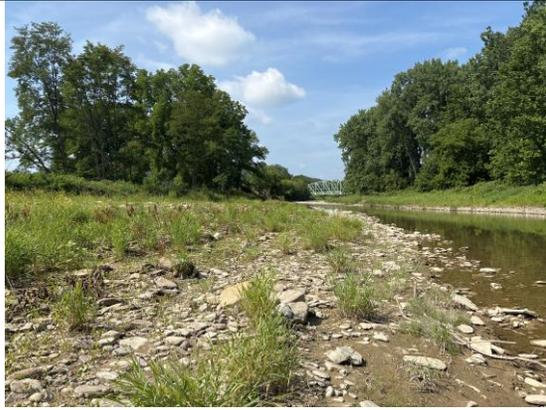
Stream Restoration	Map ID: 119
<p>DEERFIELD TWP (Y) Lat: 41.954155 (X) Long: -77.436323</p> <p>other Severity: Low Length: 700 ft Width: 100 ft Height: 5 ft Cubic Yards: 12962.96 Immediate Concern: No Suggested Action:</p> <p>Comments:</p>

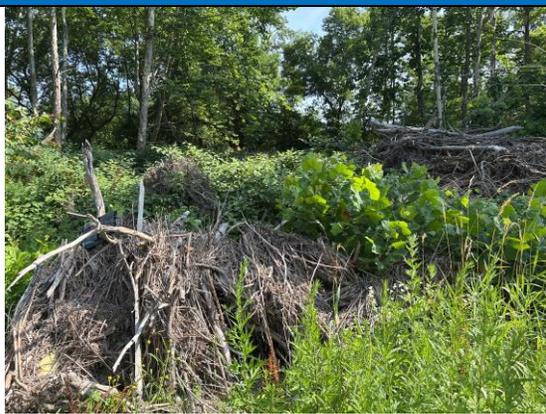
Debris Management	Map ID: 120
<p>DEERFIELD TWP (Y) Lat: 41.953293 (X) Long: -77.430347</p> <p>Debris Severity: Low Length: 40 ft Width: 2 ft Height: 5 ft Cubic Yards: 14.81 Immediate Concern: No Suggested Action:</p> <p>Comments: Woody debris plus.</p>

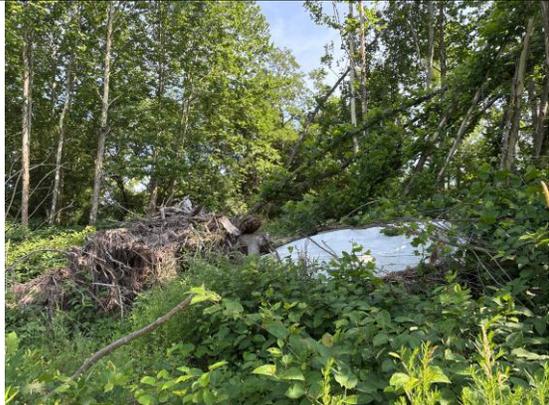
Debris Management	Map ID: 121
<p>DEERFIELD TWP (Y) Lat: 41.953446 (X) Long: -77.430122</p> <p>Debris Severity: Low Length: 50 ft Width: 6 ft Height: 9 ft Cubic Yards: 100.00 Immediate Concern: No Suggested Action:</p> <p>Comments: Woody debris and boat on bank.</p>

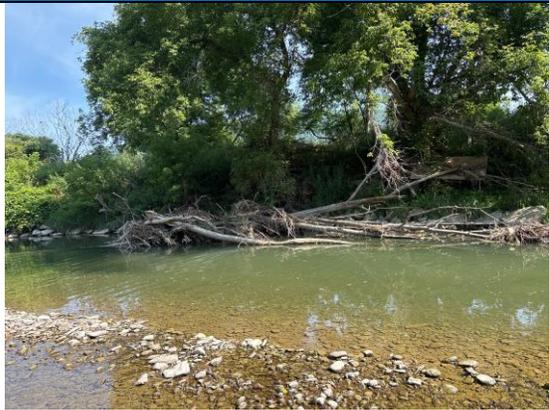
Debris Management	Map ID: 122
<p>DEERFIELD TWP (Y) Lat: 41.953155 (X) Long: -77.428910</p> <p>Debris Severity: Low Length: 55 ft Width: 4 ft Height: 3 ft Cubic Yards: 24.44 Immediate Concern: No Suggested Action:</p> <p>Comments: Tree debris.</p>

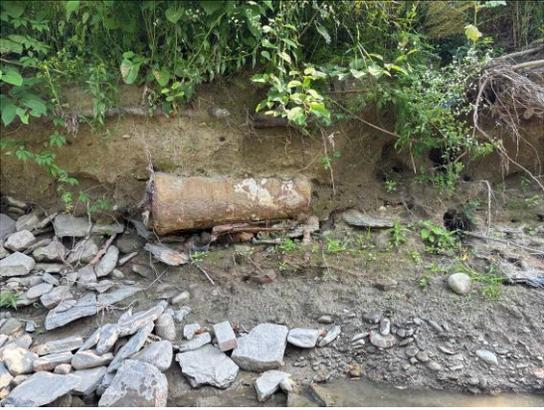
Bank Stabilization	Map ID: 123
<p>DEERFIELD TWP (Y) Lat: 41.952698 (X) Long: -77.427964</p> <p>Erosion Severity: Low Length: 100 ft Width: 5 ft Height: 7 ft Cubic Yards: 129.63 Immediate Concern: No Suggested Action:</p> <p>Comments: Erosion exposing possible farm dump.</p>

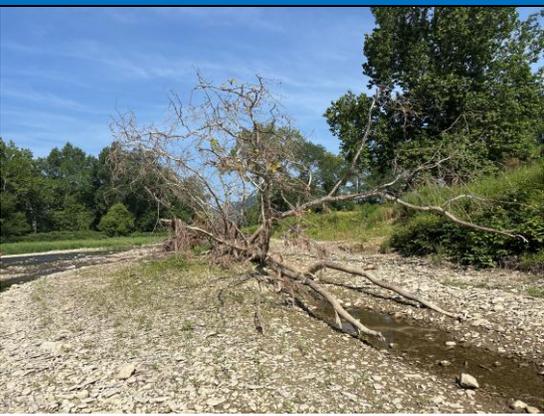
Debris Management	Map ID: 124
<p>DEERFIELD TWP (Y) Lat: 41.952741 (X) Long: -77.426094</p> <p>Debris Severity: High Length: 105 ft Width: 2 ft Height: 2 ft Cubic Yards: 15.56 Immediate Concern: No Suggested Action:</p> <p>Comments: Tree</p>

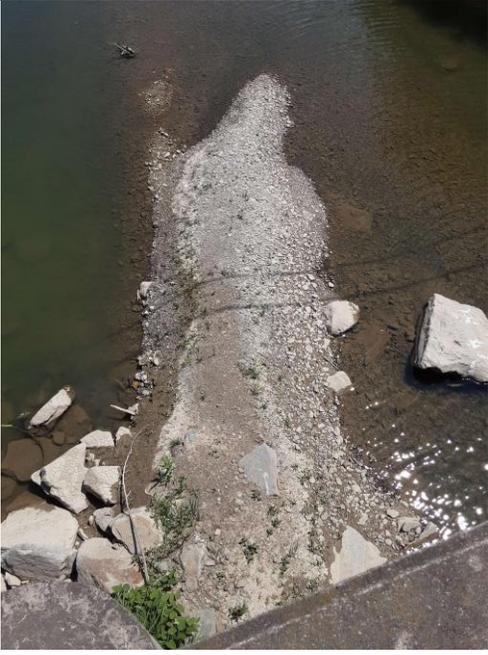
Infrastructure Protection	Map ID: 125
<p>DEERFIELD TWP (Y) Lat: 41.954215 (X) Long: -77.418432</p> <p>Gravel Bar Severity: Moderate Length: 50 ft Width: 10 ft Height: 3 ft Cubic Yards: 55.56 Immediate Concern: No Suggested Action:</p> <p>Comments: Center under bridge</p>

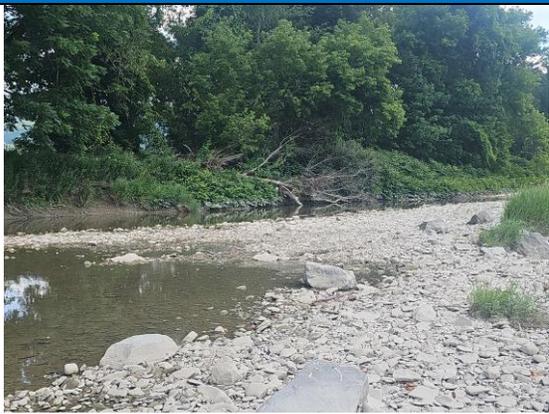
Debris Management	Map ID: 126
<p>DEERFIELD TWP (Y) Lat: 41.954284 (X) Long: -77.417300</p> <p>Gravel Bar Severity: High Length: 250 ft Width: 60 ft Height: 2 ft Cubic Yards: 1111.11 Immediate Concern: Yes Suggested Action: Restore Channel</p> <p>Comments: Trees and debris. Near bridge.</p>

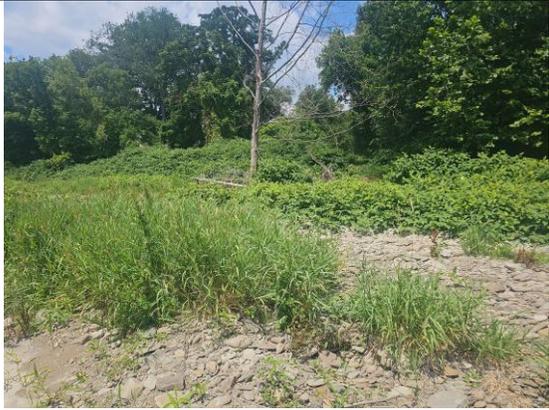
Debris Management	Map ID: 127
<p>DEERFIELD TWP (Y) Lat: 41.954638 (X) Long: -77.415566</p> <p>Debris Severity: Moderate Length: 5 ft Width: 5 ft Height: 4 ft Cubic Yards: 3.70 Immediate Concern: Yes Suggested Action: Remove Debris</p> <p>Comments: Tree. Near bridge and pipeline valve. Previous points also near valve.</p>

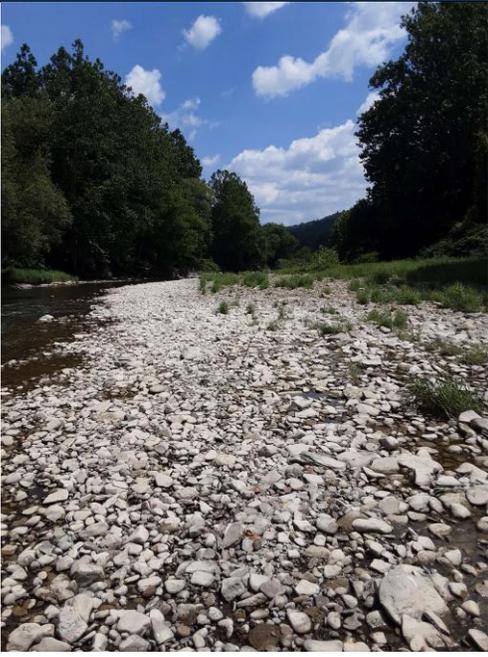
Stream Restoration	Map ID: 129
<p>DEERFIELD TWP (Y) Lat: 41.954959 (X) Long: -77.413566</p> <p>Gravel Bar Severity: Low Length: 400 ft Width: 40 ft Height: 2 ft Cubic Yards: 1185.19 Immediate Concern: No Suggested Action:</p> <p>Comments:</p>

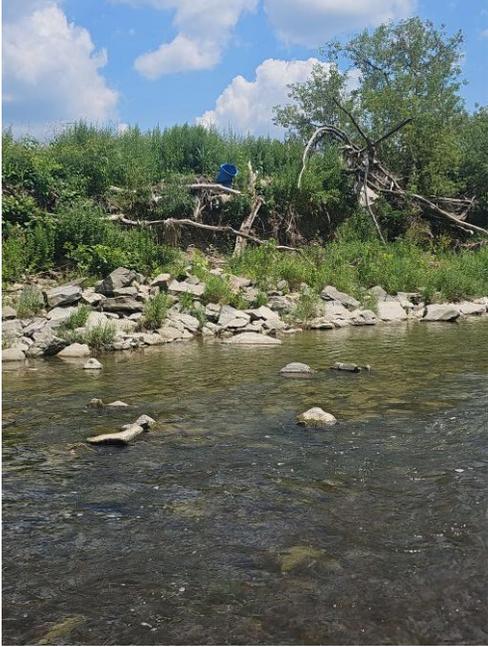
Debris Management	Map ID: 131
<p>DEERFIELD TWP (Y) Lat: 41.955016 (X) Long: -77.410921</p> <p>Debris Severity: Moderate Length: 20 ft Width: 20 ft Height: 10 ft Cubic Yards: 148.15 Immediate Concern: Yes Suggested Action: Remove Debris</p> <p>Comments: Tree and debris</p>

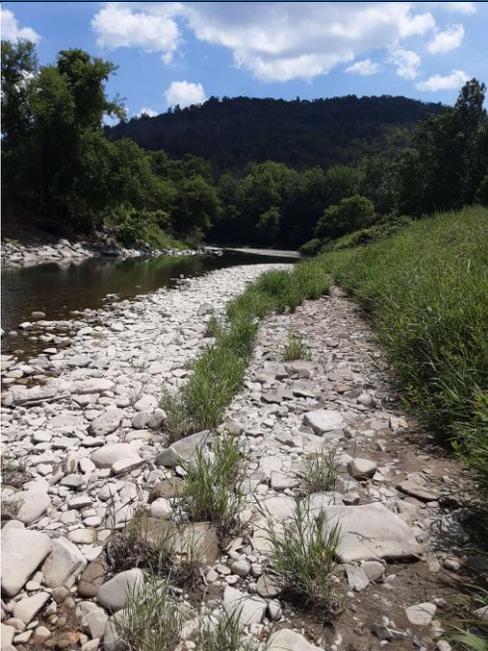
Stream Restoration	Map ID: 132
<p>DEERFIELD TWP (Y) Lat: 41.954921 (X) Long: -77.410831</p> <p>Gravel Bar Severity: Low Length: 100 ft Width: 10 ft Height: 1 ft Cubic Yards: 37.04 Immediate Concern: No Suggested Action:</p> <p>Comments:</p>

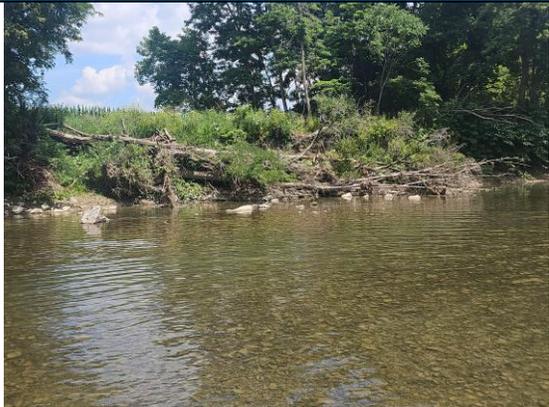
Debris Management	Map ID: 133
<p>DEERFIELD TWP (Y) Lat: 41.954344 (X) Long: -77.409960</p> <p>Debris Severity: Moderate Length: 50 ft Width: 7 ft Height: 10 ft Cubic Yards: 129.63 Immediate Concern: No Suggested Action:</p> <p>Comments: Trees on both sides of bank.</p>

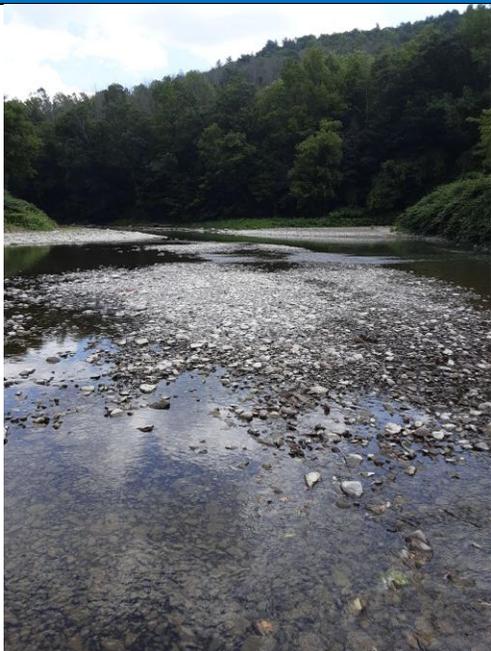
Stream Restoration	Map ID: 134
<p>DEERFIELD TWP (Y) Lat: 41.954301 (X) Long: -77.409659</p> <p>Gravel Bar Severity: Low Length: 50 ft Width: 20 ft Height: 1 ft Cubic Yards: 37.04 Immediate Concern: No Suggested Action:</p> <p>Comments: Center of stream</p>

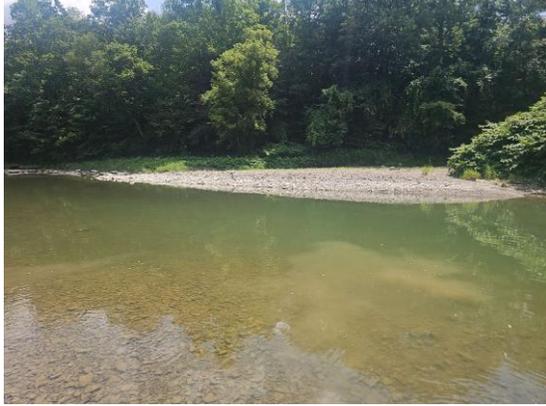
Stream Restoration	Map ID: 135
<p>DEERFIELD TWP (Y) Lat: 41.954139 (X) Long: -77.409308</p> <p>Gravel Bar Severity: High Length: 75 ft Width: 50 ft Height: 2 ft Cubic Yards: 277.78 Immediate Concern: No Suggested Action:</p> <p>Comments: Gravel bars on both sides of the river. Confluence of Yarnell Brook</p>

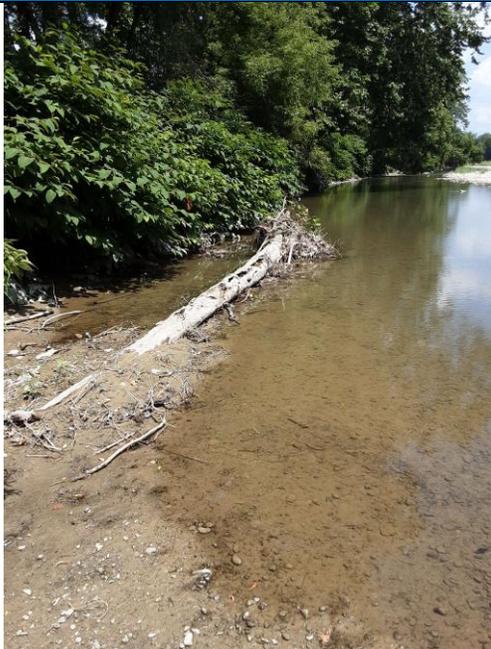
Debris Management	Map ID: 136
<p>DEERFIELD TWP (Y) Lat: 41.954337 (X) Long: -77.407915</p> <p>Debris Severity: Moderate Length: 40 ft Width: 1 ft Height: 1 ft Cubic Yards: 1.48 Immediate Concern: No Suggested Action:</p> <p>Comments:</p>

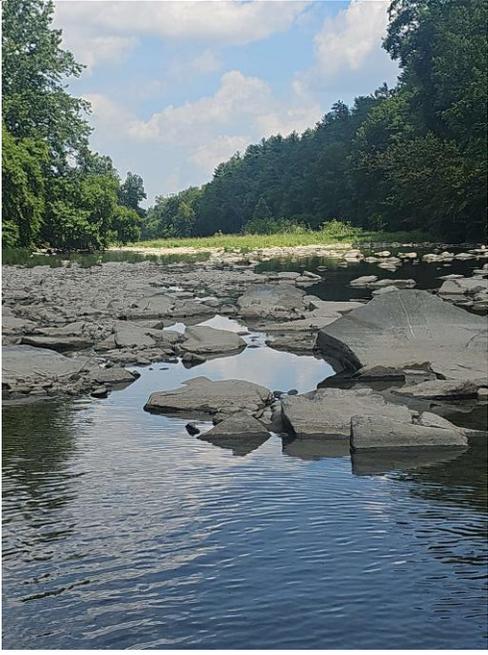
Debris Management	Map ID: 137
<p>DEERFIELD TWP (Y) Lat: 41.954513 (X) Long: -77.407741</p> <p>Debris Severity: Moderate Length: 50 ft Width: 50 ft Height: 1 ft Cubic Yards: 92.59 Immediate Concern: No Suggested Action:</p> <p>Comments: Rocks</p>

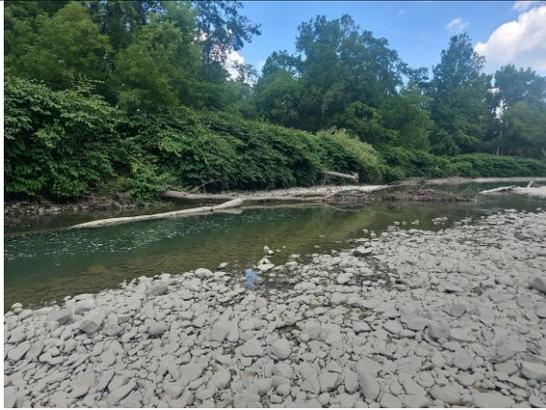
Debris Management	Map ID: 139
<p>DEERFIELD TWP (Y) Lat: 41.955560 (X) Long: -77.405694</p> <p>Debris Severity: Moderate Length: 50 ft Width: 10 ft Height: 3 ft Cubic Yards: 55.56 Immediate Concern: Yes Suggested Action: Remove Debris</p> <p>Comments: Trees</p>

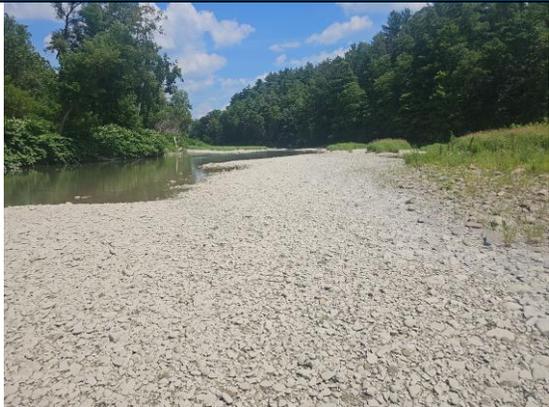
Stream Restoration	Map ID: 141
<p>DEERFIELD TWP (Y) Lat: 41.955912 (X) Long: -77.404787</p> <p>Gravel Bar Severity: Moderate Length: 200 ft Width: 50 ft Height: 1.5 ft Cubic Yards: 555.56 Immediate Concern: Yes Suggested Action: Restore Channel</p> <p>Comments: Upstream as well</p>

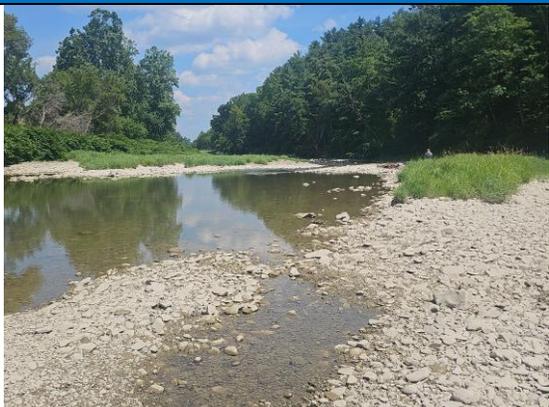
Stream Restoration	Map ID: 142
<p>DEERFIELD TWP (Y) Lat: 41.955942 (X) Long: -77.404212</p> <p>Gravel Bar Severity: Critical Length: 100 ft Width: 100 ft Height: 1.5 ft Cubic Yards: 555.56 Immediate Concern: Yes Suggested Action:</p> <p>Comments: Bad bottleneck formed.</p>

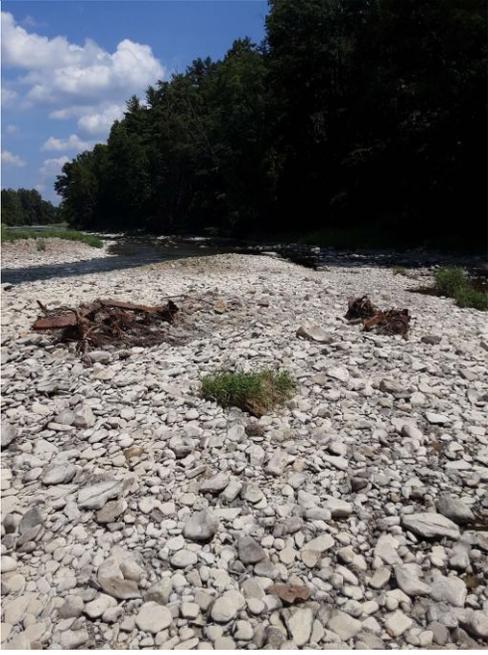
Debris Management	Map ID: 143
<p>DEERFIELD TWP (Y) Lat: 41.955955 (X) Long: -77.403791</p> <p>Debris Severity: Low Length: 6 ft Width: 2 ft Height: 2 ft Cubic Yards: 0.89 Immediate Concern: No Suggested Action:</p> <p>Comments: Car debris</p>

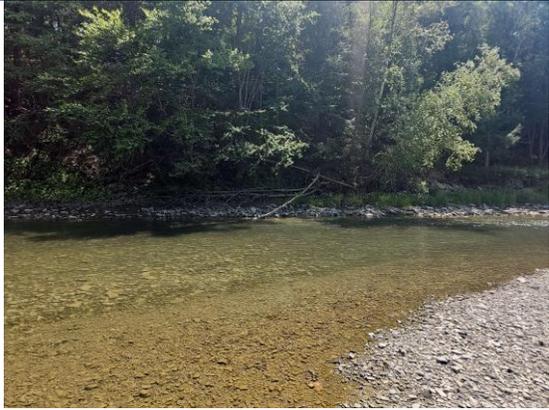
Debris Management	Map ID: 145
<p>DEERFIELD TWP (Y) Lat: 41.957018 (X) Long: -77.402048</p> <p>Gravel Bar Severity: Moderate Length: 100 ft Width: 100 ft Height: 50 ft Cubic Yards: 18518.52 Immediate Concern: No Suggested Action:</p> <p>Comments: Trees and gravel bar.</p>

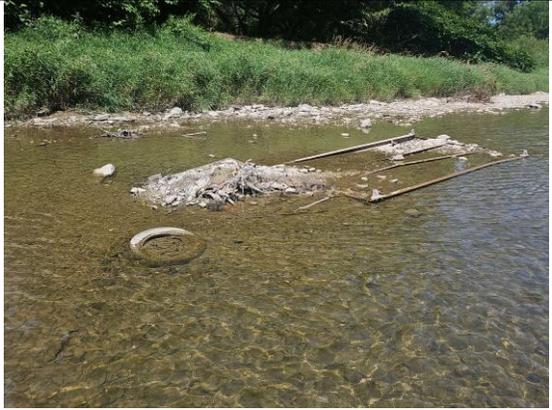
Debris Management	Map ID: 147
<p>DEERFIELD TWP (Y) Lat: 41.957646 (X) Long: -77.400965</p> <p>Debris Severity: High Length: 10 ft Width: 10 ft Height: 1 ft Cubic Yards: 3.70 Immediate Concern: Yes Suggested Action: Remove Debris</p> <p>Comments:</p>

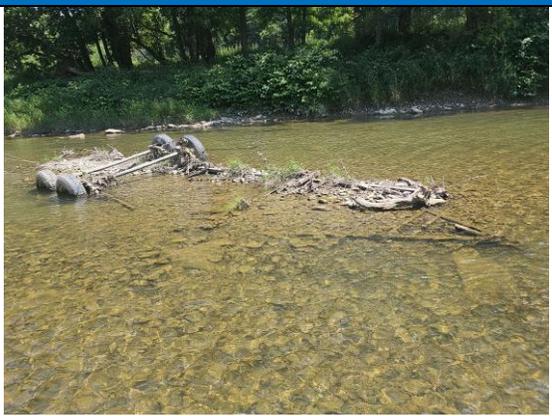
Debris Management	Map ID: 148
<p>DEERFIELD TWP (Y) Lat: 41.957595 (X) Long: -77.400908</p> <p>Debris Severity: Critical Length: 30 ft Width: 5 ft Height: 1 ft Cubic Yards: 5.56 Immediate Concern: Yes Suggested Action: Remove Debris</p> <p>Comments: Debris trailer and tires. Will get swept away in next flood.</p>

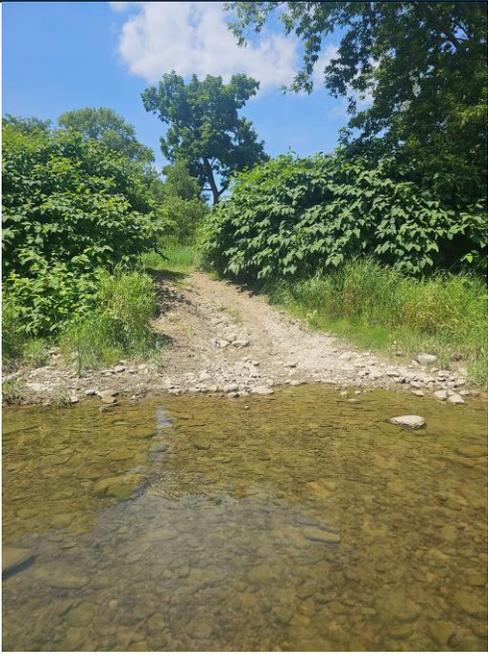
Access Point	Map ID: 149
<p>DEERFIELD TWP (Y) Lat: 41.958086 (X) Long: -77.400247</p> <p>other Severity: Moderate Length: 5 ft Width: 5 ft Height: 5 ft Cubic Yards: 4.63 Immediate Concern: No Suggested Action:</p> <p>Comments: Access out of river.</p>

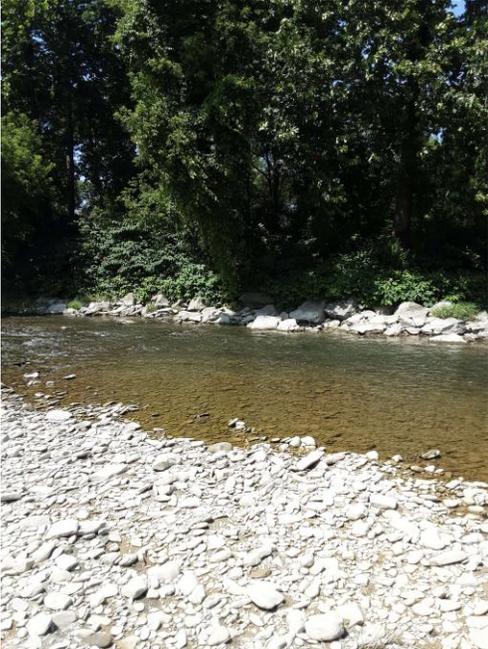
Debris Management	Map ID: 151
<p>DEERFIELD TWP (Y) Lat: 41.958820 (X) Long: -77.398397</p> <p>other Severity: Low Length: 50 ft Width: 10 ft Height: 4 ft Cubic Yards: 74.07 Immediate Concern: No Suggested Action:</p> <p>Comments:</p>

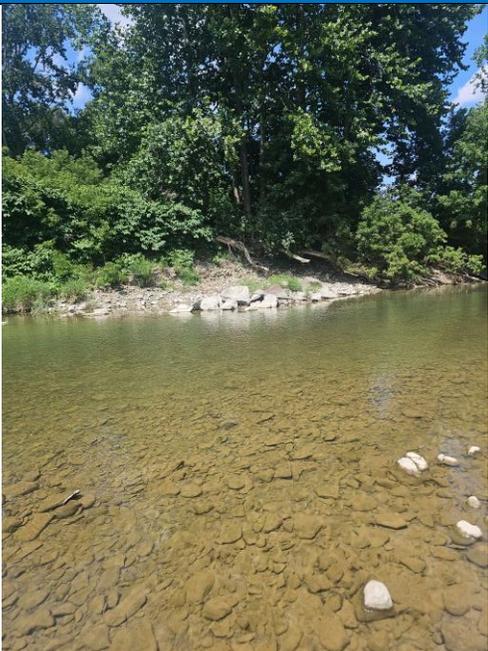
Debris Management	Map ID: 152
<p>DEERFIELD TWP (Y) Lat: 41.959002 (X) Long: -77.397996</p> <p>Debris Severity: Moderate Length: 10 ft Width: 15 ft Height: 2 ft Cubic Yards: 11.11 Immediate Concern: No Suggested Action:</p> <p>Comments: Looks like rip rap rock.</p>

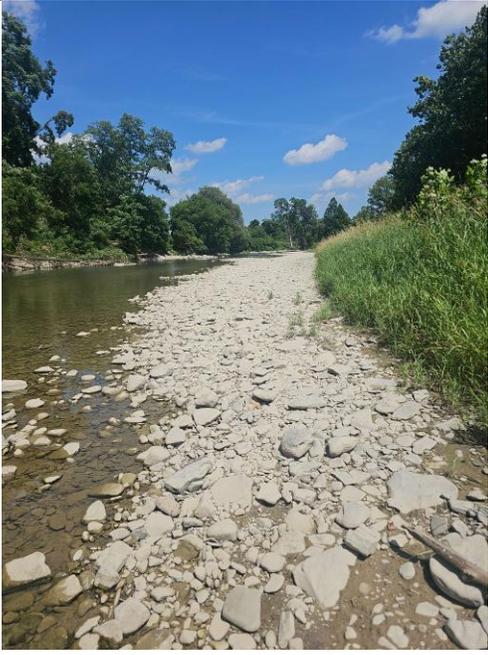
Stream Restoration	Map ID: 153
<p>DEERFIELD TWP (Y) Lat: 41.959003 (X) Long: -77.397993</p> <p>Gravel Bar Severity: Moderate Length: 100 ft Width: 25 ft Height: 1 ft Cubic Yards: 92.59 Immediate Concern: No Suggested Action:</p> <p>Comments: Rip rap.</p>

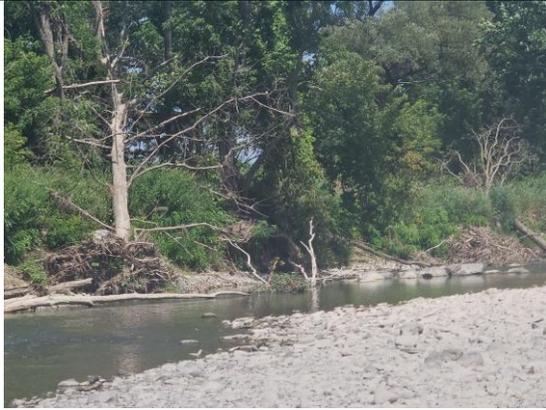
Debris Management	Map ID: 155
<p>DEERFIELD TWP (Y) Lat: 41.959403 (X) Long: -77.396344</p> <p>Debris Severity: Moderate Length: 200 ft Width: 75 ft Height: 10 ft Cubic Yards: 5555.56 Immediate Concern: Yes Suggested Action: Remove Debris</p> <p>Comments: Rip rap rocks, gravel rock bar and huge fallen trees.</p>

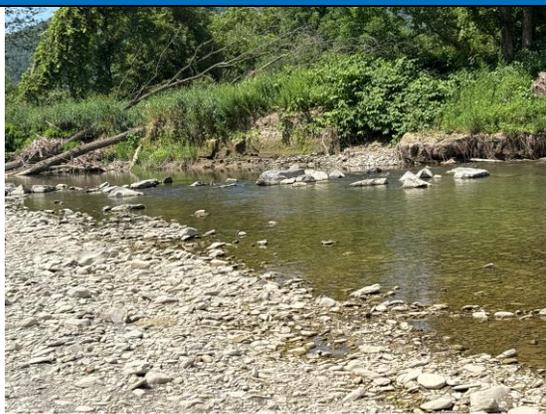
Bank Stabilization	Map ID: 156
<p>DEERFIELD TWP (Y) Lat: 41.959211 (X) Long: -77.394933</p> <p>Gravel Bar Severity: Moderate Length: 120 ft Width: 40 ft Height: 2 ft Cubic Yards: 355.56 Immediate Concern: No Suggested Action:</p> <p>Comments: Shaving gravel bar and moving displaced rip rap against left bank.</p>

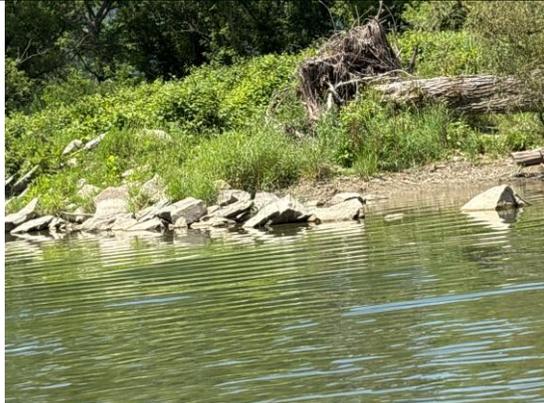
Stream Restoration	Map ID: 157
<p>DEERFIELD TWP (Y) Lat: 41.958860 (X) Long: -77.394292</p> <p>Gravel Bar Severity: Moderate Length: 15 ft Width: 5 ft Height: 4 ft Cubic Yards: 11.11 Immediate Concern: No Suggested Action:</p> <p>Comments: Rearrange rocks due to then causing erosion.</p>

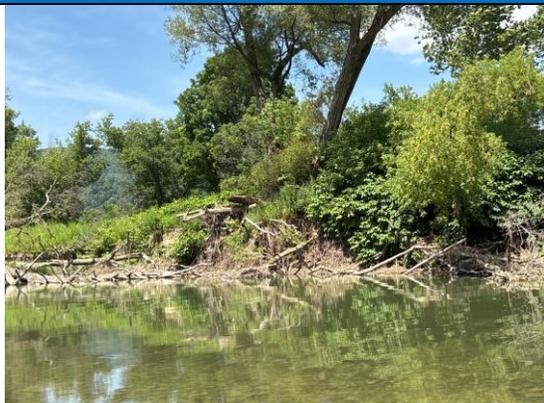
Debris Management	Map ID: 158
<p>DEERFIELD TWP (Y) Lat: 41.958772 (X) Long: -77.393999</p> <p>Debris Severity: Low Length: 50 ft Width: 3 ft Height: 3 ft Cubic Yards: 16.67 Immediate Concern: No Suggested Action:</p> <p>Comments:</p>
