Tioga County Mitigation Advisory Committee

The following legislative master document is the product of a series of special meetings convened in the summer of 2025 by the Tioga County Mitigation Advisory Committee (MAC), operating under the exclusive authority of the FEMA and PEMA approved Tioga County All-Hazard Mitigation Plan. This Plan has been adopted by the Tioga County Board of Commissioners, all municipalities, stakeholder groups, and formally approved by FEMA and PEMA, ensuring its alignment with both local priorities and federal/state standards.

The centerpiece of the document, featuring imagery, site descriptions, and data collected during field assessments throughout the Cowanesque Valley. This section highlights observed damages, erosion sites, and areas requiring stabilization, as well as opportunities for proactive mitigation.

Published By: Tioga County (PA) GIS Department
September 22, 2025

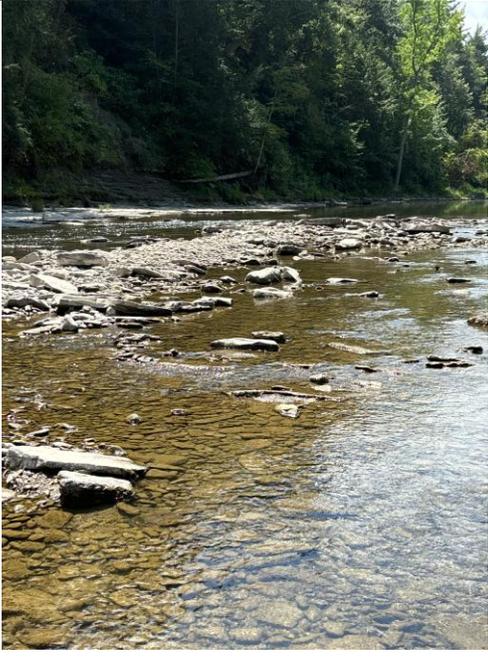
Stream Restoration	Map ID: 159
<p>DEERFIELD TWP (Y) Lat: 41.959061 (X) Long: -77.391339</p> <p>Gravel Bar Severity: Low Length: 30 ft Width: 3 ft Height: 1 ft Cubic Yards: 3.33 Immediate Concern: No Suggested Action:</p> <p>Comments:</p>

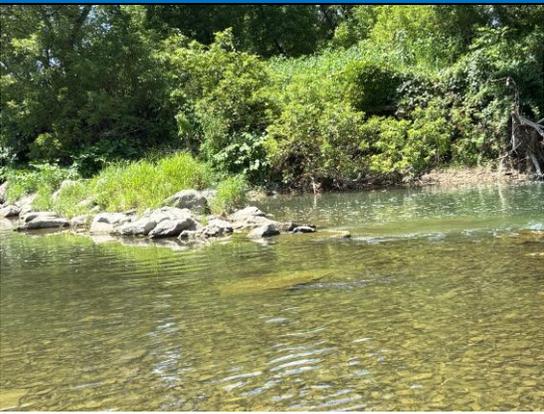
Bank Stabilization	Map ID: 160
<p>DEERFIELD TWP (Y) Lat: 41.964690 (X) Long: -77.382036</p> <p>other Severity: Moderate Length: 25 ft Width: 5 ft Height: 4 ft Cubic Yards: 18.52 Immediate Concern: No Suggested Action:</p> <p>Comments:</p>

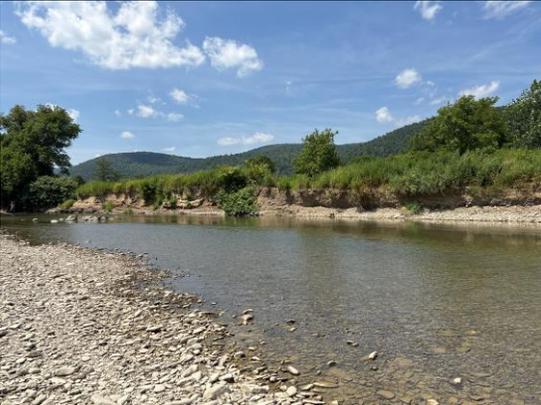
Bank Stabilization	Map ID: 161
<p>DEERFIELD TWP (Y) Lat: 41.965962 (X) Long: -77.378965</p> <p>Erosion Severity: Moderate Length: 250 ft Width: 5 ft Height: 11 ft Cubic Yards: 509.26 Immediate Concern: No Suggested Action:</p> <p>Comments:</p>

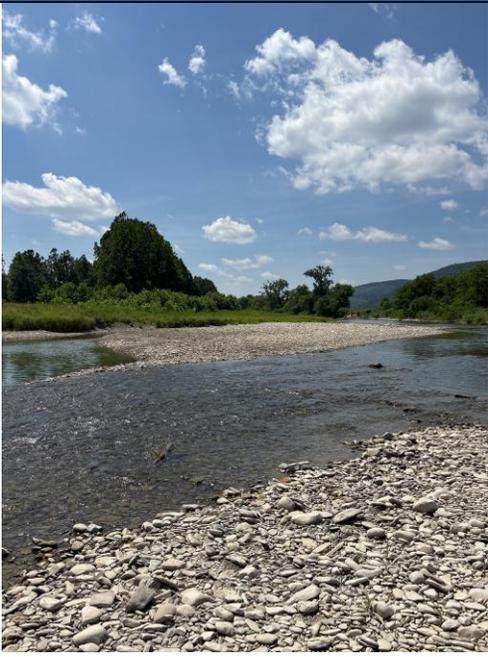
Stream Restoration	Map ID: 162
<p>DEERFIELD TWP (Y) Lat: 41.966103 (X) Long: -77.376533</p> <p>Gravel Bar Severity: Moderate Length: 70 ft Width: 35 ft Height: 2 ft Cubic Yards: 181.48 Immediate Concern: No Suggested Action:</p> <p>Comments:</p>

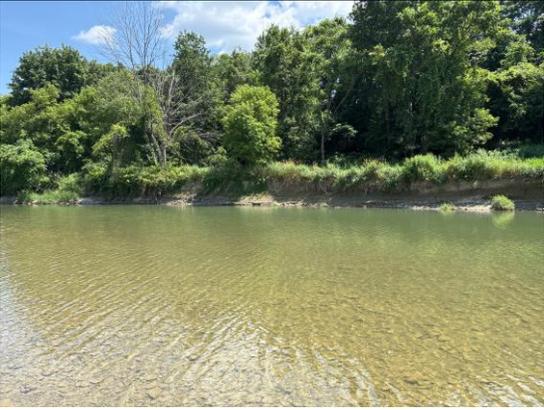
Bank Stabilization	Map ID: 163
<p>DEERFIELD TWP (Y) Lat: 41.966965 (X) Long: -77.374455</p> <p>Erosion Severity: Moderate Length: 700 ft Width: 5 ft Height: 12 ft Cubic Yards: 1555.56 Immediate Concern: No Suggested Action:</p> <p>Comments:</p>

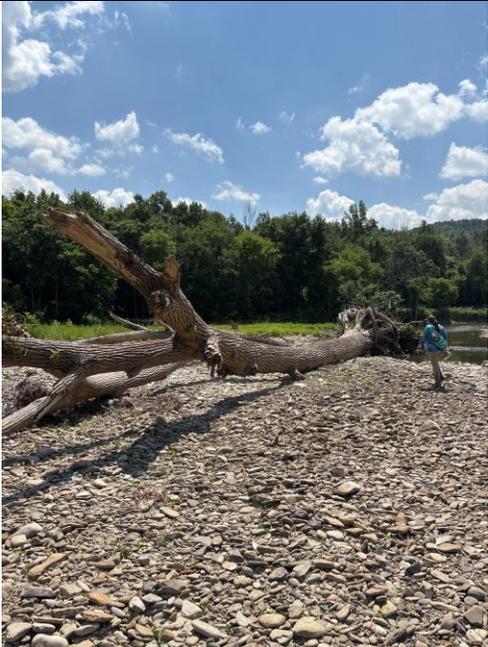
Debris Management	Map ID: 164
<p>DEERFIELD TWP (Y) Lat: 41.968025 (X) Long: -77.373544</p> <p>Debris Severity: Low Length: 100 ft Width: 4 ft Height: 3 ft Cubic Yards: 44.44 Immediate Concern: No Suggested Action:</p> <p>Comments:</p>

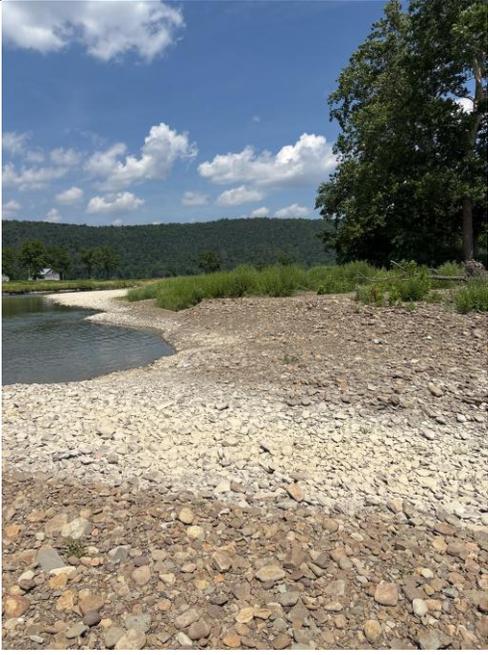
Stream Restoration	Map ID: 165
<p>DEERFIELD TWP (Y) Lat: 41.968671 (X) Long: -77.373509</p> <p>Gravel Bar Severity: Moderate Length: 200 ft Width: 90 ft Height: 5 ft Cubic Yards: 3333.33 Immediate Concern: No Suggested Action:</p> <p>Comments: Shave and shape.</p>

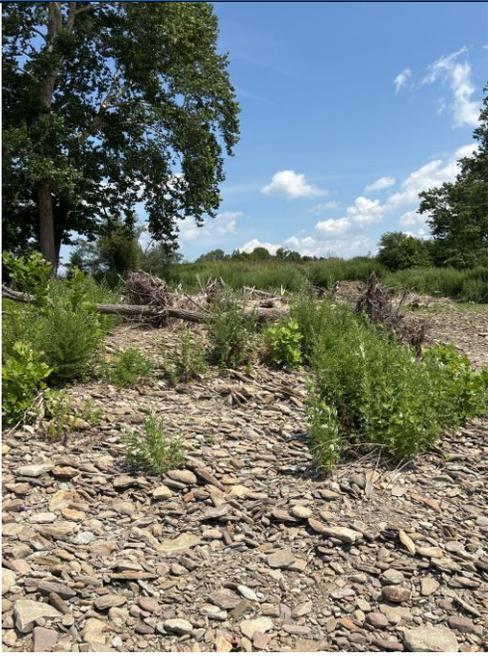
Debris Management	Map ID: 166
<p>DEERFIELD TWP (Y) Lat: 41.968846 (X) Long: -77.373397</p> <p>Debris Severity: Low Length: 50 ft Width: 5 ft Height: 3 ft Cubic Yards: 27.78 Immediate Concern: No Suggested Action:</p> <p>Comments: Trees.</p>

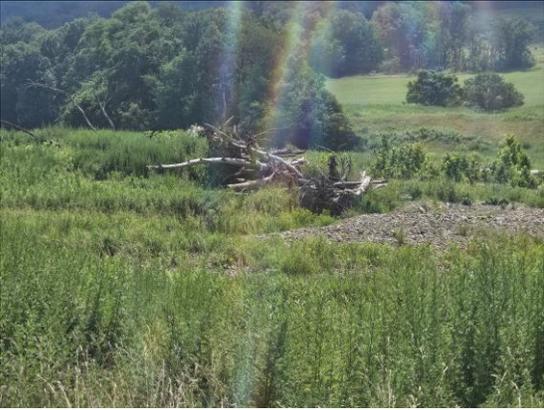
Debris Management	Map ID: 167
<p>OSCEOLA TWP (Y) Lat: 41.971249 (X) Long: -77.372597</p> <p>Gravel Bar Severity: Moderate Length: 100 ft Width: 35 ft Height: 3 ft Cubic Yards: 388.89 Immediate Concern: Yes Suggested Action: Remove Debris</p> <p>Comments: Gravel bar and big trees. Homes nearby across river.</p>

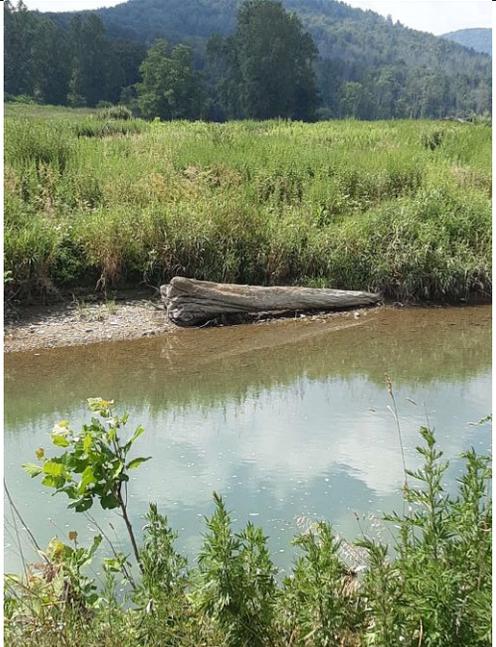
Debris Management	Map ID: 168
<p>OSCEOLA TWP (Y) Lat: 41.971250 (X) Long: -77.371714</p> <p>Debris Severity: Moderate Length: 30 ft Width: 3 ft Height: 3 ft Cubic Yards: 10.00 Immediate Concern: No Suggested Action:</p> <p>Comments:</p>

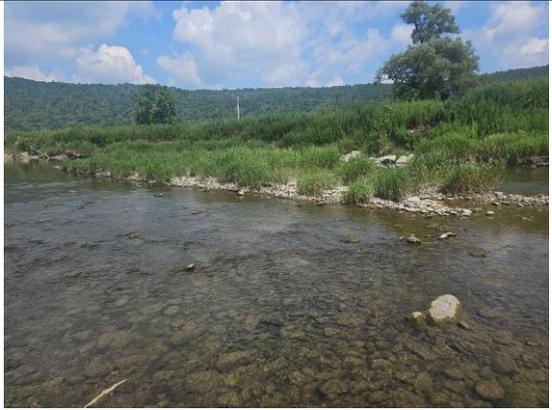
Stream Restoration	Map ID: 169
<p>OSCEOLA TWP (Y) Lat: 41.971195 (X) Long: -77.370616</p> <p>Gravel Bar Severity: Moderate Length: 69 ft Width: 7 ft Height: 2.5 ft Cubic Yards: 44.72 Immediate Concern: No Suggested Action:</p> <p>Comments: Little gravel bar with vegetation.</p>

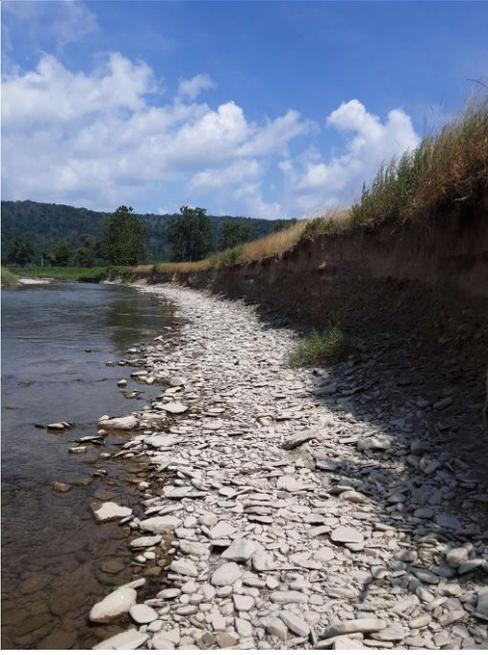
Bank Stabilization	Map ID: 171
<p>OSCEOLA TWP (Y) Lat: 41.970003 (X) Long: -77.368310</p> <p>Undercut Bank Severity: Moderate Length: 200 ft Width: 3 ft Height: 10 ft Cubic Yards: 222.22 Immediate Concern: No Suggested Action:</p> <p>Comments:</p>

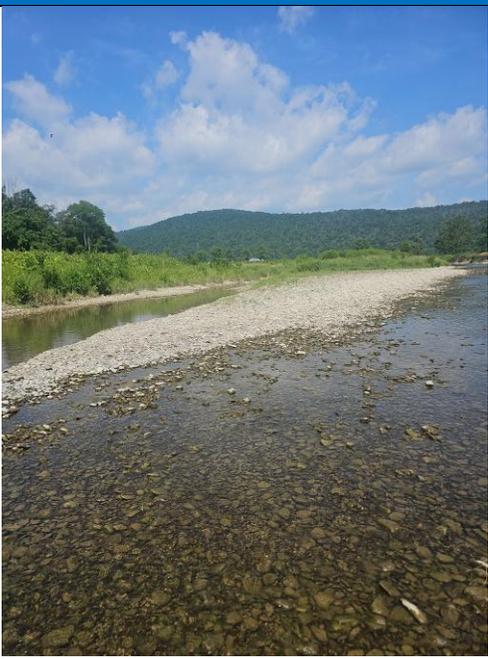
Stream Restoration	Map ID: 172
<p>OSCEOLA TWP (Y) Lat: 41.969394 (X) Long: -77.368063</p> <p>Gravel Bar Severity: Moderate Length: 200 ft Width: 55 ft Height: 2 ft Cubic Yards: 814.81 Immediate Concern: Yes Suggested Action:</p> <p>Comments: Bad bank undercutting as well.</p>

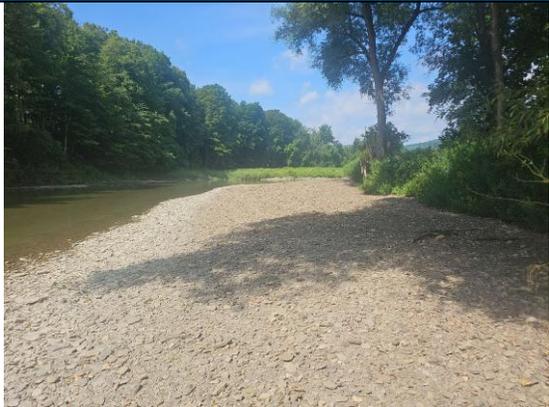
Stream Restoration	Map ID: 173
<p>OSCEOLA TWP (Y) Lat: 41.969186 (X) Long: -77.366685</p> <p>Gravel Bar Severity: Moderate Length: 100 ft Width: 30 ft Height: 2 ft Cubic Yards: 222.22 Immediate Concern: Yes Suggested Action: Remove Debris</p> <p>Comments:</p>

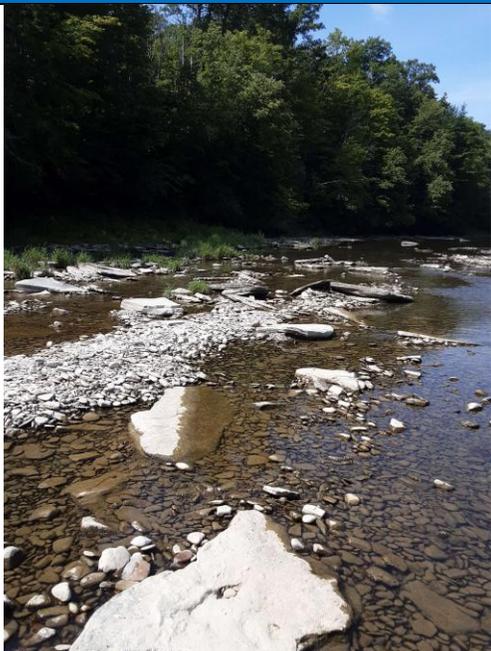
Stream Restoration	Map ID: 174
<p>OSCEOLA TWP (Y) Lat: 41.969483 (X) Long: -77.365426</p> <p>Gravel Bar Severity: Low Length: 50 ft Width: 20 ft Height: 2 ft Cubic Yards: 74.07 Immediate Concern: No Suggested Action: Restore Channel</p> <p>Comments: Middle of stream.</p>

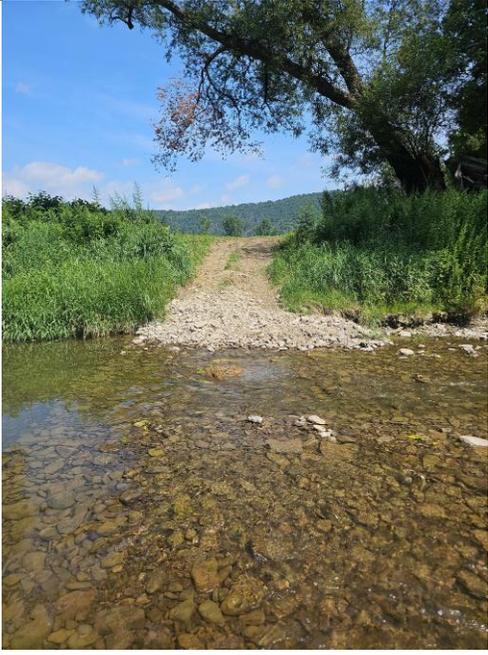
Access Point	Map ID: 175
<p>OSCEOLA TWP (Y) Lat: 41.969789 (X) Long: -77.364313</p> <p>other Severity: Low Length: 20 ft Width: 7 ft Height: 10 ft Cubic Yards: 51.85 Immediate Concern: No Suggested Action:</p> <p>Comments: Good access point from private land.</p>

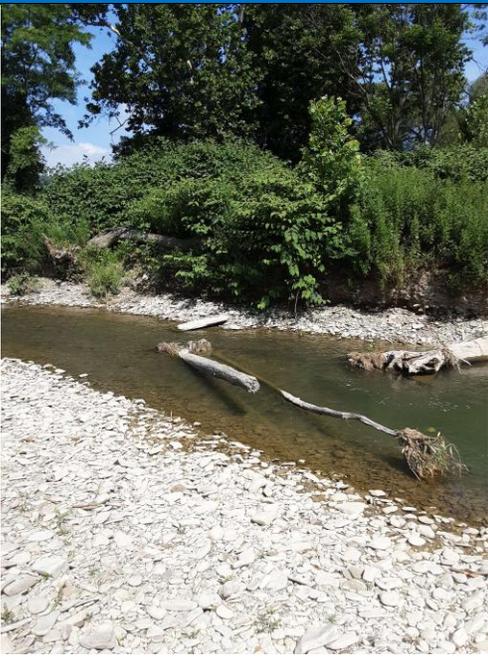
Debris Management	Map ID: 176
<p>OSCEOLA TWP (Y) Lat: 41.969927 (X) Long: -77.363576</p> <p>Debris Severity: Moderate Length: 70 ft Width: 15 ft Height: 5 ft Cubic Yards: 194.44 Immediate Concern: No Suggested Action:</p> <p>Comments:</p>

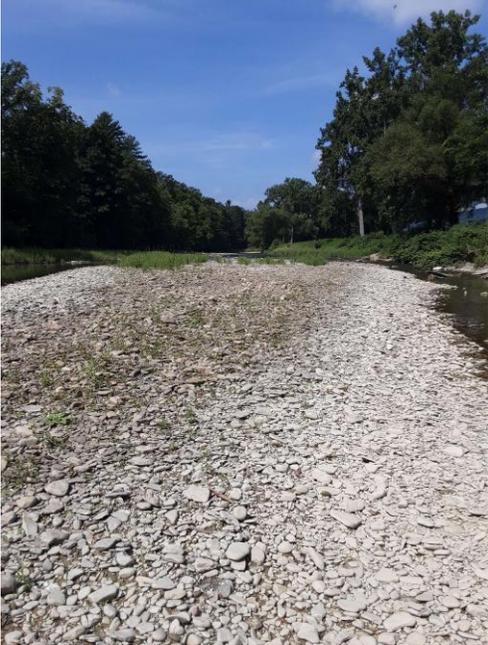
Stream Restoration	Map ID: 177
<p>OSCEOLA TWP (Y) Lat: 41.969814 (X) Long: -77.363497</p> <p>Gravel Bar Severity: Moderate Length: 150 ft Width: 40 ft Height: 2 ft Cubic Yards: 444.44 Immediate Concern: No Suggested Action:</p> <p>Comments: Middle of stream.</p>

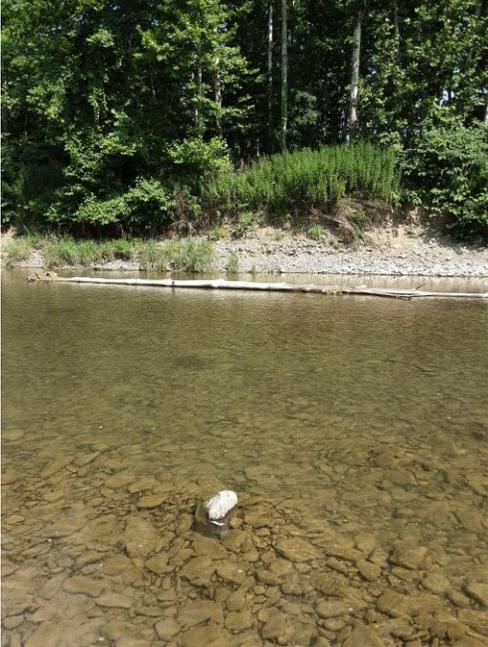
Debris Management	Map ID: 178
<p>OSCEOLA TWP (Y) Lat: 41.970026 (X) Long: -77.362161</p> <p>Debris Severity: Moderate Length: 50 ft Width: 2 ft Height: 2 ft Cubic Yards: 7.41 Immediate Concern: No Suggested Action:</p> <p>Comments:</p>

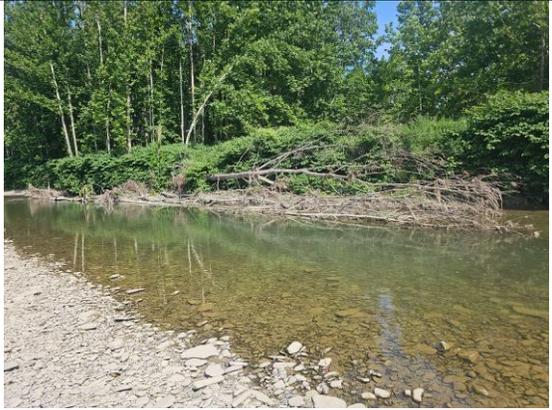
Debris Management	Map ID: 179
<p>OSCEOLA TWP (Y) Lat: 41.970076 (X) Long: -77.361094</p> <p>Debris Severity: High Length: 72 ft Width: 8 ft Height: 7 ft Cubic Yards: 149.33 Immediate Concern: Yes Suggested Action: Remove Debris</p> <p>Comments: Big tree. Affects channel.</p>

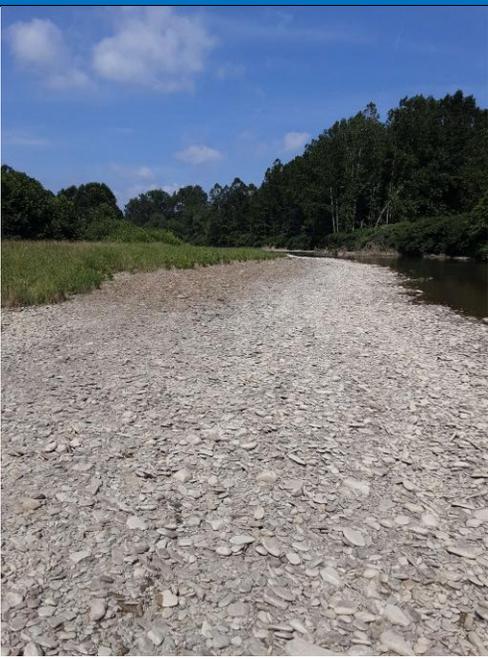
Stream Restoration	Map ID: 180
<p>OSCEOLA TWP (Y) Lat: 41.969817 (X) Long: -77.360550</p> <p>Gravel Bar Severity: Low Length: 200 ft Width: 20 ft Height: 2 ft Cubic Yards: 296.30 Immediate Concern: No Suggested Action:</p> <p>Comments:</p>

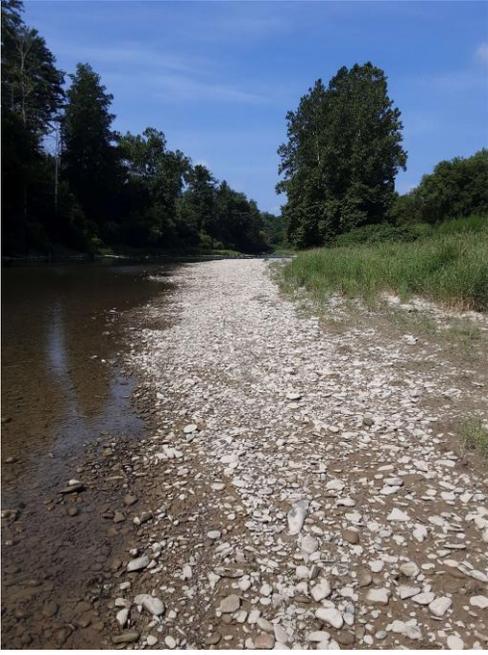
Stream Restoration	Map ID: 181
<p>OSCEOLA TWP (Y) Lat: 41.970302 (X) Long: -77.357593</p> <p>Gravel Bar Severity: Low Length: 200 ft Width: 30 ft Height: 1 ft Cubic Yards: 222.22 Immediate Concern: No Suggested Action:</p> <p>Comments:</p>

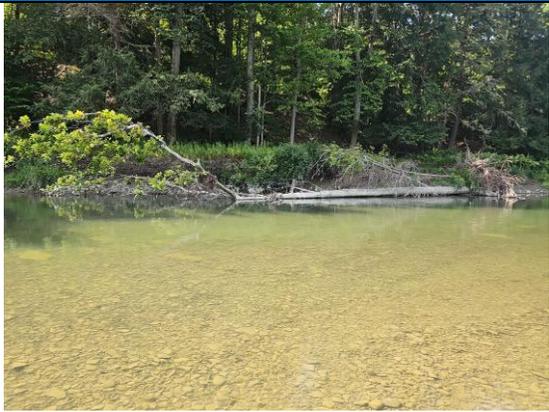
Debris Management	Map ID: 182
<p>OSCEOLA TWP (Y) Lat: 41.970373 (X) Long: -77.357115</p> <p>Debris Severity: Moderate Length: 50 ft Width: 5 ft Height: 2.5 ft Cubic Yards: 23.15 Immediate Concern: Yes Suggested Action: Remove Debris</p> <p>Comments: Big tree. Could float down river and affect bridge.</p>

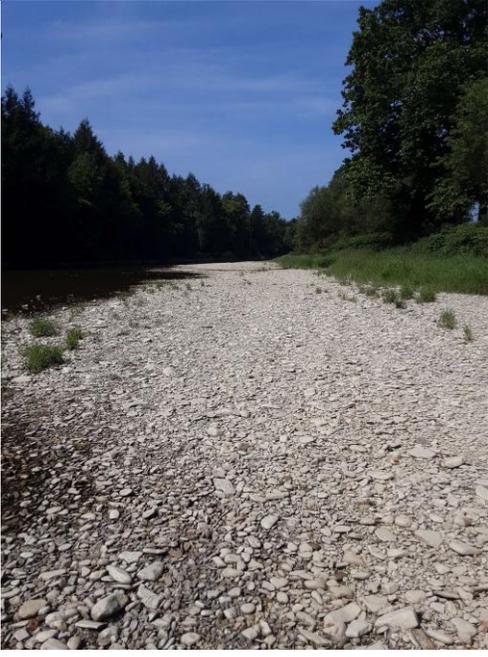
Stream Restoration	Map ID: 183
<p>OSCEOLA TWP (Y) Lat: 41.971169 (X) Long: -77.355161</p> <p>Gravel Bar Severity: Low Length: 200 ft Width: 30 ft Height: 1 ft Cubic Yards: 222.22 Immediate Concern: No Suggested Action:</p> <p>Comments:</p>

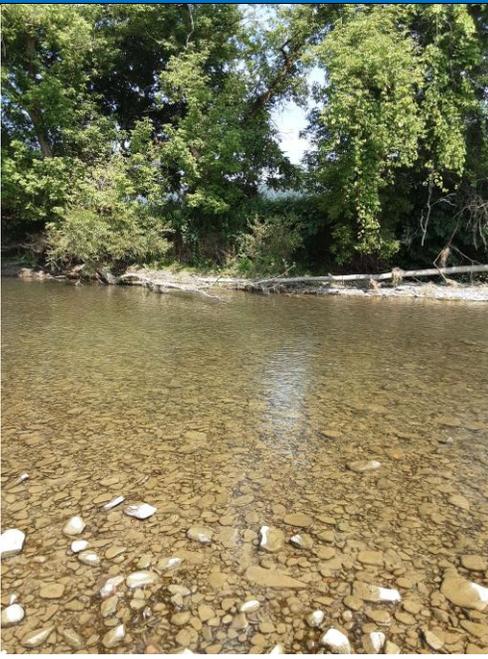
Debris Management	Map ID: 184
<p>OSCEOLA TWP (Y) Lat: 41.971512 (X) Long: -77.354308</p> <p>Debris Severity: Low Length: 50 ft Width: 1 ft Height: 1 ft Cubic Yards: 1.85 Immediate Concern: No Suggested Action:</p> <p>Comments:</p>

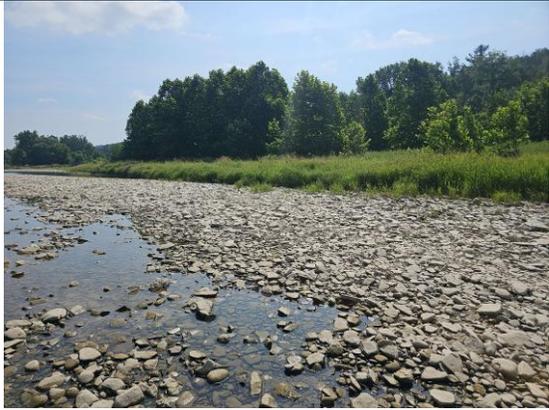
Debris Management	Map ID: 185
<p>OSCEOLA TWP (Y) Lat: 41.971676 (X) Long: -77.353706</p> <p>Vegetation Encroachment Severity: High Length: 300 ft Width: 100 ft Height: 2 ft Cubic Yards: 2222.22 Immediate Concern: Yes Suggested Action:</p> <p>Comments: Vegetation on gravel bar.</p>

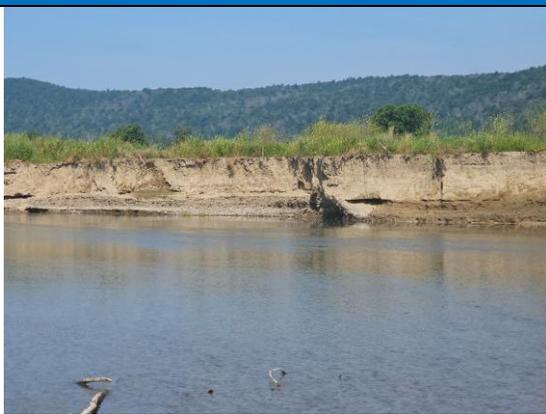
Bank Stabilization	Map ID: 188
<p>OSCEOLA TWP (Y) Lat: 41.972744 (X) Long: -77.350840</p> <p>Undercut Bank Severity: High Length: 500 ft Width: 10 ft Height: 8 ft Cubic Yards: 1481.48 Immediate Concern: Yes Suggested Action: Stabilize Bank</p> <p>Comments: Severe undercut.</p>

186	Stream Restoration	Gravel Bar	OSCEOLA TWP	Moderate	
187	Debris Management	Debris	OSCEOLA TWP	Moderate	Could float down river and cause problems.
188	Bank Stabilization	Undercut Bank	OSCEOLA TWP	High	Severe undercut.
189	Debris Management	Debris	OSCEOLA TWP	Moderate	Center where large gravel bar spills stream.
190	Stream Restoration	Gravel Bar	OSCEOLA TWP	High	Two gravel bars.
191	Debris Management	Debris	OSCEOLA TWP	Moderate	
192	Debris Management	Debris	OSCEOLA TWP	High	Long tree in stream.
193	Debris Management	Debris	OSCEOLA TWP	Moderate	
194	Stream Restoration	Gravel Bar	OSCEOLA TWP	High	Second part of huge gravel bar.
195	Debris Management	Debris	OSCEOLA TWP	Low	
196	Stream Restoration	Gravel Bar	OSCEOLA TWP	High	Big island gravel bar.
197	Stream Restoration	Gravel Bar	OSCEOLA TWP	Low	Center of stream
198	Stream Restoration	Gravel Bar	OSCEOLA TWP	Low	Small gravel bar.
199	Debris Management	Debris	OSCEOLA TWP	Moderate

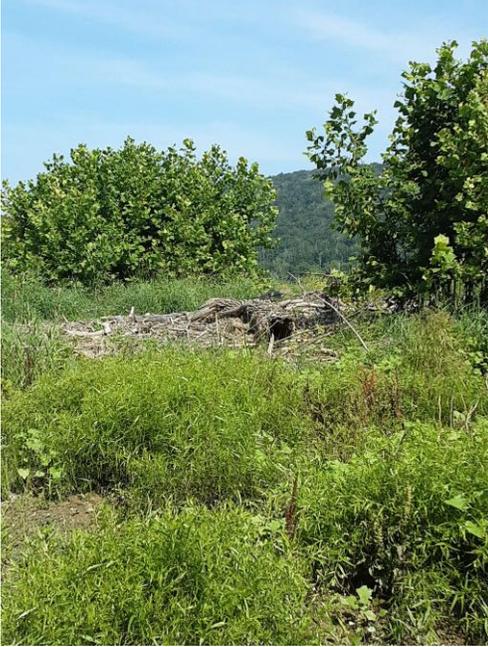
Debris Management	Map ID: 189
<p>OSCEOLA TWP (Y) Lat: 41.972105 (X) Long: -77.350415</p> <p>Debris Severity: Moderate Length: 50 ft Width: 20 ft Height: 4 ft Cubic Yards: 148.15 Immediate Concern: No Suggested Action:</p> <p>Comments: Center where large gravel bar splits stream.</p>

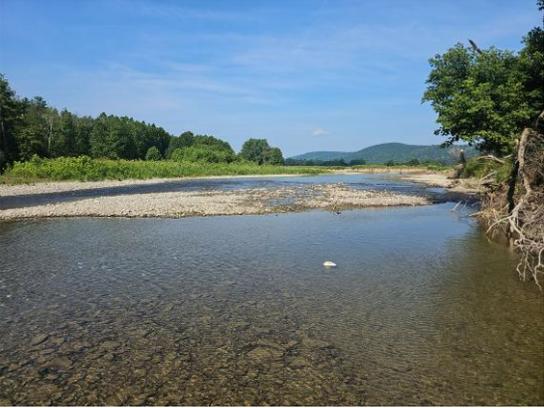
Stream Restoration	Map ID: 190
<p>OSCEOLA TWP (Y) Lat: 41.972650 (X) Long: -77.349446</p> <p>Gravel Bar Severity: High Length: 200 ft Width: 75 ft Height: 2 ft Cubic Yards: 1111.11 Immediate Concern: Yes Suggested Action:</p> <p>Comments: Two gravel bars.</p>

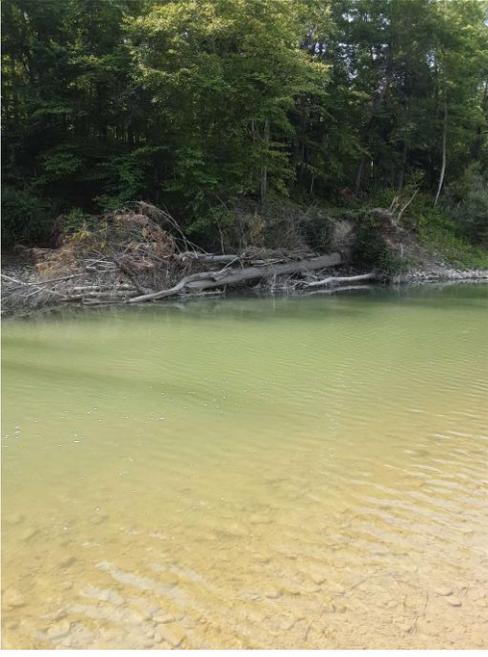
Debris Management	Map ID: 191
<p>OSCEOLA TWP (Y) Lat: 41.972697 (X) Long: -77.348749</p> <p>Debris Severity: Moderate Length: 60 ft Width: 10 ft Height: 5 ft Cubic Yards: 111.11 Immediate Concern: Yes Suggested Action: Remove Debris</p> <p>Comments:</p>

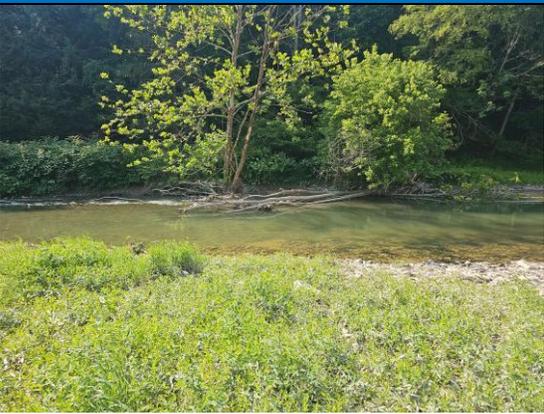
Debris Management	Map ID: 192
<p>OSCEOLA TWP (Y) Lat: 41.973368 (X) Long: -77.347561</p> <p>Debris Severity: High Length: 10 ft Width: 10 ft Height: 3 ft Cubic Yards: 11.11 Immediate Concern: Yes Suggested Action: Remove Debris</p> <p>Comments: Long tree in stream.</p>

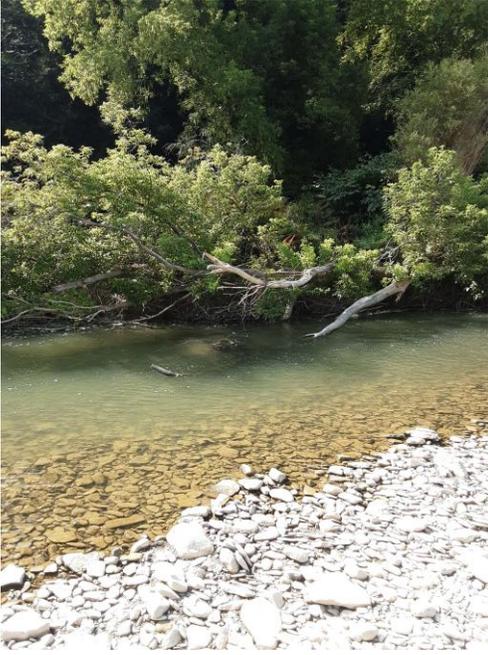
Debris Management	Map ID: 193
<p>OSCEOLA TWP (Y) Lat: 41.973631 (X) Long: -77.346900</p> <p>Debris Severity: Moderate Length: 40 ft Width: 10 ft Height: 2 ft Cubic Yards: 29.63 Immediate Concern: No Suggested Action:</p> <p>Comments:</p>

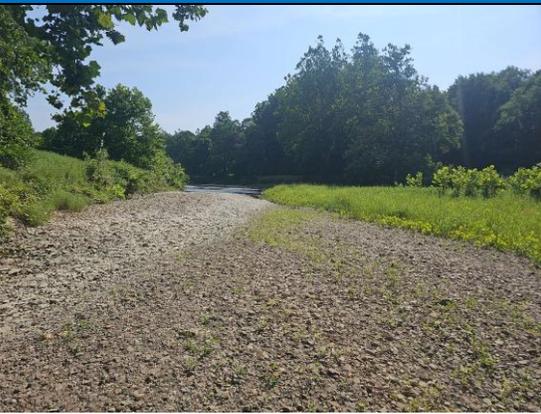
Stream Restoration	Map ID: 194
<p>OSCEOLA TWP (Y) Lat: 41.973950 (X) Long: -77.347044</p> <p>Gravel Bar Severity: High Length: 350 ft Width: 200 ft Height: 3 ft Cubic Yards: 7777.78 Immediate Concern: Yes Suggested Action: Restore Channel</p> <p>Comments: Second part of huge gravel bar.</p>

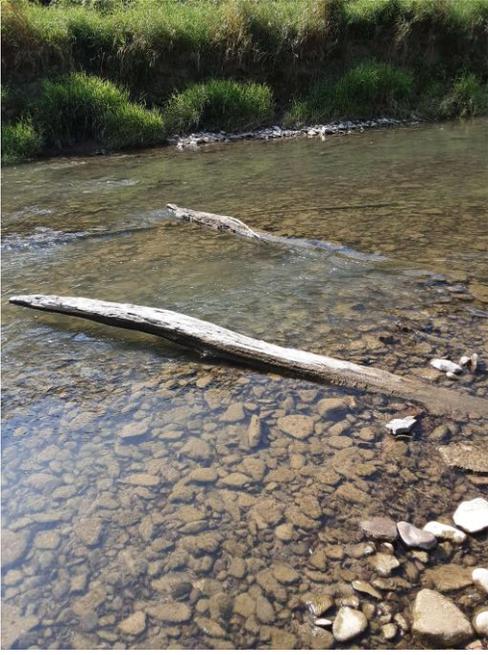
Debris Management	Map ID: 195
<p>OSCEOLA TWP (Y) Lat: 41.973911 (X) Long: -77.346557</p> <p>Debris Severity: Low Length: 10 ft Width: 1 ft Height: 1 ft Cubic Yards: 0.37 Immediate Concern: No Suggested Action:</p> <p>Comments:</p>

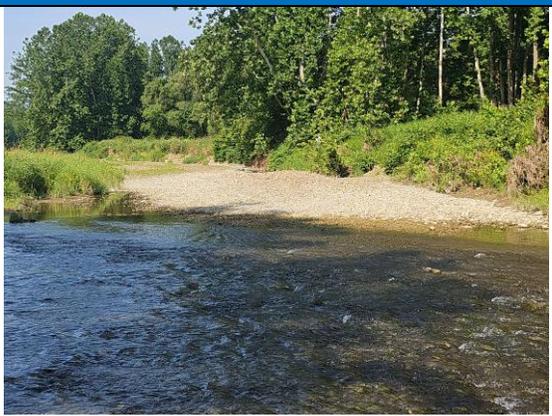
Stream Restoration	Map ID: 196
<p>OSCEOLA TWP (Y) Lat: 41.974218 (X) Long: -77.346140</p> <p>Gravel Bar Severity: High Length: 68 ft Width: 250 ft Height: 2.5 ft Cubic Yards: 1574.07 Immediate Concern: Yes Suggested Action: Restore Channel</p> <p>Comments: Big island gravel bar.</p>

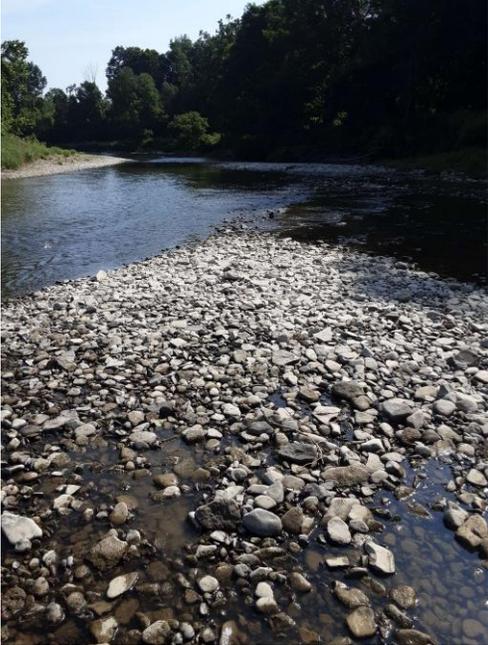
Stream Restoration	Map ID: 197
<p>OSCEOLA TWP (Y) Lat: 41.974289 (X) Long: -77.346046</p> <p>Gravel Bar Severity: Low Length: 15 ft Width: 10 ft Height: 1 ft Cubic Yards: 5.56 Immediate Concern: No Suggested Action:</p> <p>Comments: Center of stream</p>

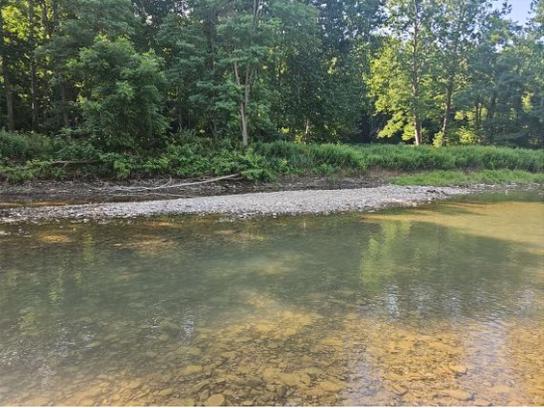
Stream Restoration	Map ID: 198
<p>OSCEOLA TWP (Y) Lat: 41.974564 (X) Long: -77.345582</p> <p>Gravel Bar Severity: Low Length: 30 ft Width: 13 ft Height: 1 ft Cubic Yards: 14.44 Immediate Concern: No Suggested Action:</p> <p>Comments: Small gravel bar.</p>

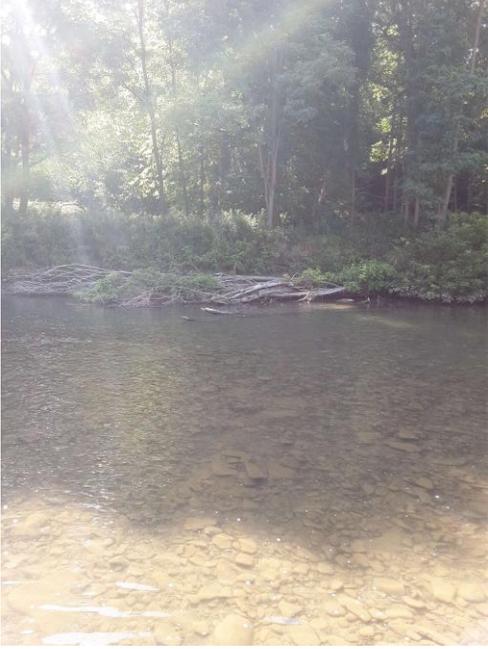
Debris Management	Map ID: 199
<p>OSCEOLA TWP (Y) Lat: 41.974753 (X) Long: -77.345272</p> <p>Debris Severity: Moderate Length: 40 ft Width: 5 ft Height: 2 ft Cubic Yards: 14.81 Immediate Concern: No Suggested Action:</p> <p>Comments:</p>

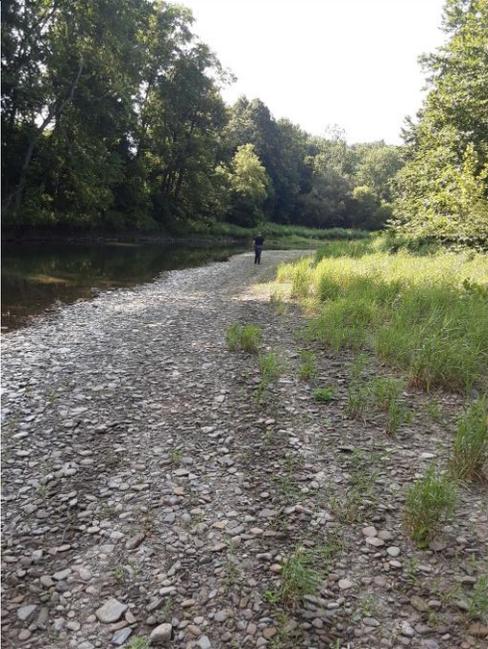
Stream Restoration	Map ID: 200
<p>OSCEOLA TWP (Y) Lat: 41.976603 (X) Long: -77.345149</p> <p>Gravel Bar Severity: Low Length: 1000 ft Width: 15 ft Height: 1 ft Cubic Yards: 555.56 Immediate Concern: No Suggested Action:</p> <p>Comments: Long gravel bar on right side of stream.</p>

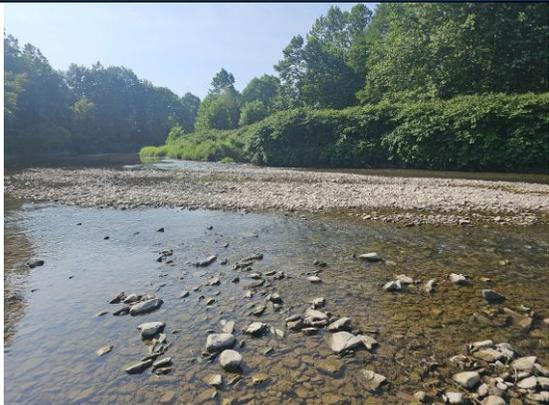
Stream Restoration	Map ID: 201
<p>OSCEOLA TWP (Y) Lat: 41.977404 (X) Long: -77.346033</p> <p>Gravel Bar Severity: Low Length: 69 ft Width: 21 ft Height: 1 ft Cubic Yards: 53.67 Immediate Concern: No Suggested Action:</p> <p>Comments:</p>

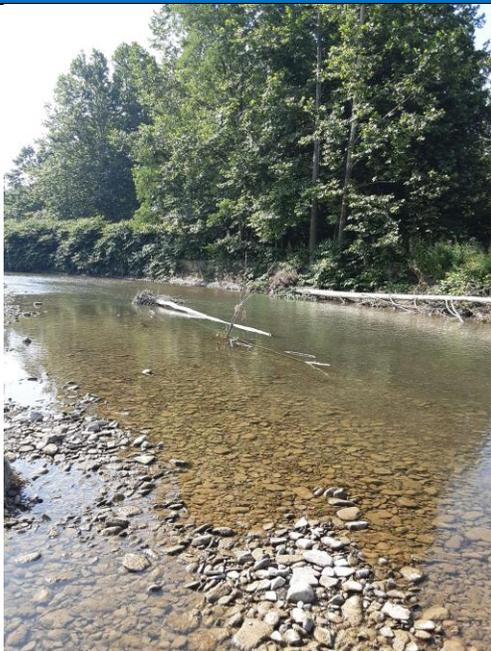
Debris Management	Map ID: 202
<p>OSCEOLA TWP (Y) Lat: 41.977568 (X) Long: -77.346656</p> <p>Debris Severity: High Length: 50 ft Width: 1 ft Height: 1 ft Cubic Yards: 1.85 Immediate Concern: Yes Suggested Action: Remove Debris</p> <p>Comments: One tree on right bank and one middle of stream.</p>

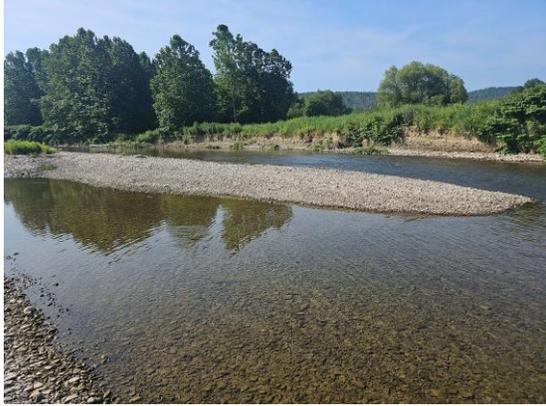
Stream Restoration	Map ID: 203
<p>OSCEOLA TWP (Y) Lat: 41.978030 (X) Long: -77.347010</p> <p>Gravel Bar Severity: Moderate Length: 68 ft Width: 22 ft Height: 2 ft Cubic Yards: 110.81 Immediate Concern: No Suggested Action:</p> <p>Comments:</p>

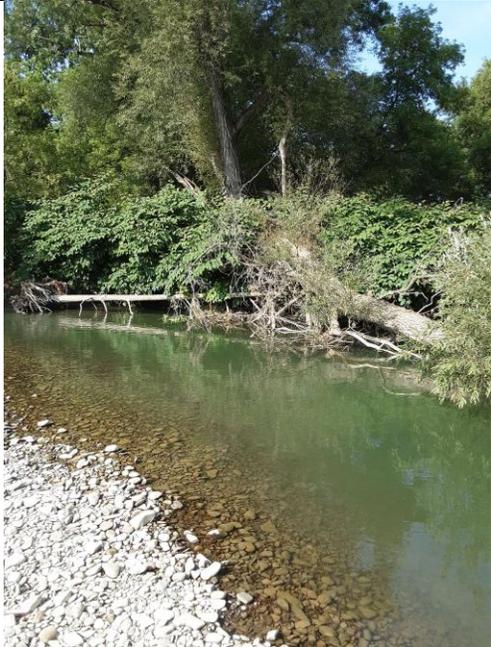
Debris Management	Map ID: 204
<p>OSCEOLA TWP (Y) Lat: 41.979047 (X) Long: -77.347526</p> <p>Debris Severity: Moderate Length: 40 ft Width: 2 ft Height: 2 ft Cubic Yards: 5.93 Immediate Concern: Yes Suggested Action: Remove Debris</p> <p>Comments:</p>

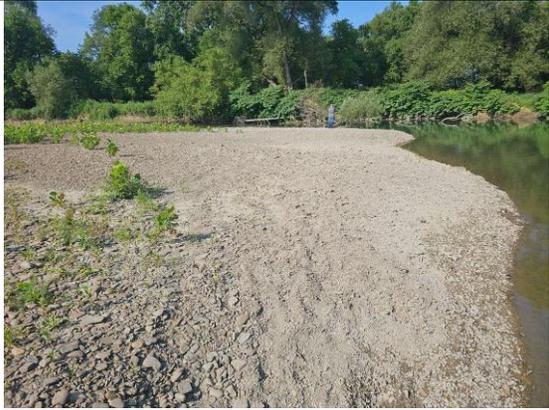
Stream Restoration	Map ID: 205
<p>OSCEOLA TWP (Y) Lat: 41.978991 (X) Long: -77.347275</p> <p>Gravel Bar Severity: High Length: 51 ft Width: 62 ft Height: 2.7000000000000002 ft Cubic Yards: 316.20 Immediate Concern: Yes Suggested Action:</p> <p>Comments: Bad gravel bar.</p>

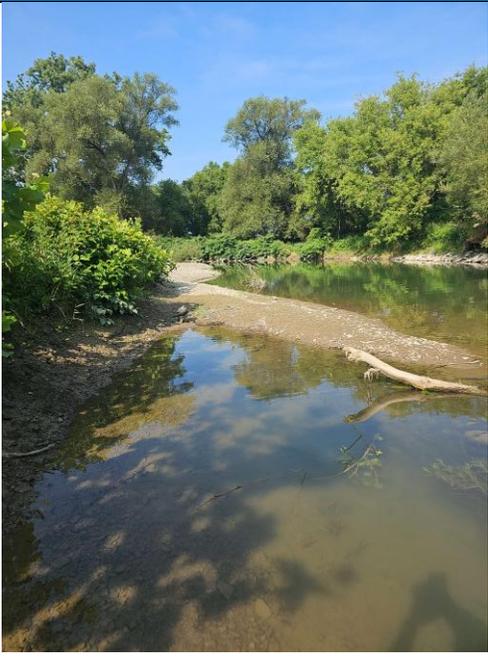
Debris Management	Map ID: 206
<p>OSCEOLA TWP (Y) Lat: 41.979066 (X) Long: -77.347073</p> <p>Debris Severity: High Length: 77 ft Width: 13 ft Height: 2 ft Cubic Yards: 74.15 Immediate Concern: Yes Suggested Action:</p> <p>Comments: Tree and gravel.</p>

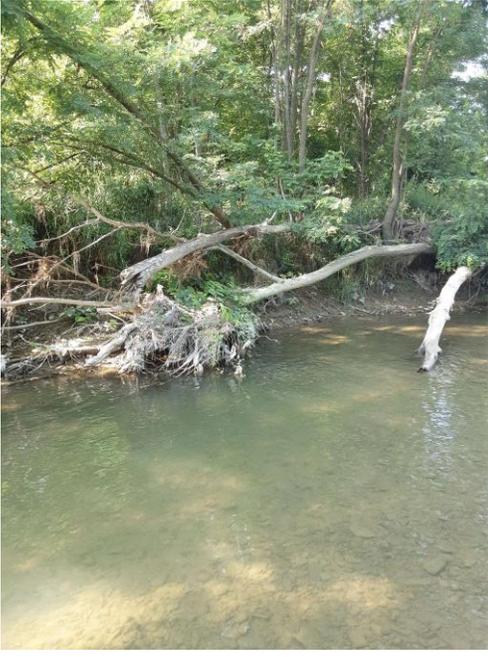
Debris Management	Map ID: 207
<p>OSCEOLA TWP (Y) Lat: 41.979210 (X) Long: -77.346604</p> <p>Debris Severity: Low Length: 50 ft Width: 1 ft Height: 1 ft Cubic Yards: 1.85 Immediate Concern: No Suggested Action:</p> <p>Comments: Downed trees.</p>

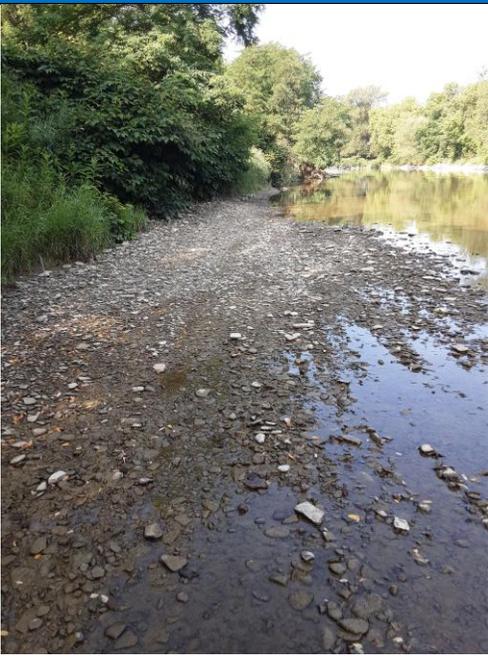
Stream Restoration	Map ID: 208
<p>OSCEOLA TWP (Y) Lat: 41.979423 (X) Long: -77.345976</p> <p>Gravel Bar Severity: Low Length: 50 ft Width: 10 ft Height: 0.5 ft Cubic Yards: 9.26 Immediate Concern: No Suggested Action: Restore Channel</p> <p>Comments:</p>

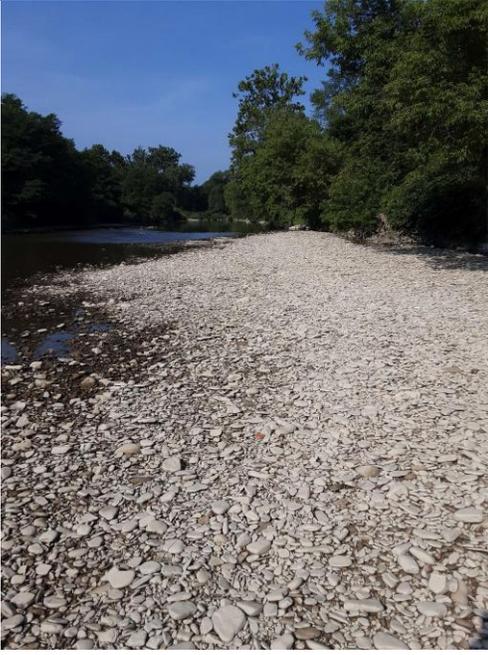
Stream Restoration	Map ID: 209
<p>OSCEOLA TWP (Y) Lat: 41.979931 (X) Long: -77.345037</p> <p>Gravel Bar Severity: Low Length: 100 ft Width: 30 ft Height: 1 ft Cubic Yards: 111.11 Immediate Concern: No Suggested Action:</p> <p>Comments:</p>

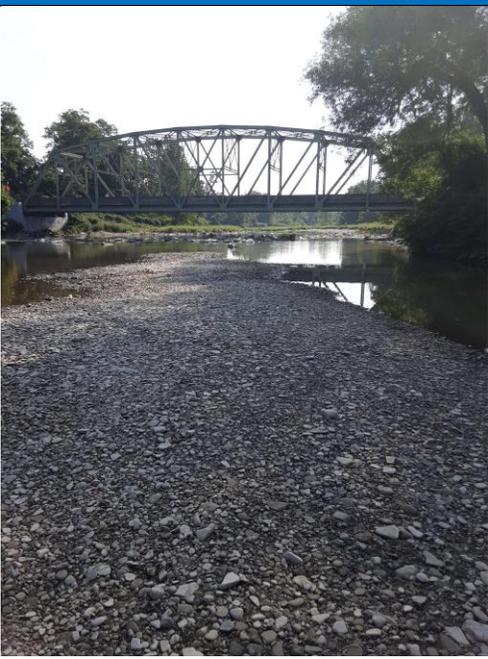
Stream Restoration	Map ID: 210
<p>OSCEOLA TWP (Y) Lat: 41.980207 (X) Long: -77.343838</p> <p>Gravel Bar Severity: Low Length: 150 ft Width: 20 ft Height: 1 ft Cubic Yards: 111.11 Immediate Concern: No Suggested Action:</p> <p>Comments:</p>

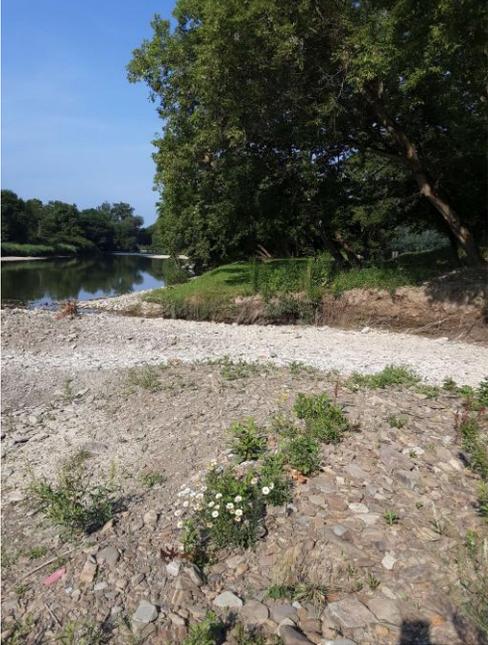
Stream Restoration	Map ID: 211
<p>OSCEOLA TWP (Y) Lat: 41.980503 (X) Long: -77.343549</p> <p>Gravel Bar Severity: Moderate Length: 30 ft Width: 20 ft Height: 2 ft Cubic Yards: 44.44 Immediate Concern: No Suggested Action:</p> <p>Comments: Gravel bar built up where tributary enters stream.</p>

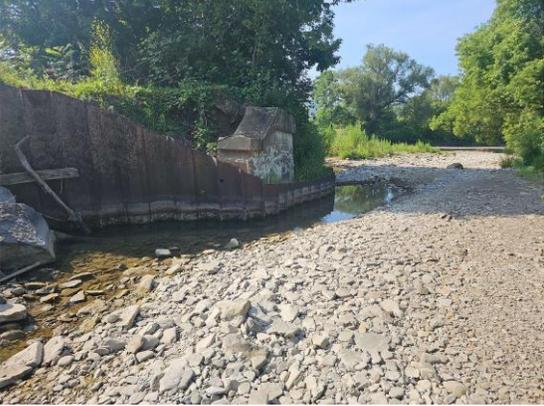
Debris Management	Map ID: 212
<p>OSCEOLA TWP (Y) Lat: 41.980867 (X) Long: -77.343619</p> <p>Debris Severity: High Length: 200 ft Width: 17 ft Height: 2 ft Cubic Yards: 251.85 Immediate Concern: Yes Suggested Action: Remove Debris</p> <p>Comments: Significant debris upsteam in tributary.</p>

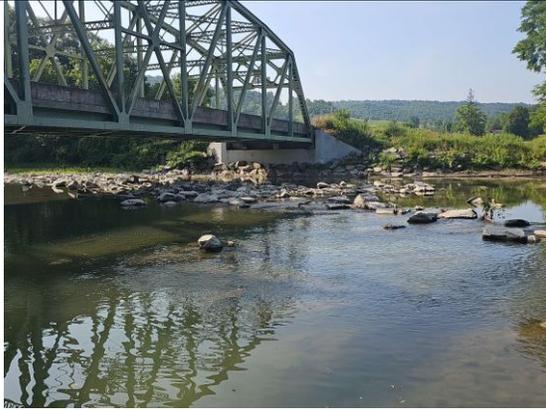
Debris Management	Map ID: 213
<p>OSCEOLA TWP (Y) Lat: 41.980554 (X) Long: -77.343438</p> <p>Debris Severity: Moderate Length: 100 ft Width: 25 ft Height: 2.5 ft Cubic Yards: 231.48 Immediate Concern: Yes Suggested Action: Remove Debris</p> <p>Comments: Other side of bridge.</p>

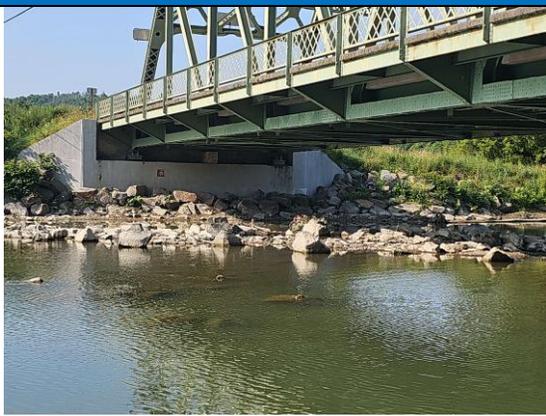
Debris Management	Map ID: 214
<p>OSCEOLA TWP (Y) Lat: 41.980549 (X) Long: -77.342969</p> <p>Debris Severity: Moderate Length: 100 ft Width: 25 ft Height: 2.5 ft Cubic Yards: 231.48 Immediate Concern: Yes Suggested Action: Remove Debris</p> <p>Comments: Affecting bridge on right side.</p>
